Technical Service Information

MITSUBISHI 4 SPEED UNITS

NO CONVERTER FILL/PREMATURE PUMP BUSHING FAILURE

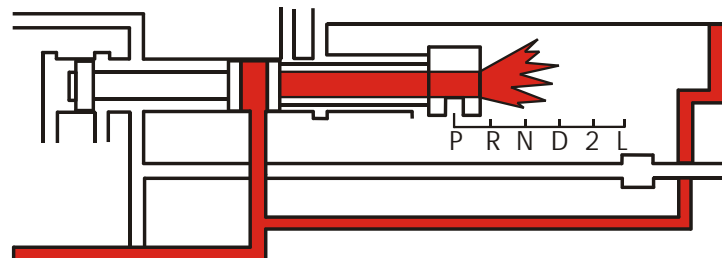
Figure 1

COMPLAINT: The converter will not fill with fluid after overhaul possibly causing premature failure of the pump bushing. Signs of lubrication failure may also be present.

CAUSE: One cause may be that the manual valve is designed to exhaust line pressure while in the Park range through a passage formed inside the valve (See Figure 1). The passage is approximately .250" in diameter which allows for a rather large exhaust to occur. This large exhaust drops line pressure low enough to prevent converter fill and stops all cooler flow. With a lack of fluid flowing into the converter and a loss of front lubrication, the bushing and converter neck may be damaged before converter fill and cooler flow is obtained.

Manual Valve Exhausting Line While In Park

CORRECTION: Pre-fill the converter with as much fluid as possible. Also lube the pump bushing generously. Always fill the unit with the selector lever in the Neutral range, **NOT** in Park. To allow for cooler flow to be present while in the Park range, an **orificed** cup plug supplied by **Sonnax** under part number 41750-01, with a .062" orifice can be driven into the end of the manual valve, as shown in Figure 2. This will allow for full converter charge as well as cooler flow in Park.
