Technical Service Information

THM 4T60-E TIE-UP IN PARK AND REVERSE MOVES FORWARD IN NEUTRAL TIE-UP ON 2-3 UPSHIFT

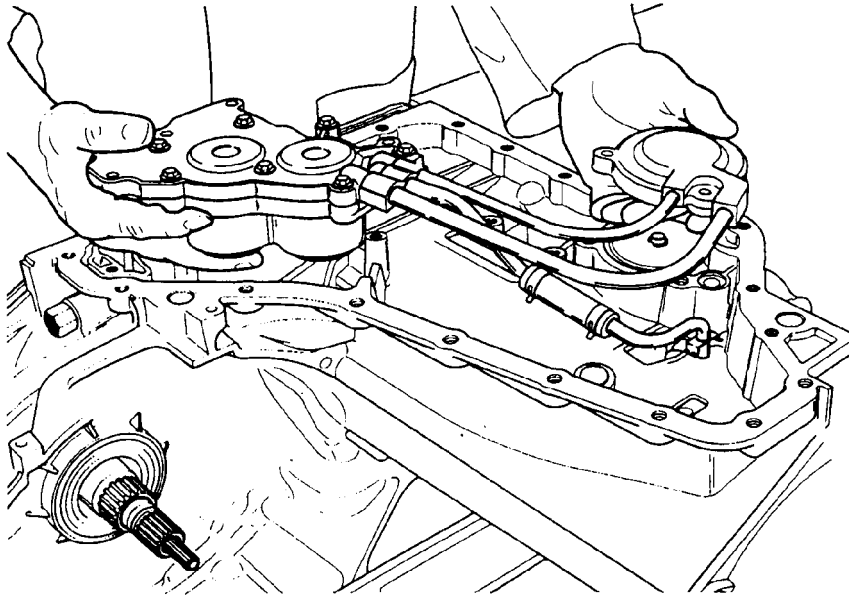
CAUSE: The cause may be, the. rear lube pipe and the apply pipe for the 2-1 manual servo, reversed in the accumulator housing cover (See Figure 1). This will allow lube oil to apply the 2-1 manual servo and the band as soon as the engine is started.

Figure 1 shows the 'incorrect' assembly of the pipes.

"INCORRECT" INSTALLATION

REAR LUBE PIPE IS IN CENTER HOLE IN ACCUMULATOR COVER

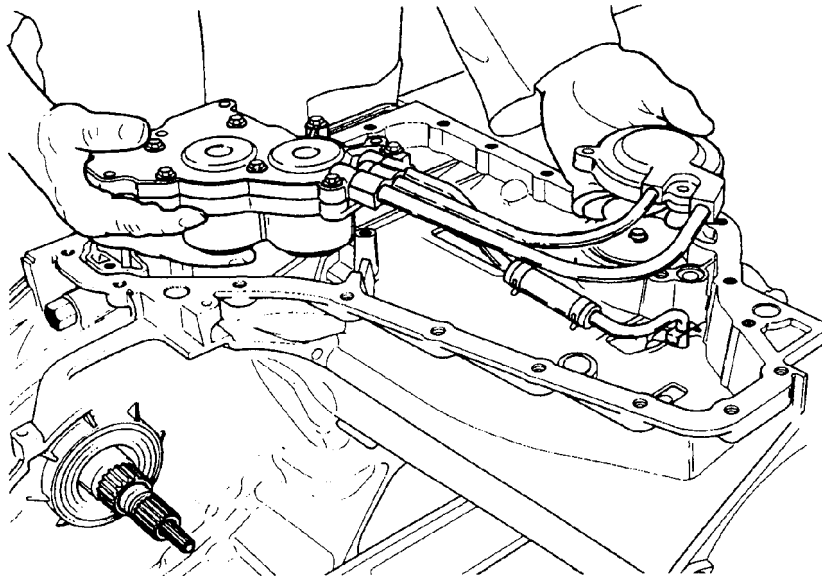
Figure 2 shows the "Correct" assembly of the pipes.

"CORRECT" INSTALLATION

REAR LUBE PIPE IS IN RIGHT HOLE IN ACCUMULATOR COVER

CORRECTION: Install the tubes into the accumulator housing cover with the 2-1 manual servo apply pipe in the "Center" hole, as shown in Figure 2, and the rear lube pipe in the right hand hole, as shown in Figure 2. The forward servo apply pipe cannot be installed in the wrong hole as it is a larger diameter than the other two.
