Technical Service Information

FORD A4LD HARSH 1-2 SHIFTS

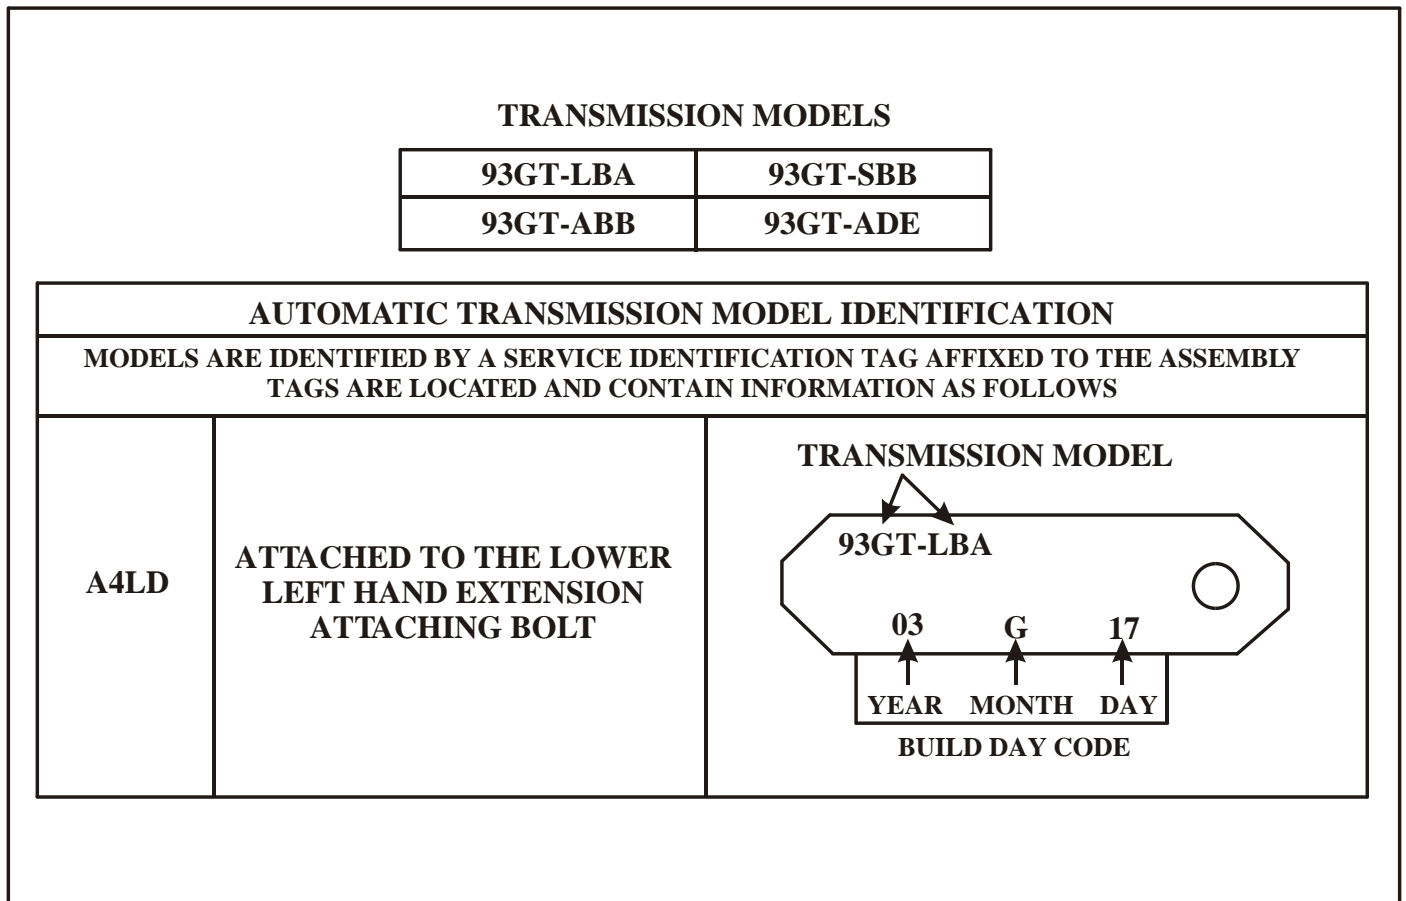
- COMPLAINT:** Some models of the Ford A4LD transmission found in 1993- 1994 Ford Rangers may display a harsh 1-2 upshift.
- CAUSE:** The cause may be the calibration of the Intermediate Servo Release (TSR) accumulator spring, located in the valve body..
- CORRECTION:** Perform the On-Board Diagnostic procedures to verify that no other concerns and/or trouble codes exist. If no other concerns exist, refer to the chart in Figure 1 to ensure that the transmission model you are servicing is listed. If it is listed, replace the Brown production intermediate servo release spring with a White (re-calibrated) service spring, available under part number E4TZ-7F261 -AVMR. Refer to Figure 2 for ISR accumulator spring location in the valve body.
- NOTE:** *Performing the above procedure on transmission models that are not listed in Figure 1, may result in damage to the transmission.*

ISR Accumulator Spring (White - Re-calibrated) E4TZ-7F26 1 -AVMR
