## CHRYSLER AND DODGE VEHICLES

### 1776 SOLENOID SWITCH LATCHED IN THE LR POSITION

**COMPLAINT:** The on board computer system for the transmission may intermittently produce a code P1776 Solenoid Switch Valve Latched in the LR Position causing a default to limp.

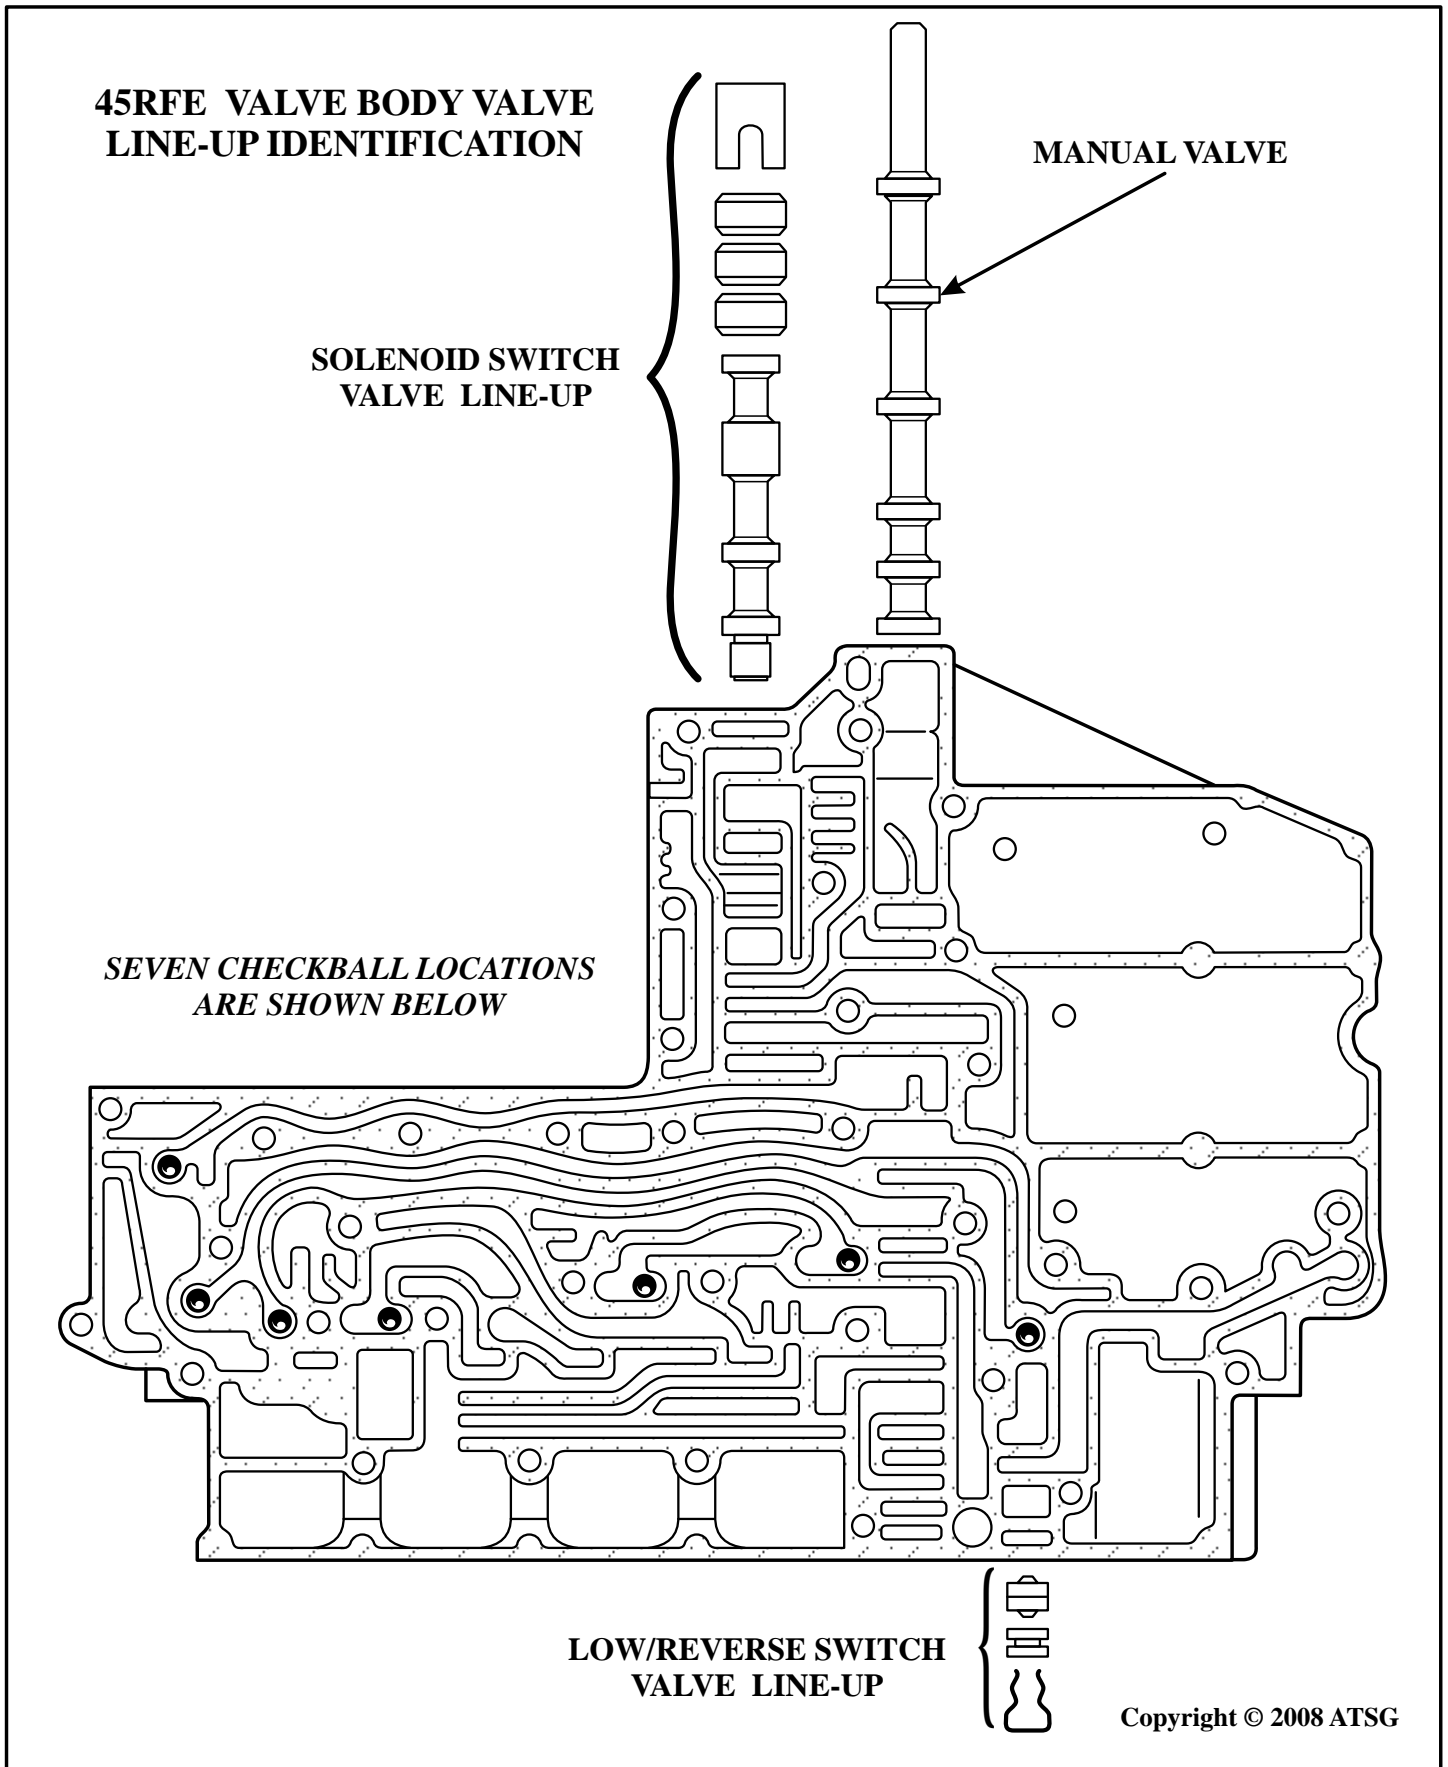
4. The Solenoid Switch Valve in the valve body is sticking in the Low/Reverse position.  
Refer to Figure 1 for the location of the Solenoid Switch Valve on 45RFE models.  
Refer to Figure 2 for a hydraulic schematic of 4th gear with TCC Off.  
Refer to Figure 3 for a hydraulic schematic of 4th gear with the TCC On.

**CORRECTION:** 4. Clean the solenoid switch valve line up in the valve body and ensure that it has free movement. When the valve body is assembled, you should be able to shake the valve body and hear that it is moving.

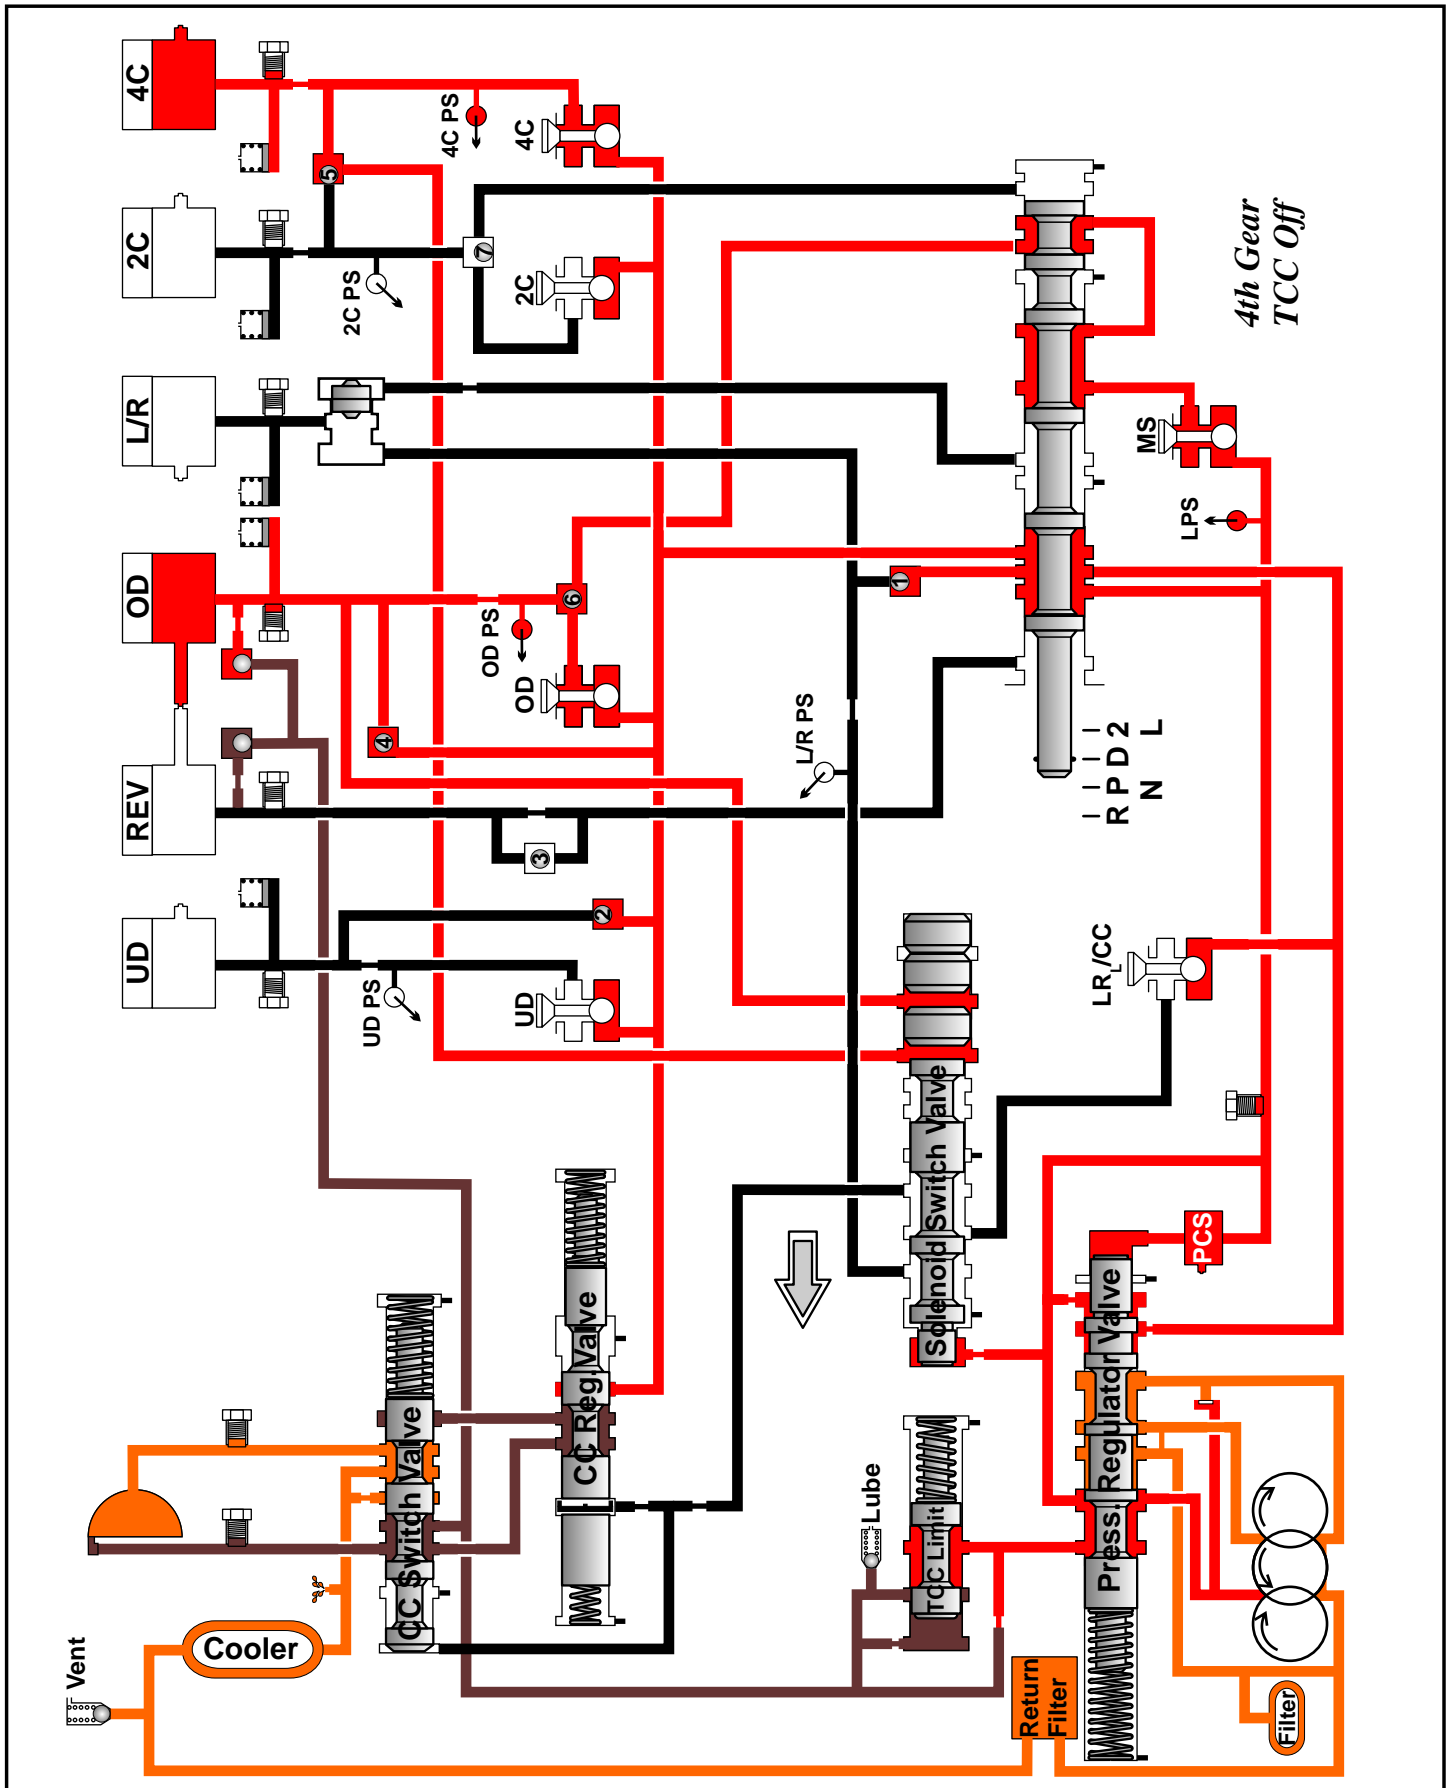
Figure 2

***Notice the position of the switch valve as it is held to the left blocking the passage to the Low Reverse Clutch and pressure switch.***  
Refer to Figure 4 for a hydraulic schematic of 4th gear with the Solenoid Switch valve stuck to the right, (Low Reverse Position).

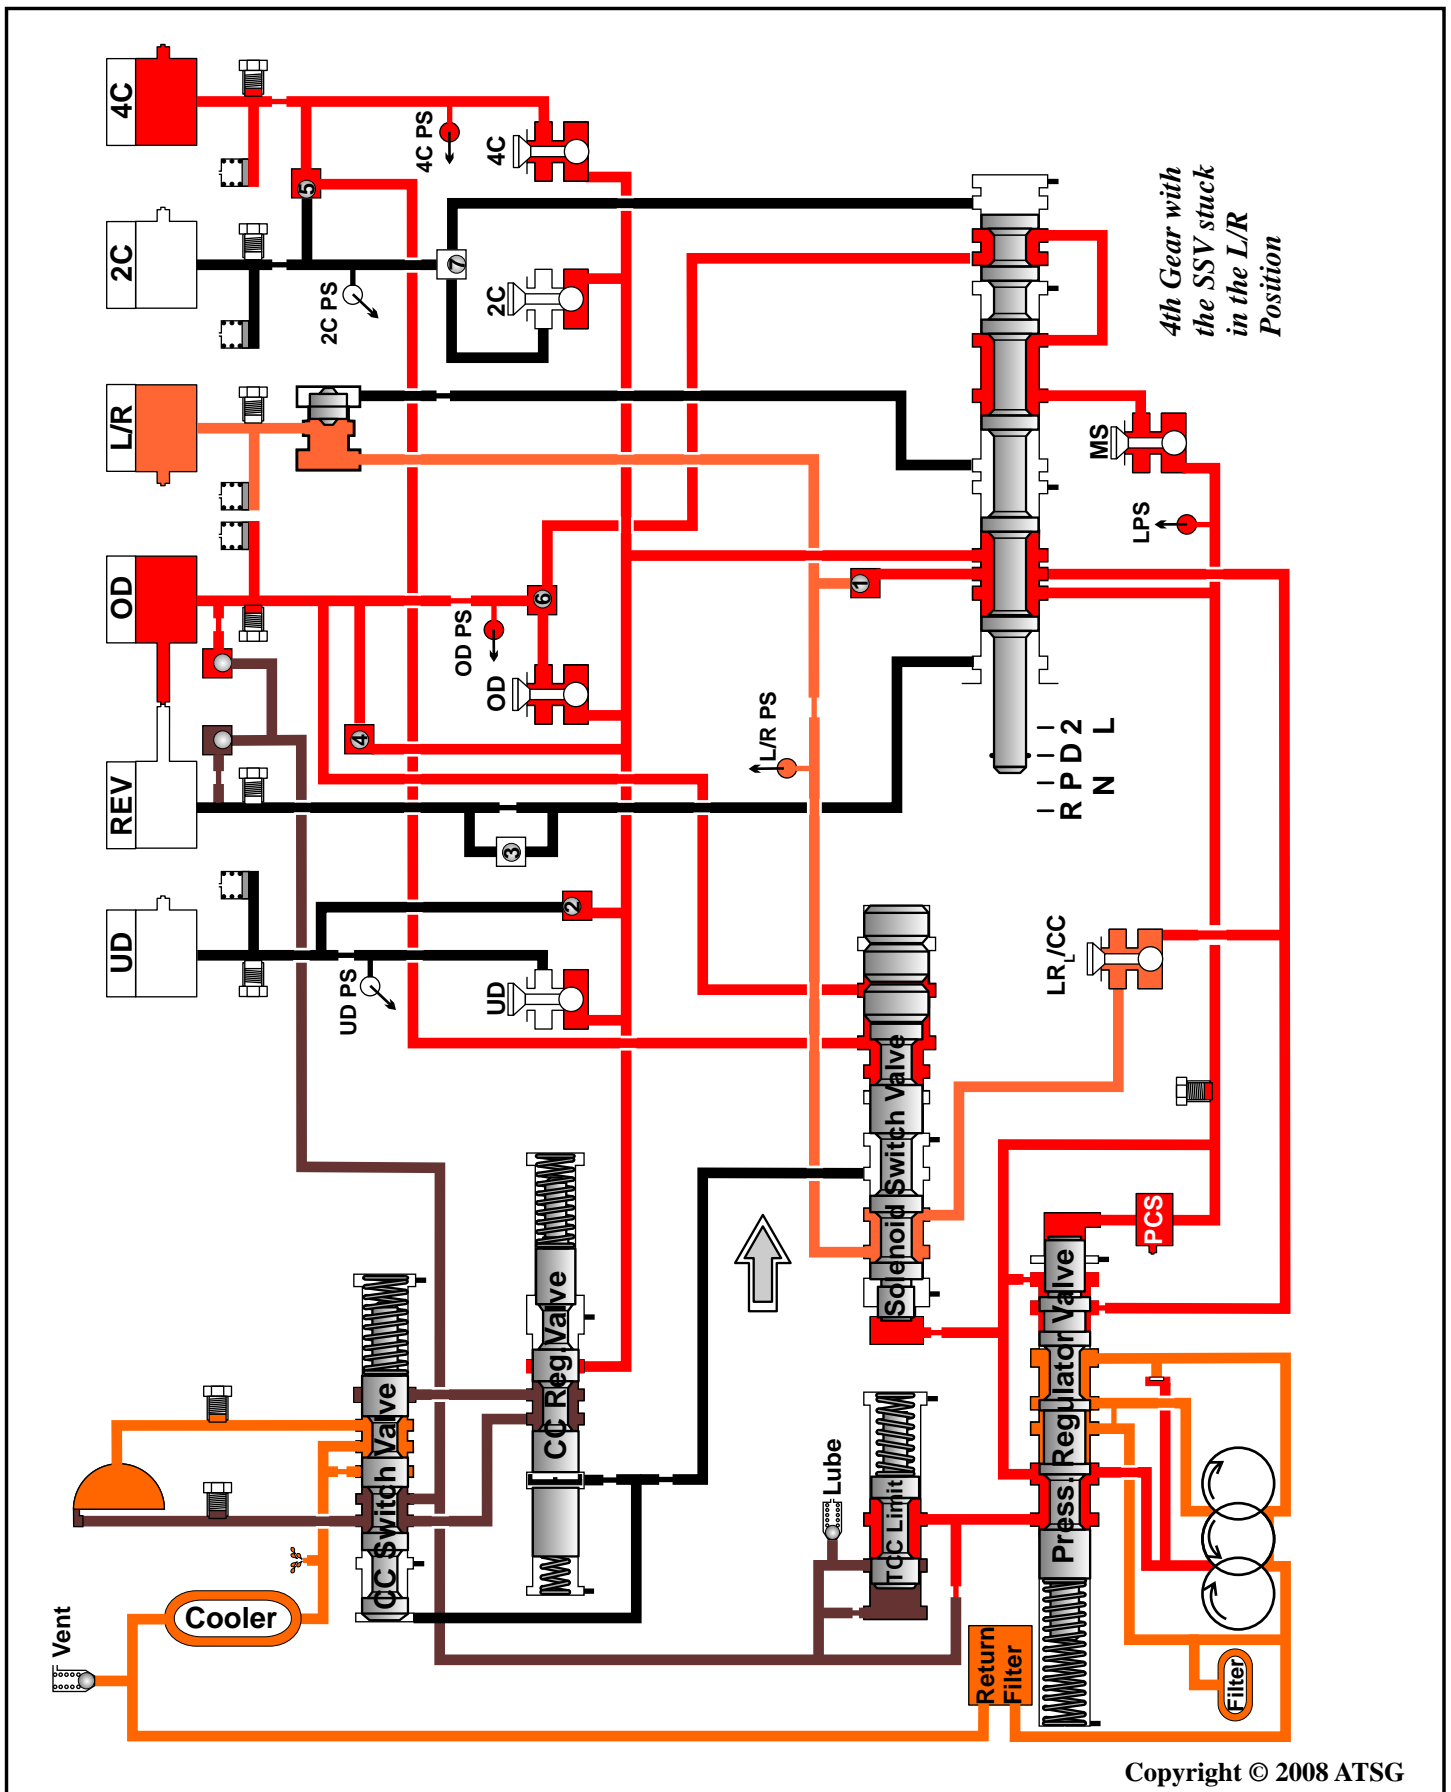
Figure 4

***In this position the Low Reverse Solenoid can apply the Low Reverse Clutch instead of the TCC. This also allows the Low Reverse Pressure switch to be contacted setting the DTC 1776.***

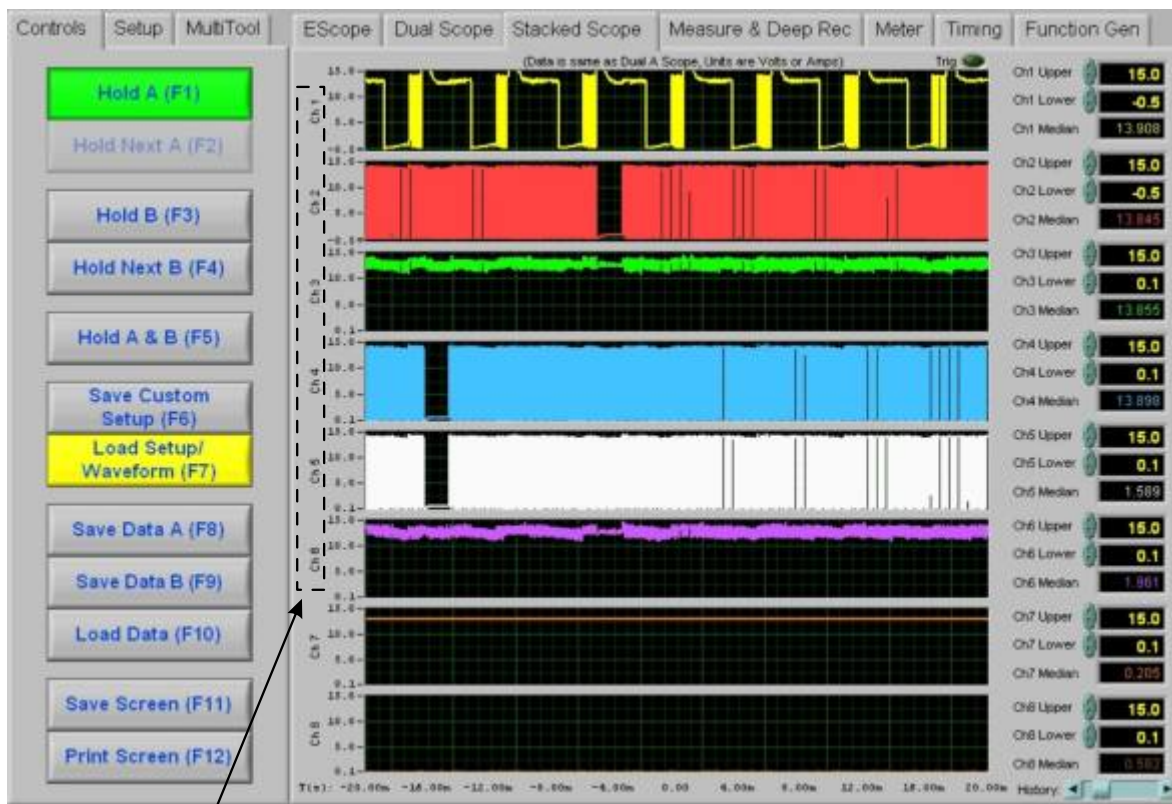
Figure 9

## SCOPE CHANNEL I.D.

### 4th Gear

**Channel 1** = LR /CC Solenoid (NV) is energized for TCC Apply

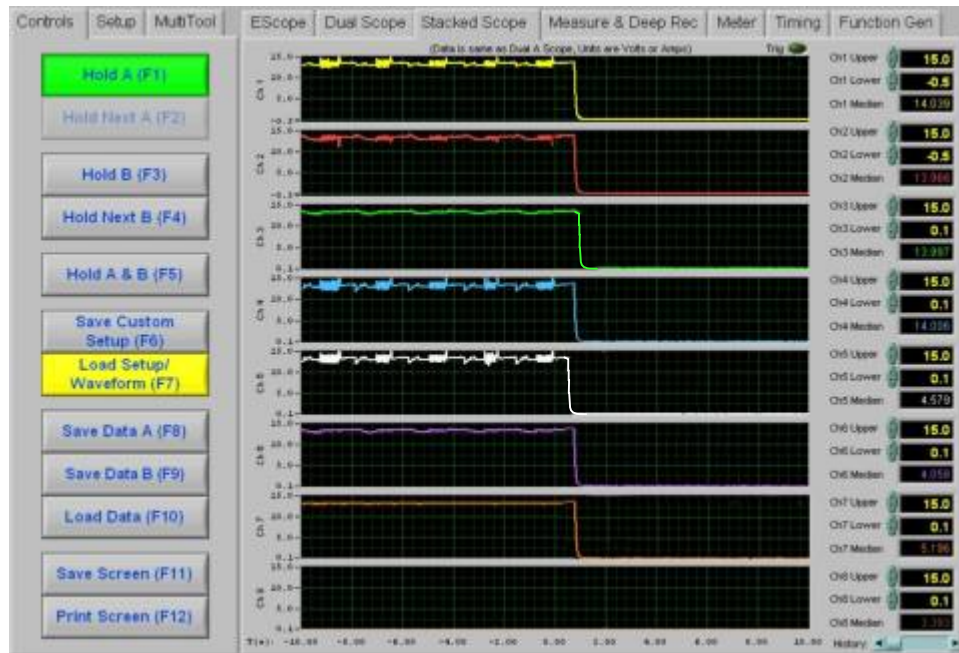
Figure 10

## 4th Gear to Limp- (all channels indicate all solenoids OFF)

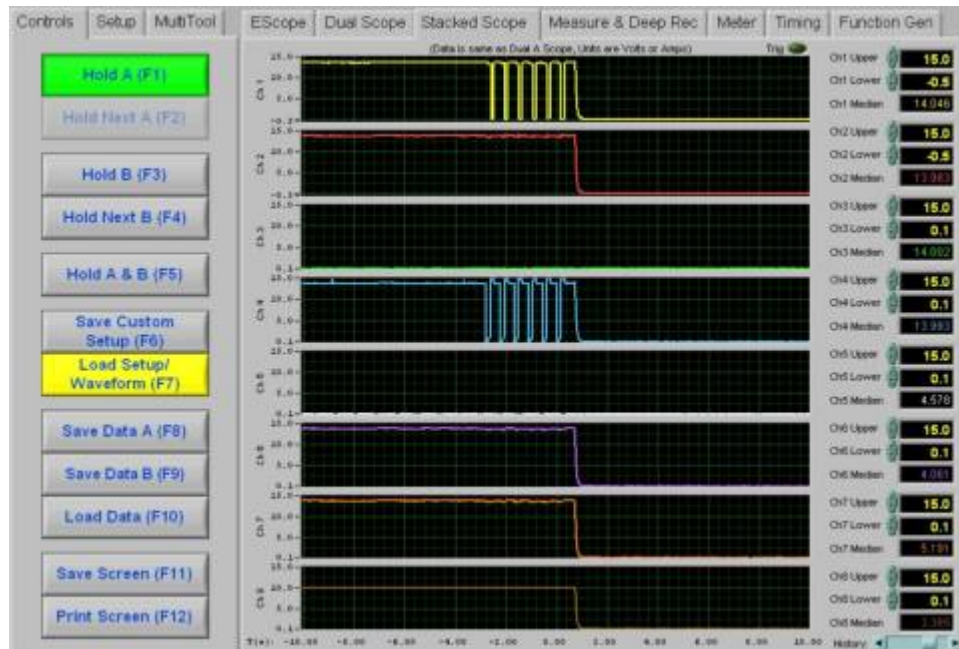
Figure 11

## LR Solenoid & LR Pressure Switch Comparison

**Channel 1** = LR Pressure Switch Signal during TCC Command

**Channel 4** = LR Solenoid Duty Cycle during TCC Command

As the computer was commanding the TCC to be applied the pressure switch was toggled to ground indicating that the solenoid switch valve was latched in the LR position. The computer went to failsafe cutting all power to the transmission.

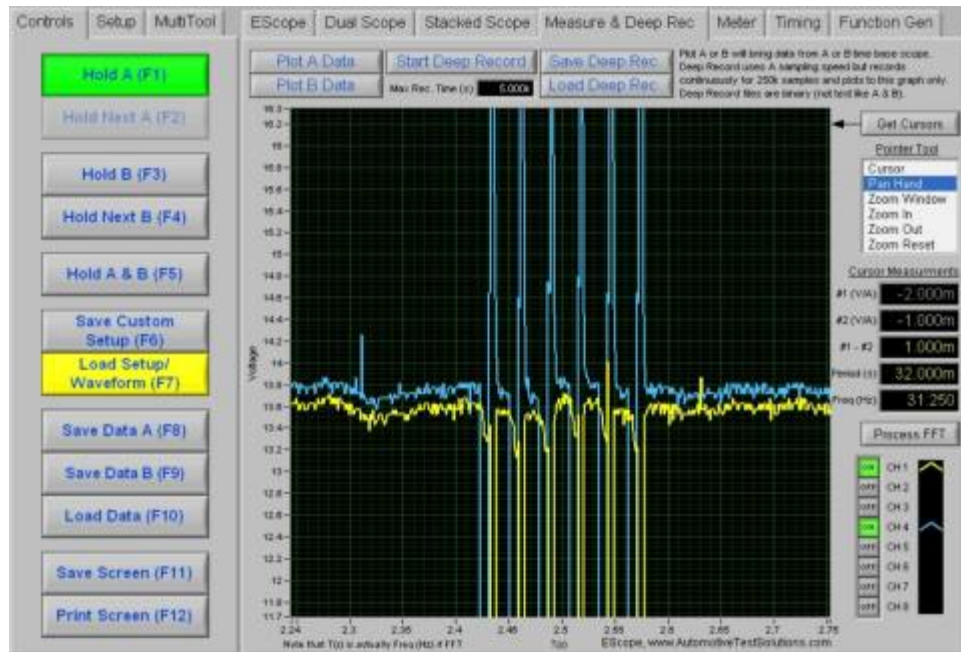
Figure 12

## Closer view of LR Solenoid and LR Pressure Switch

Notice that as the Low Reverse Solenoid is pulsed the Low Reverse Pressure Switch is closing, indicating a stuck Solenoid Switch Valve.
