Technical Service Information

THM 4T80-E NO ENGINE BRAKING AND OR DELAYED ENGAGEMENT IN THE D3 POSITION

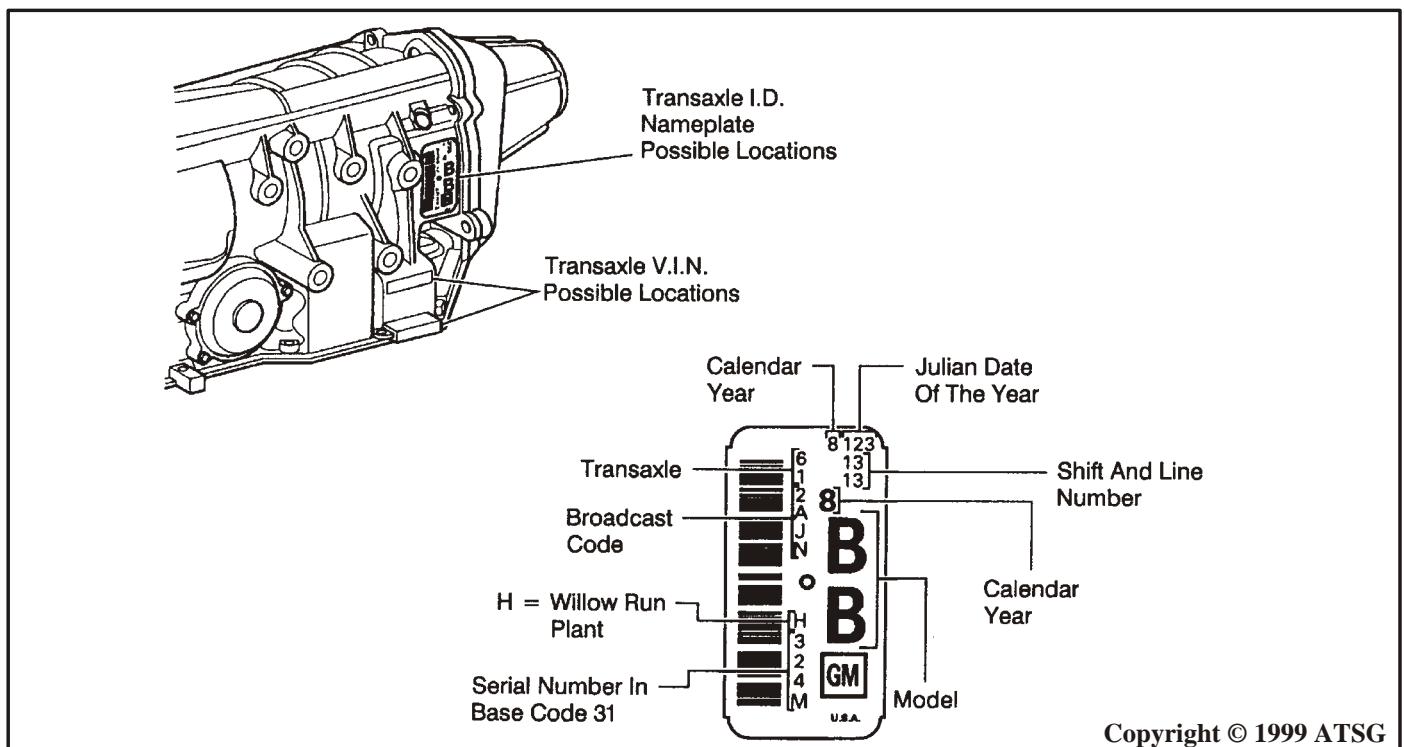
Figure 1

COMPLAINT: Units built prior to October 24, 1997, Julian date 297 (See Figure 1) may experience a loss of engine braking in the D3 position and/or a several second delayed engagement when selector lever is moved into the D3 position.

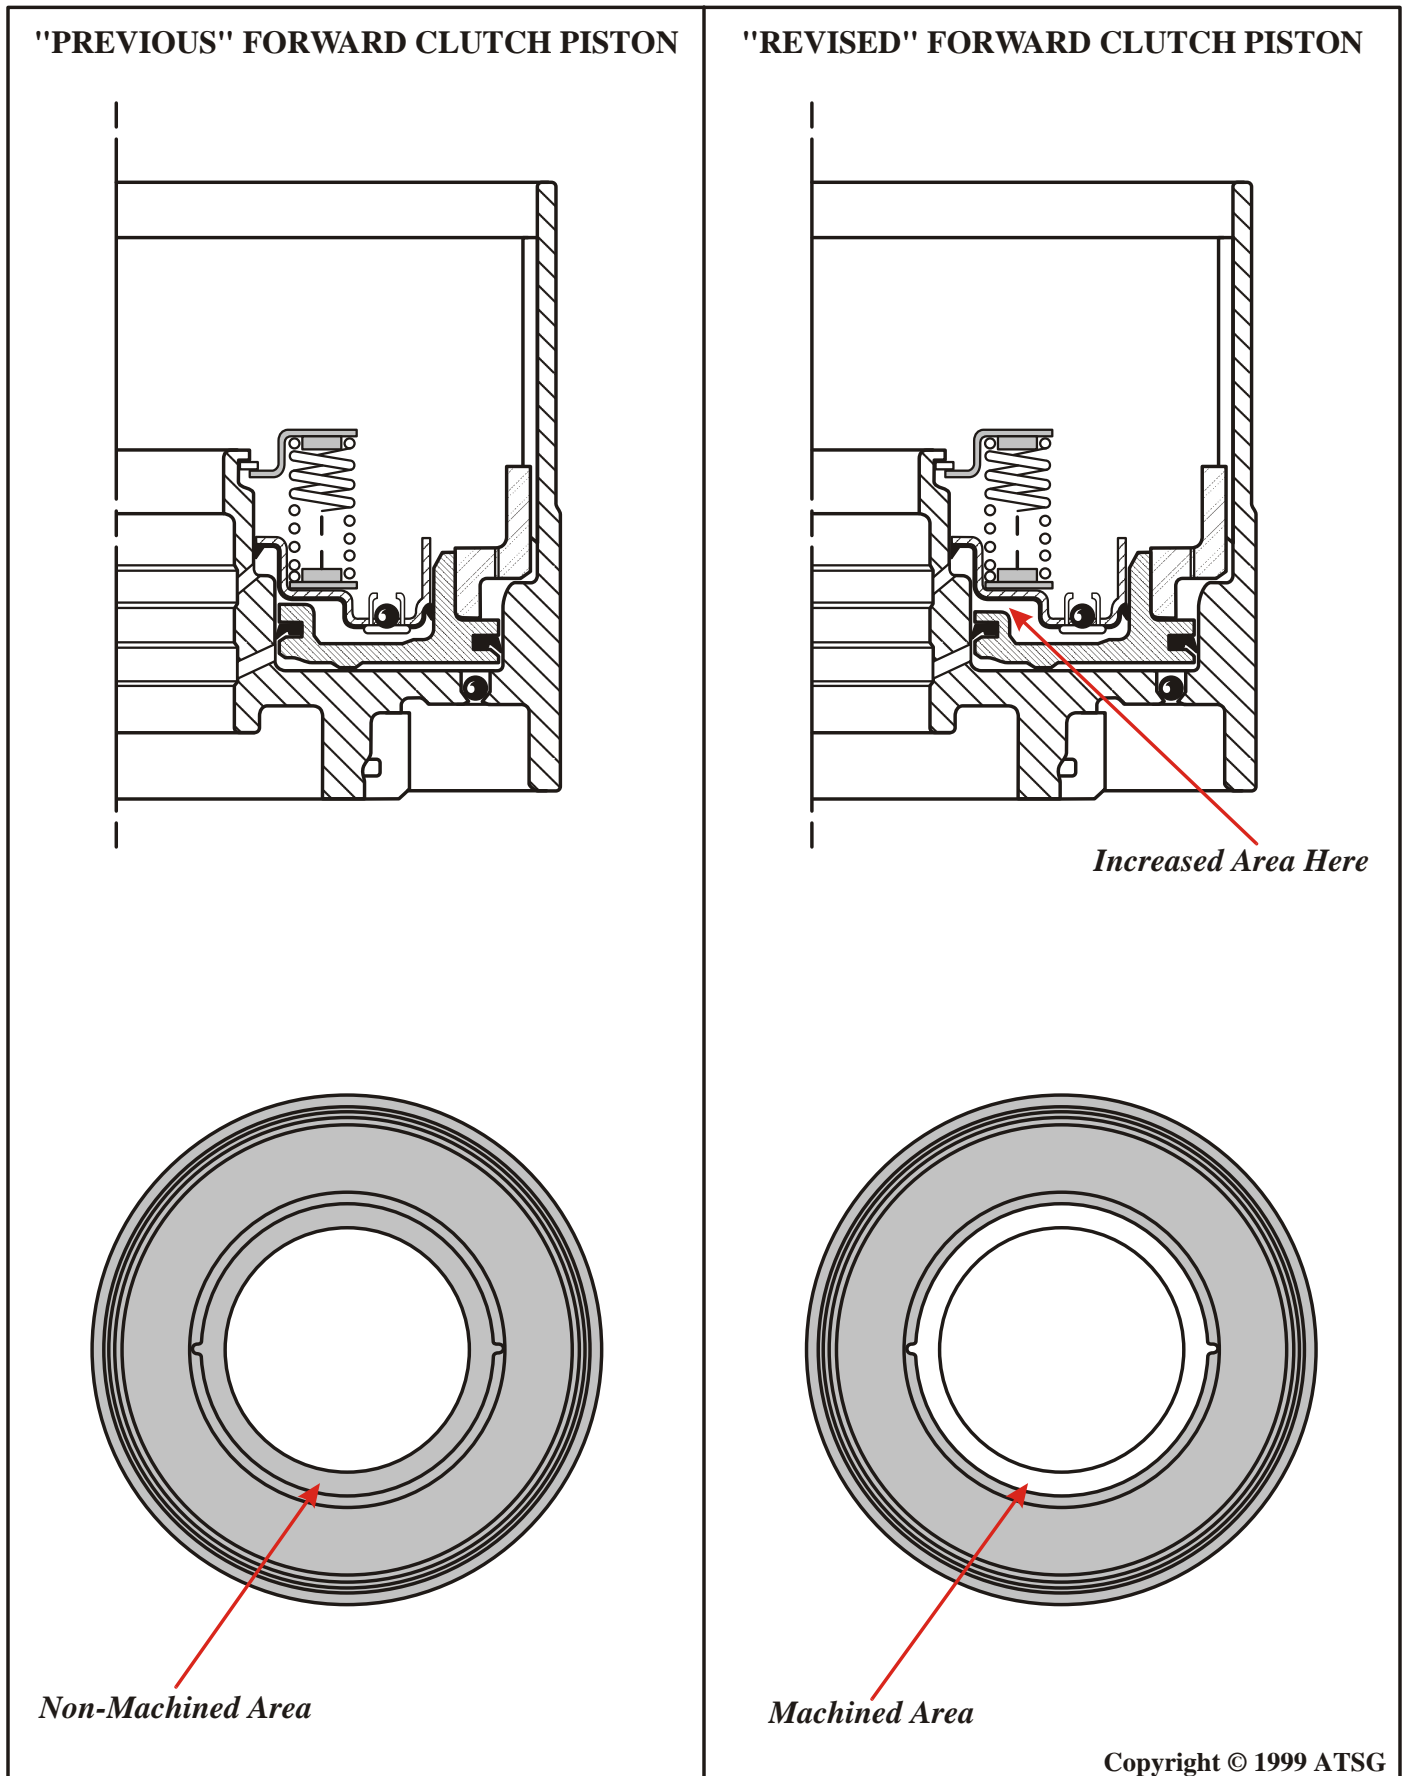
Figure 2

CAUSE: The complaint may be caused by the coast clutch piston side of the forward clutch piston restricting the coast clutch apply fluid (See Figure 2).

CORRECTION: There is now a revised forward clutch piston available where an additional machining process occurred, reducing the restriction of coast clutch apply fluid between the forward clutch piston and coast clutch piston. The new forward clutch piston can be easily identified by a shiny surface at the center hub of the forward clutch piston as shown in Figure 2.

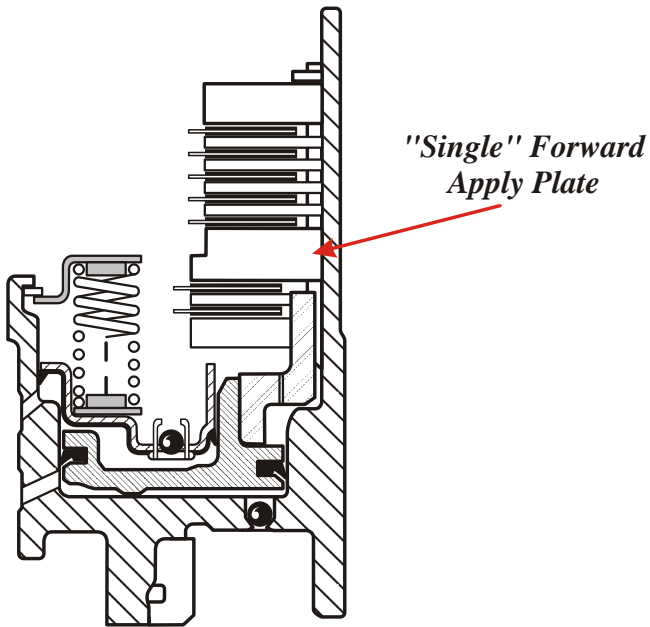
1993 FORWARD CLUTCH STACK-UP

Special Note: There was also an another update that occurred on the forward clutch in model year 1994. The "single" forward clutch apply plate was replaced with a cone shaped cushion plate, sandwiched between "two" thinner apply plates, as illustrated in Figure 3, and should be updated during overhaul, if servicing a 1993 model.

**ALL 1993 MODELS SHOULD BE
UPDATED AS SHOWN ABOVE**
