Technical Service Information

5R110W

ERRATIC SHIFTS AND TFT GAUGE OPERATION

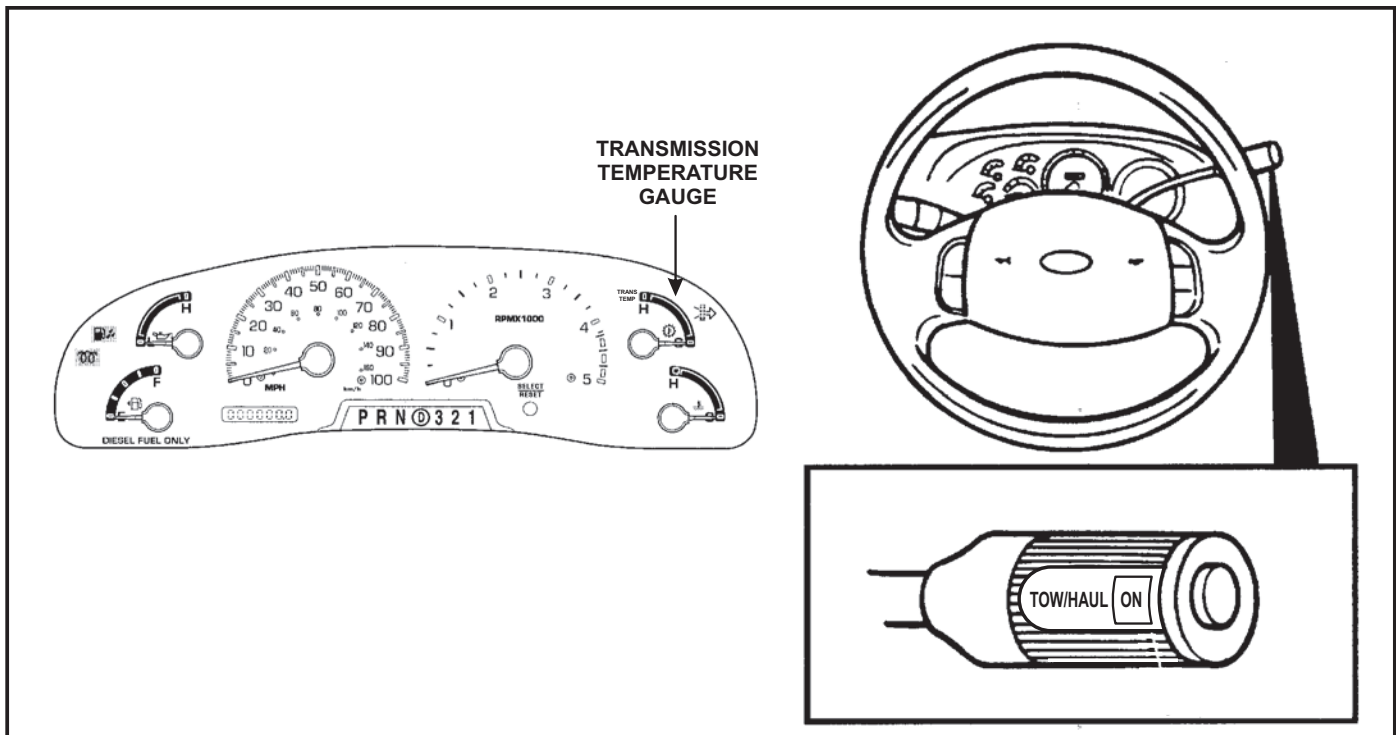
Figure 1

COMPLAINT: A Ford truck equipped with a 5R110W transmission comes to the shop with complaints of erratic shifts, intermittent TFT gauge operation and no Tow/Haul mode function. The MIL may be on and the Tow/Haul indicator lamp may be blinking. (See figure 1) Scan tool data reveals transmission fluid temperature (TFT) readings are fluctuating from normal ranges to -40 degrees (F) coinciding with the erratic display seen on the TFT gauge in the instrument cluster. Code retrieval may indicate fault codes such as P0711-P0712-P0713, or P1711, with no signs of Transmission overheating.

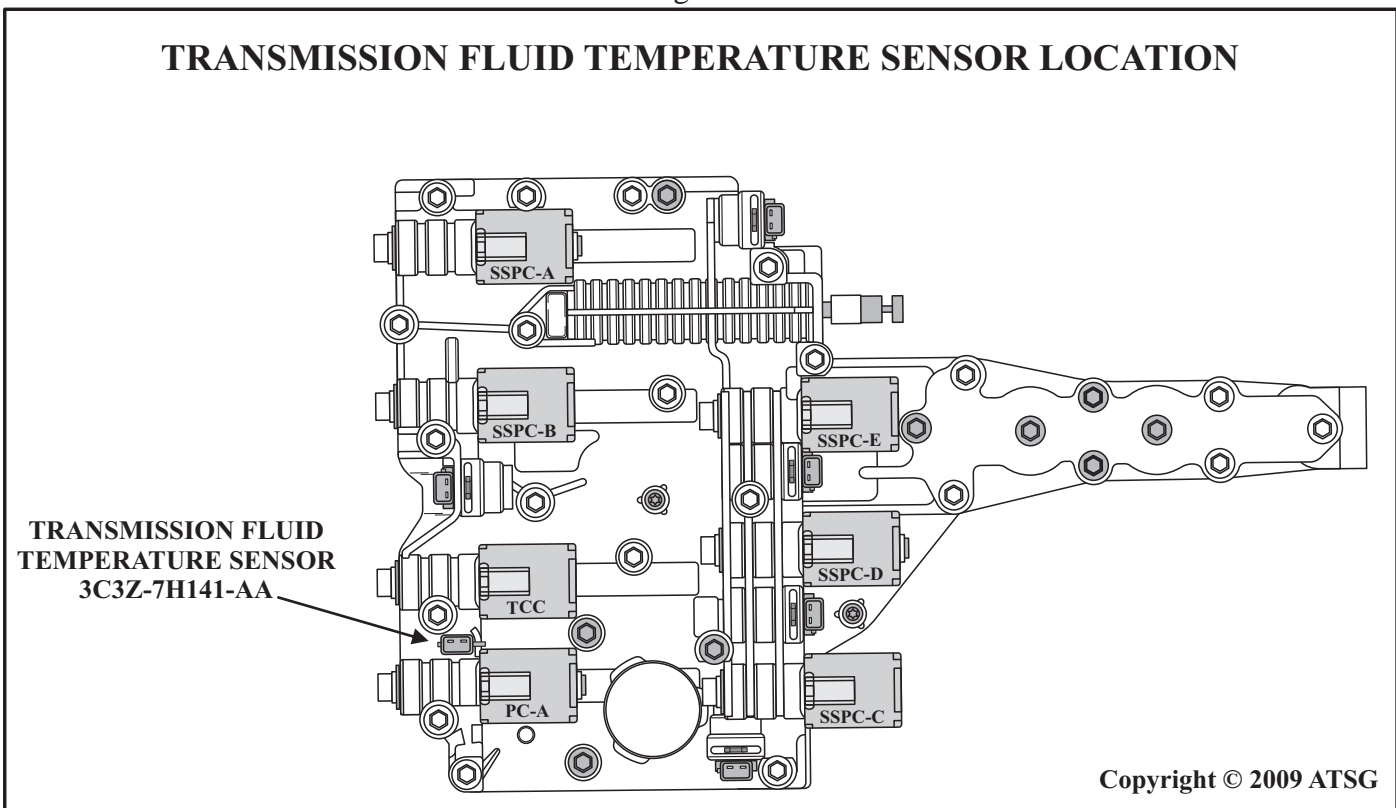
Figure 2

CAUSE: Either the TFT sensor is faulty (Figure 2) or the internal wiring harness is faulty (Figure 3). The transmission fluid temperature (TFT) sensor twist-locks into the solenoid body and is a temperature sensitive device called a thermistor (Figure 2). As the fluid temperature increases, the TFT resistance decreases, as shown in the chart in Figure 4. The PCM uses the TFT signal as an input to determine cold and hot temperature shift scheduling and for TCC apply and release scheduling.

TRANSMISSION FLUID TEMPERATURE SENSOR LOCATION

Note: Plug in the trans harness connector and the same voltage and ground tests can be performed with the trans pan removed at the 2 terminal connector when unplugged from the TFT sensor as seen in figure 2. This will confirm the complete circuit integrity to the sensor. If this test fails, the internal harness is faulty.
