Technical Service Information

FORD CD4E/MAZDA LA4A-EL FRONT SEAL BLOW-OUT OR CONSTANT LEAK

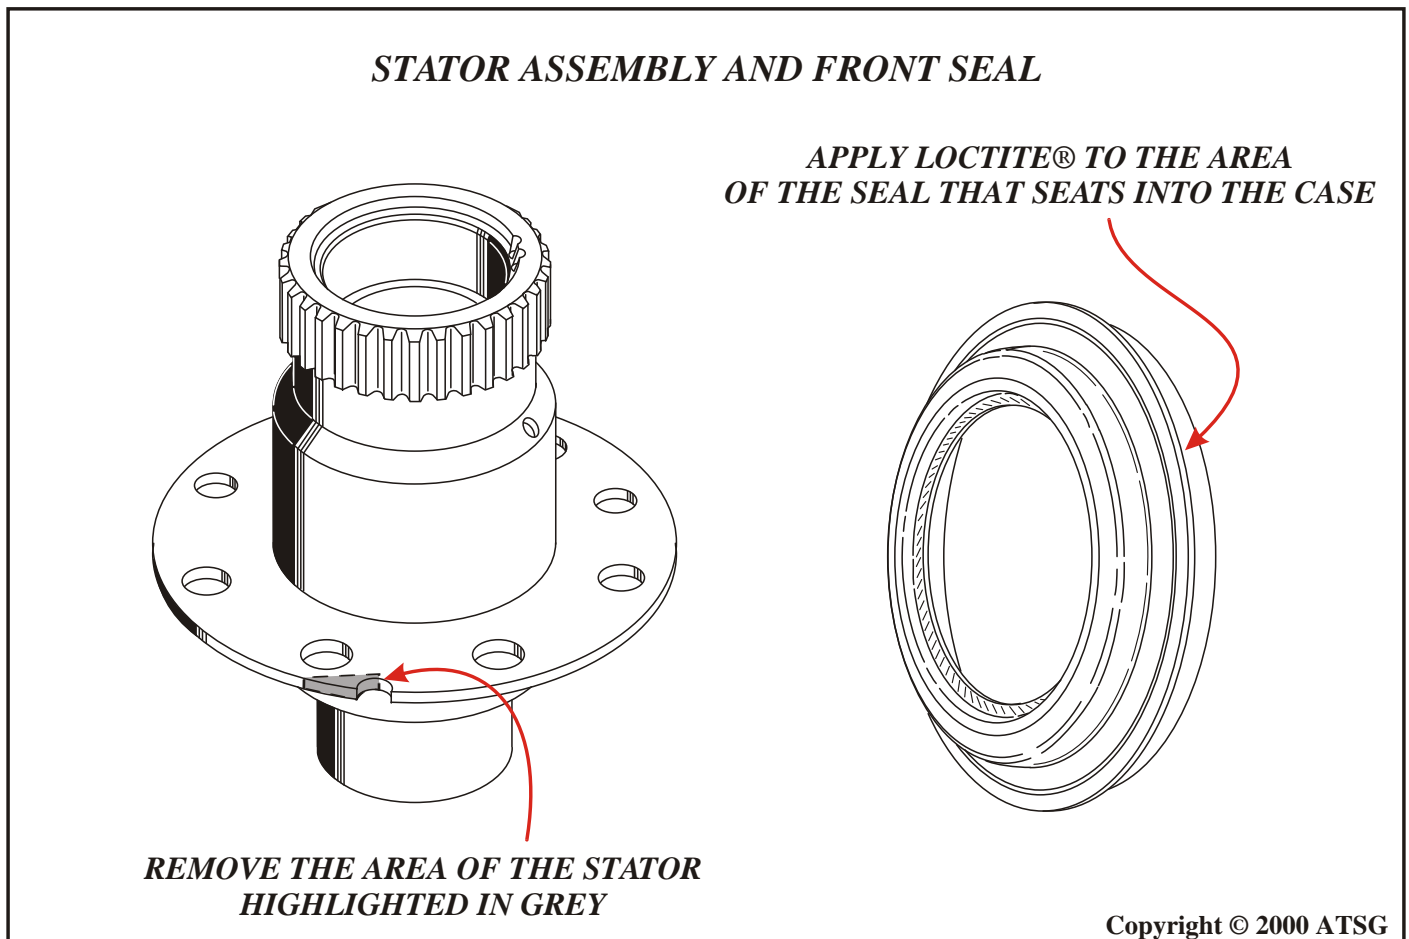
Figure 1

COMPLAINT: Vehicles equipped with CD4E/LA4A-EL transmissions may exhibit repeated front seal "blow-out" or constant front seal leak.

CAUSE: The cause may be, an undersized drain back passage in the bellhousing.

BELL HOUSING REAR VIEW

1. Remove the Stator from the front of the bellhousing. Remove the area highlighted in grey, as shown in Figure 1, with a bench grinder.

2. With a 3/16" or 13/64" drill bit, drill at an angle through the area shown in Figure 2.
3. Refer to Figure 3 to see the modified drain back passage from the front side of the bellhousing.
4. Apply Loctite ® to the front seal before installing it into the bellhousing as shown in Figure 1.
