Technical Service Information

CHRYSLER A470 SERIES REVERSE BAND STRUT BREAKAGE

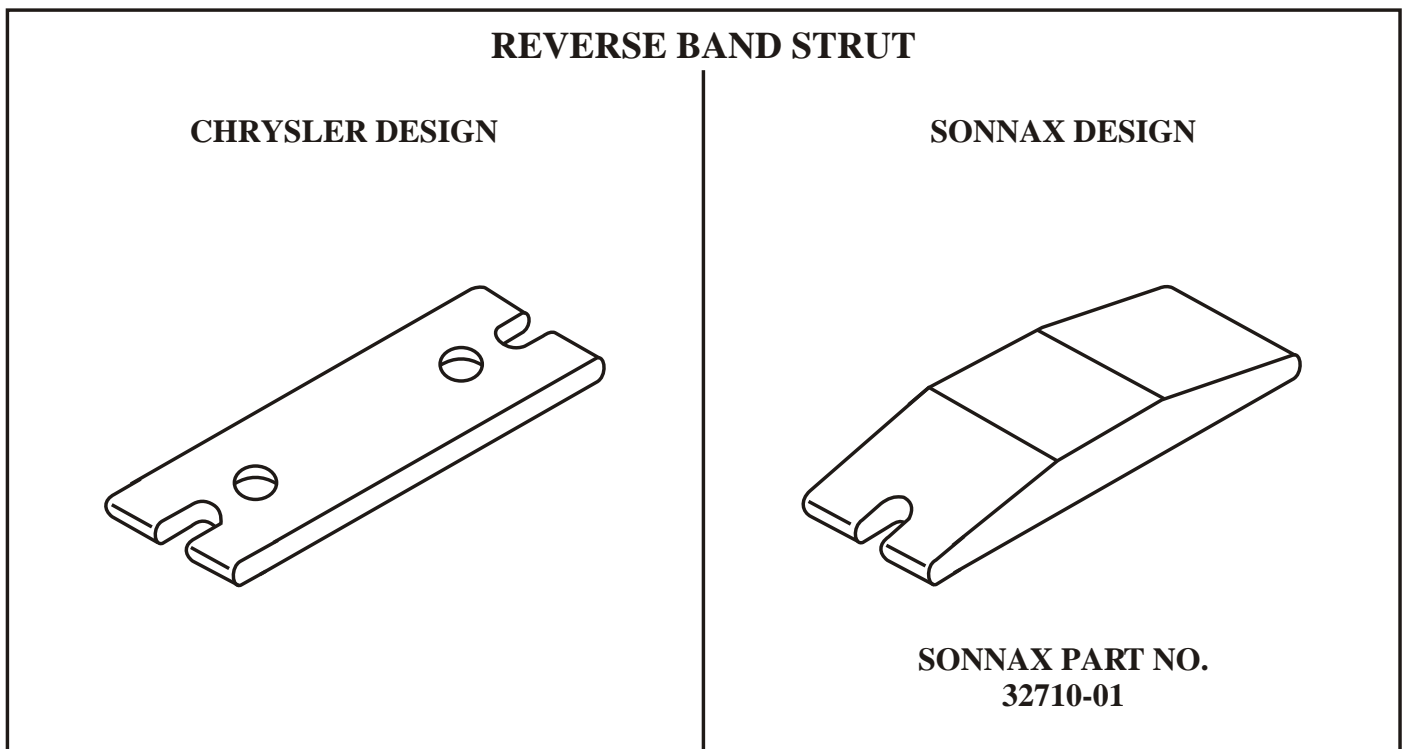
Figure 1

COMPLAINT: Some vehicles equipped with the Chrysler A404, A413, A470, A670 front wheel drive transaxle, may exhibit a no reverse condition before and/or after rebuild.

CAUSE: The cause may be, a bent or broken reverse band strut (See Figure 1).

CORRECTION: There is now a new design reverse band strut available from Aftermarket Suppliers for the Chrysler A404 Series transaxle, that has a thicker cross-section in the middle to provide much greater resistance to bending, and is manufactured out of a high quality hardened alloy steel that has a much higher yield strength than the original equipment material. This new design reverse band strut is manufactured by Sonnax, and is available under Sonnax part number 32710-01 (See Figure 1).
