Technical Service Information

FORD E4OD SLIDE/BUMP 1-2 UPSHIFT 1997 MODEL ONLY

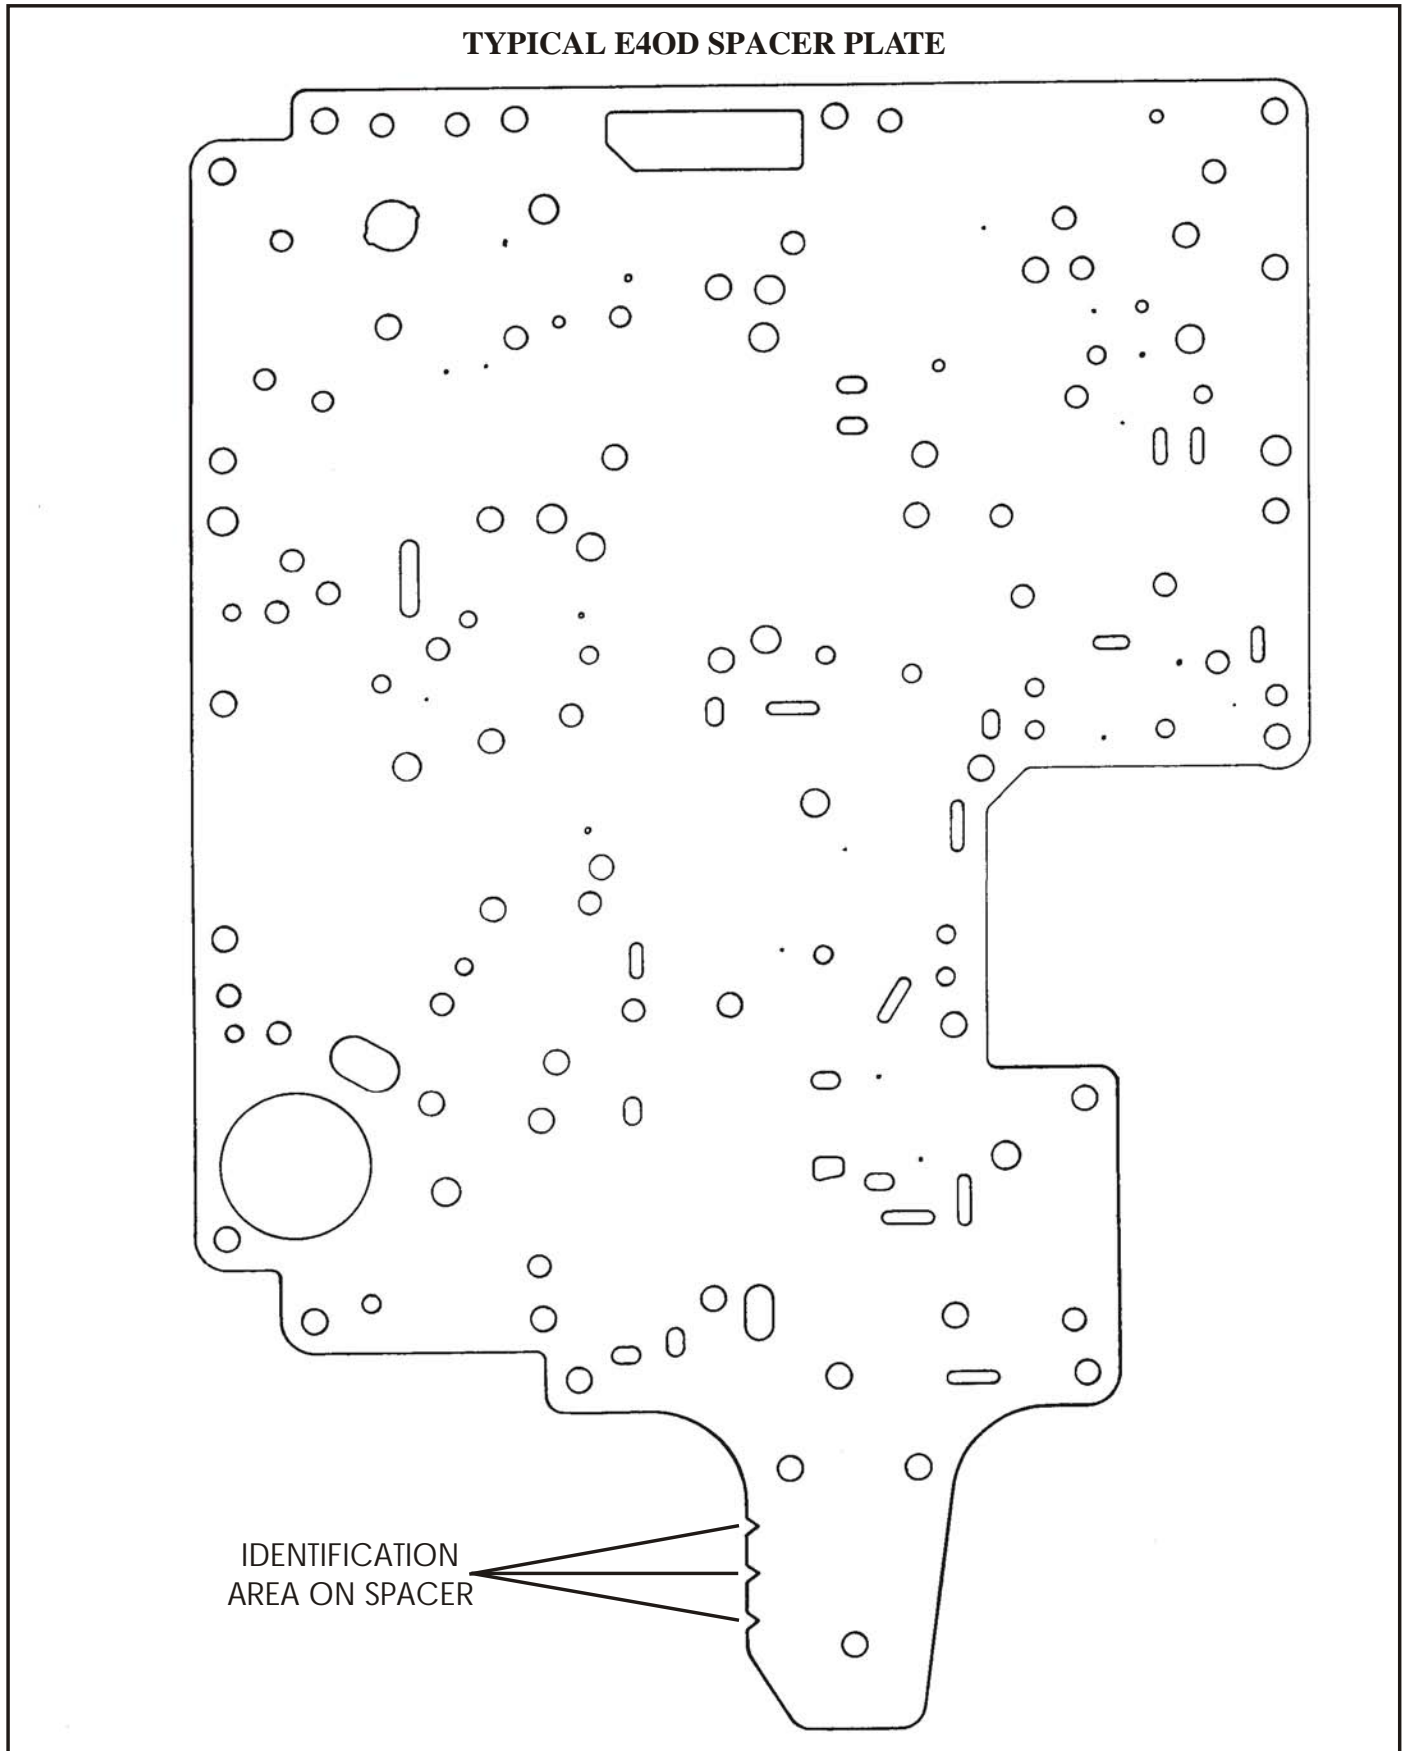
CAUSE: The cause may be, the transmission being built with the wrong valve body spacer plate.

CORRECTION: Once confirmation has been made that you have a suspect transmission that falls between the build dates and serial numbers listed above, remove the pan and inspect the spacer plate identification stamped into the "tail" of the plate. Figure 2 shows the location of the identification notches, and the chart in Figure 1 below shows the 1997 spacer plate identification that is wrong. Install new spacer plate F7TZ-7A008-AA, along with new valve body gaskets.
