Technical Service Information

THM 4T40-E TROUBLE CODE P1887 OR P0742

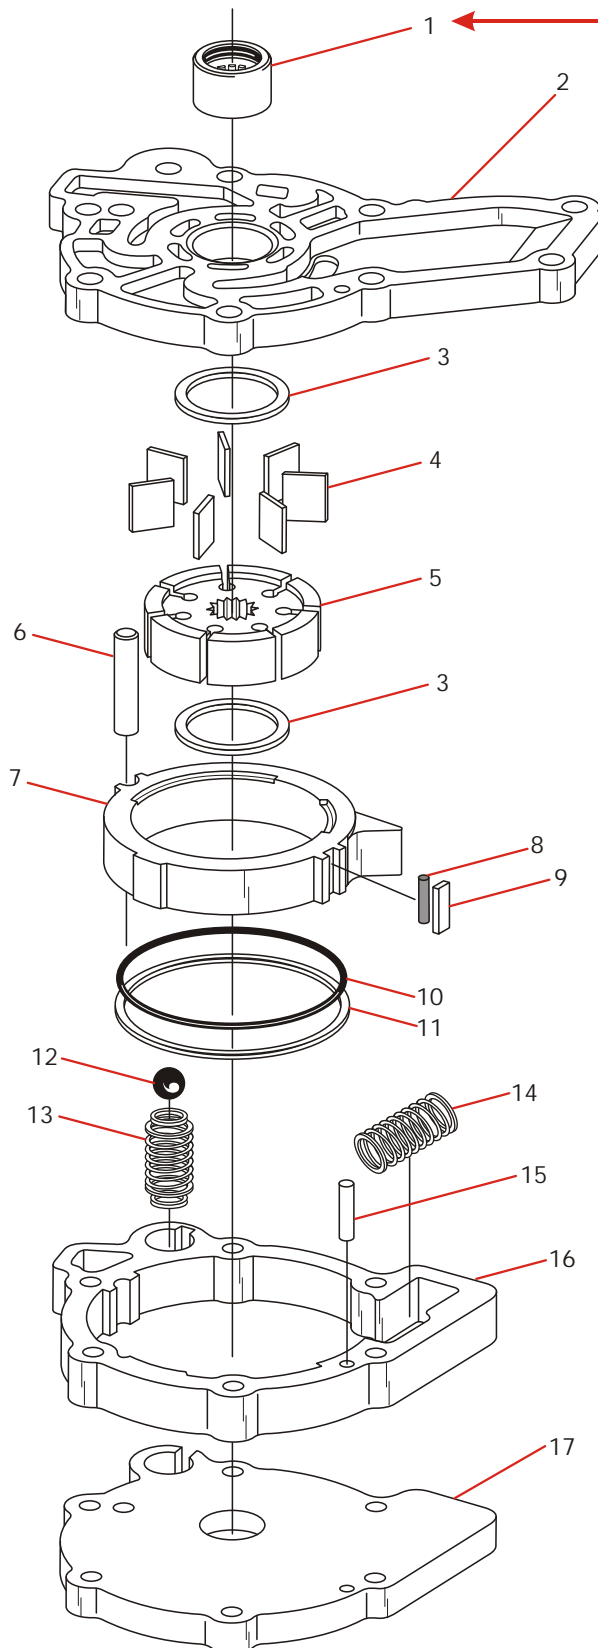
THM 4T40-E OIL PUMP ASSEMBLY

CAUSE: This is usually created by a leak of TCC release oil through the needle bearing and seal assembly located in the oil pump, as shown in Figure 1.

This Needle Bearing and Seal Assembly Is Not Serviced. You Must Purchase The Complete Pump Assembly Available Under OEM Part Number 24208987

CORRECTION: The unfortunate part of the correction process is that the Needle Bearing and Seal Assembly is not available as a service item from General Motors. The **only** way to acquire the Needle Bearing and Seal Assembly is to purchase a complete pump assembly from the OEM supplier, available under OEM part number 24208987.
This Needle Bearing and Seal Assembly has been such a high failure item that ATSG recommends the pump assembly be replaced on every rebuild.

Oil Pump Assembly Complete 24208987
