# Technical Service Information

## GM 5L40E / BMW A5S360R

### DELAYED FORWARD ENGAGEMENT

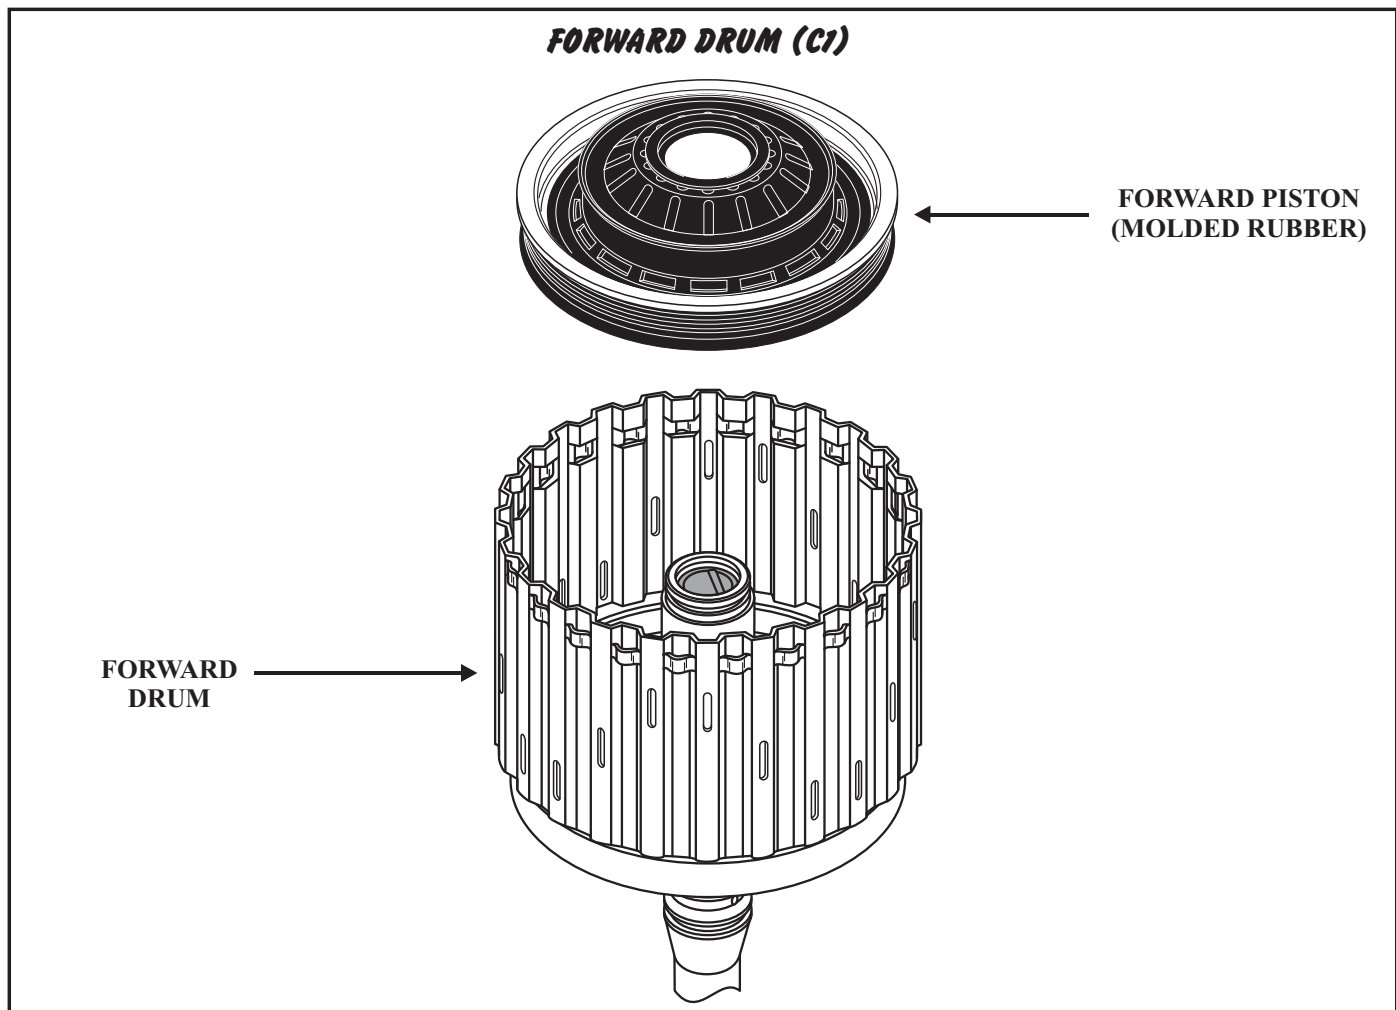
Figure 1

**COMPLAINT:** Some BMW “E” series and Cadillac CTS models built from 09/02 to 12/03 may exhibit a delayed engagement from park to drive when cold. The delay may last anywhere from two to thirty seconds.

**CAUSE:** The forward drum (C1) was manufactured with improper tolerances that cause the clutch piston to not make a good seal between it and the clutch housing when the vehicle is parked for a prolonged period of time, such as overnight. Therefore on the initial start, the forward clutch does not apply.

**CORRECTION:** Since internal parts are not available, a reman transmission will be necessary. Because the manufacturer does not disclose any build code information, it is impossible to tell which drum would be a good one if used parts are acquired.
