Technical Service Information

MAZDA RA4A-EL NISSAN RE4R03A

LOCK-UP SHUDDER (2 LOCK-UP SOLENOID UNITS ONLY)

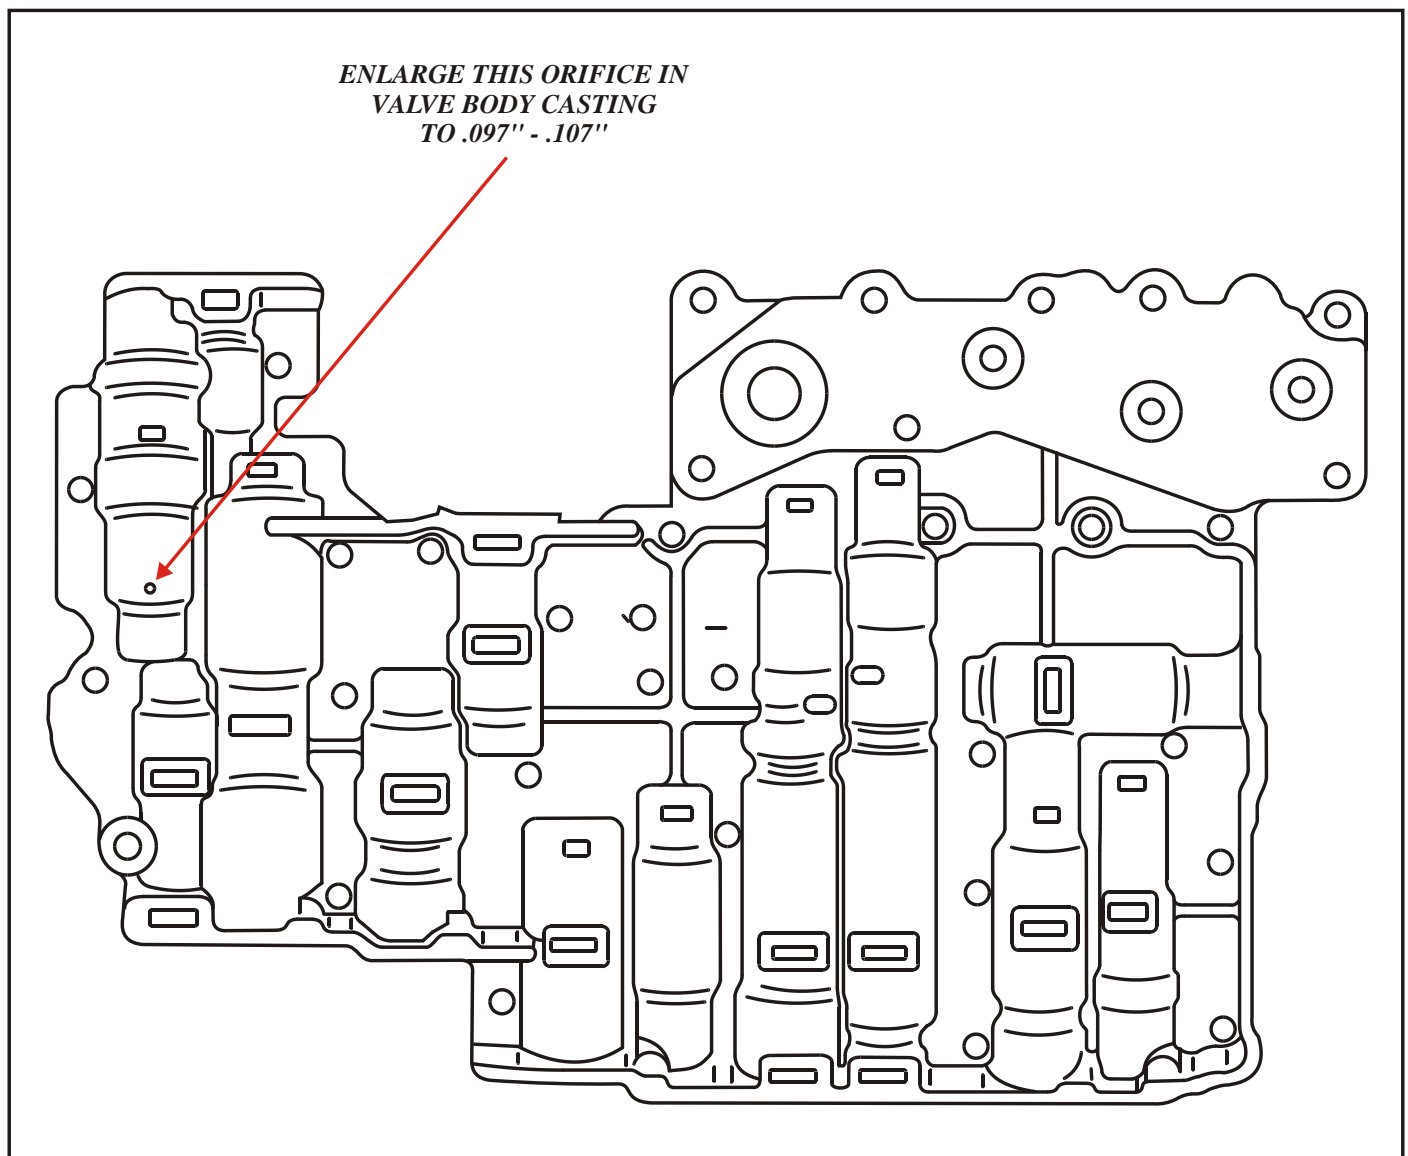
COMPLAINT: Some Mazda or Nissan vehicles equipped with the RA4AEL or RE4R03A may exhibit a lock-up shutter upon application of the lock-up clutch.

CAUSE: One cause may be lock-up release oil not exhausting quickly enough through the lock-up control valve.

CORRECTION: Drill hole and open orifice in the bottom of the valve-body as shown in Figure 1 below.
