Technical Service Information

THM 4T80-E DTC 76 AND 84 1995 AURORA OR 1995 CADILLAC

THM 4T80E, 1995 CADILLAC**CODE P080, TP SENSOR IDLE RELEARN NOT COMPLETE**

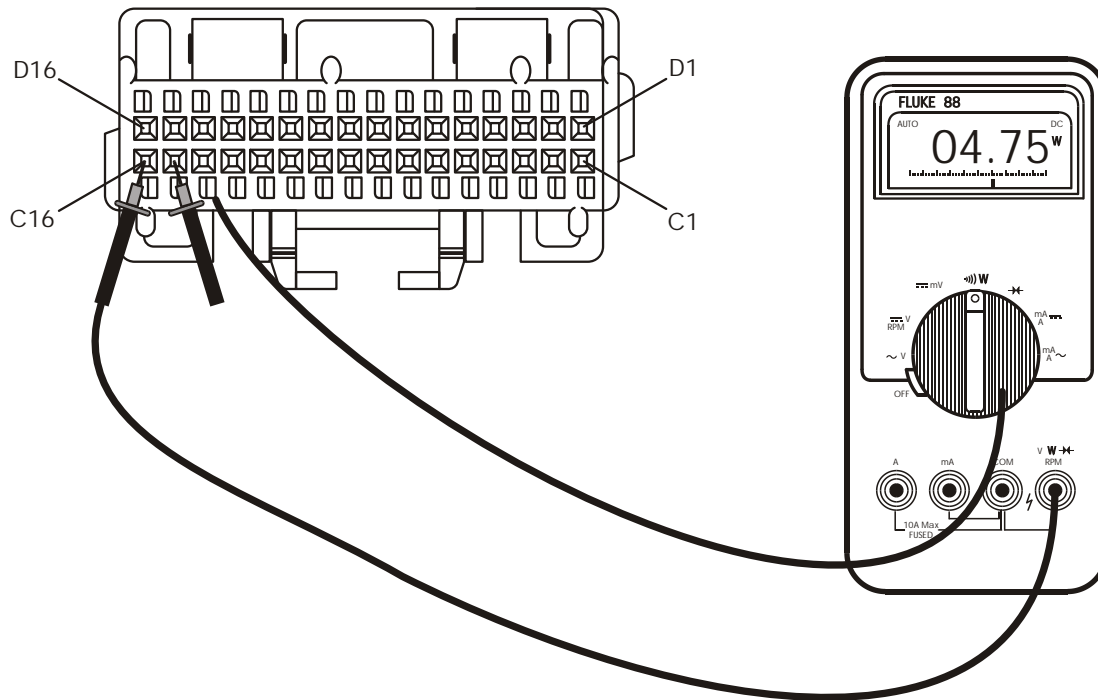
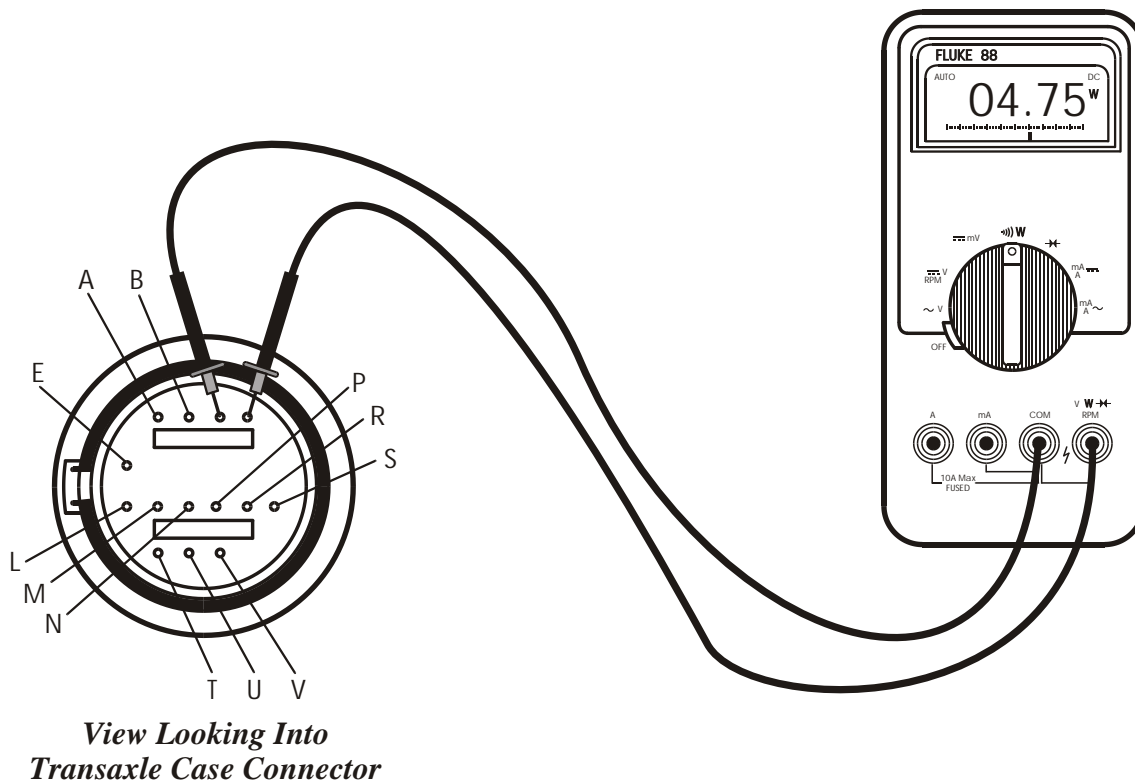
Figure 1

Second, disconnect the PCM "C2" connector which is "White" in color. Place the DVOM leads across pin cavities C15 (Lt. Blue/White) wire and C16 (Red/Black) wire, as shown in Figure 1, and verify that we have a reading of 3-6 ohms resistance. We have now verified the pressure Control Solenoid Circuit all the way back to the Powertrain Control Module, *and PCM replacement will now be necessary.*

PCM CONNECTOR C2

"White" In Color
