# Technical Service Information

## FORD 4F50N 1-2 SLIDE / BANG

**COMPLAINT:** 2004 and newer Ford vehicles equipped with the 4F50N transaxle may exhibit a 1-2 slide bang before or after overhaul.

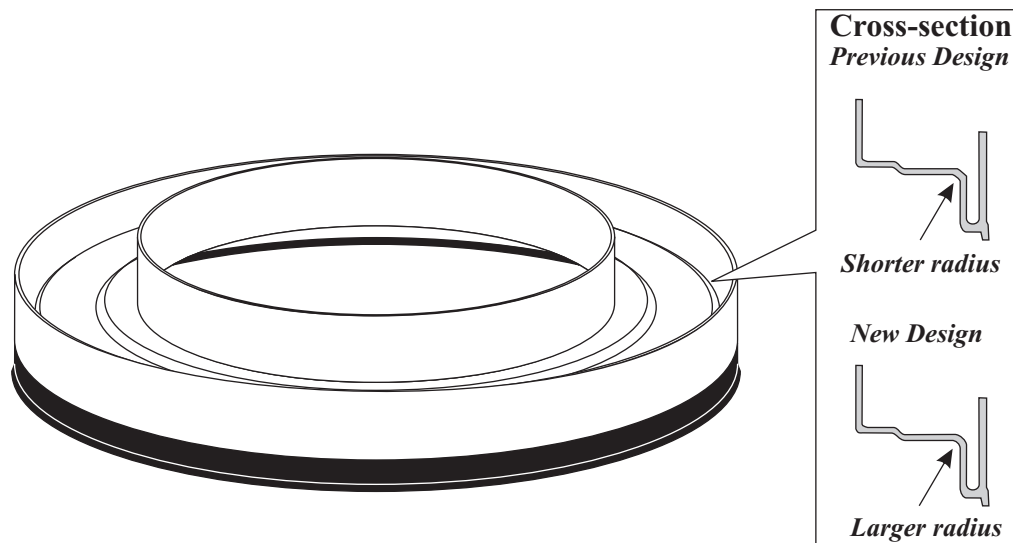
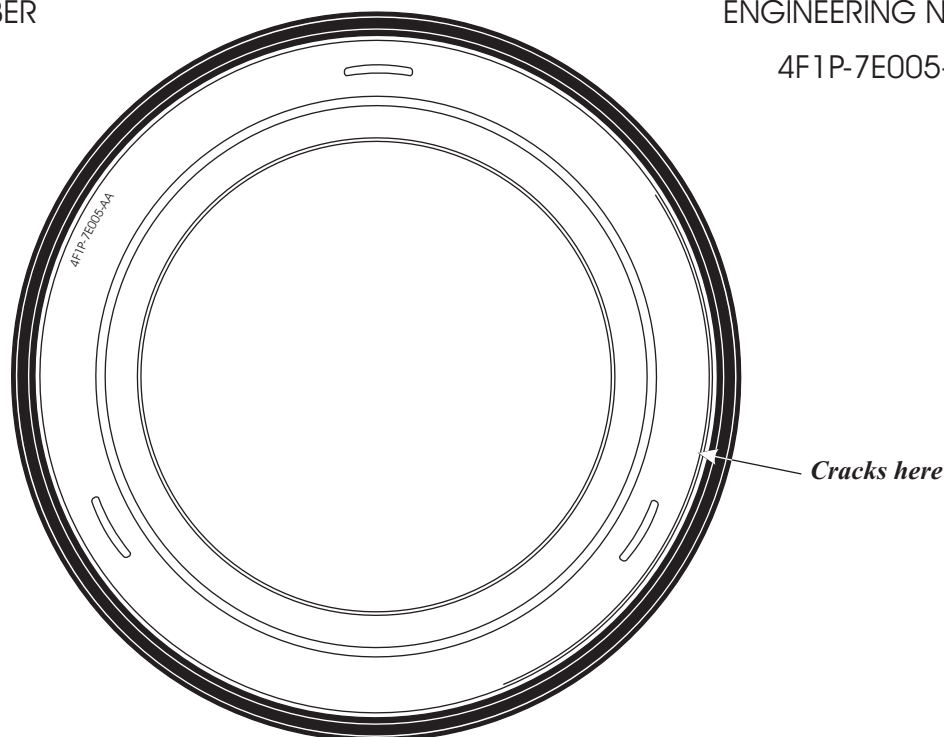
Figure 3

**CAUSE:** The cause may be, a cracked Intermediate Piston, as shown in Figure 3, or a weak 1-2 Capacity Modulator Valve Spring. Note: 2004 and Up 4F50N are equipped with the 1-2 Capacity Modulator Valve that controls the rate of application of the Intermediate Clutch, like the previous 1-2 Capacity Modulator Valve on the AXOD/AX4S. See Figure 4.

*An updated piston can be identified by the engineering number printed on the bottom side of the piston as seen in figure 3. This number is slightly different than the part number.*

## INTERMEDIATE PISTON TOP VIEW

PREVIOUS DESIGN  
ENGINEERING NUMBER  
F88P-7E005-AA

NEW DESIGN  
ENGINEERING NUMBER  
4F1P-7E005-AA

**CORRECTION:** To correct this condition, replace the Intermediate piston with an updated piston from Ford or from your parts distributor as some distributors sell the O.E. pistons. Install a heavier spring into the 1-2 Capacity Modulator valve line-up. Note: the 2-3 Capacity Modulator Valve spring is the same as the 1-2 , if a firmer 2-3 upshift is desired , a firmer spring can be used there also. See Service information for available aftermarket replacement springs. *Note: the 1-2 and 2-3 Capacity Modulator Valve springs are identical so 2 aftermarket springs can be used, to cover 2nd and 3rd gear shift feel, per transmission overhaul.*

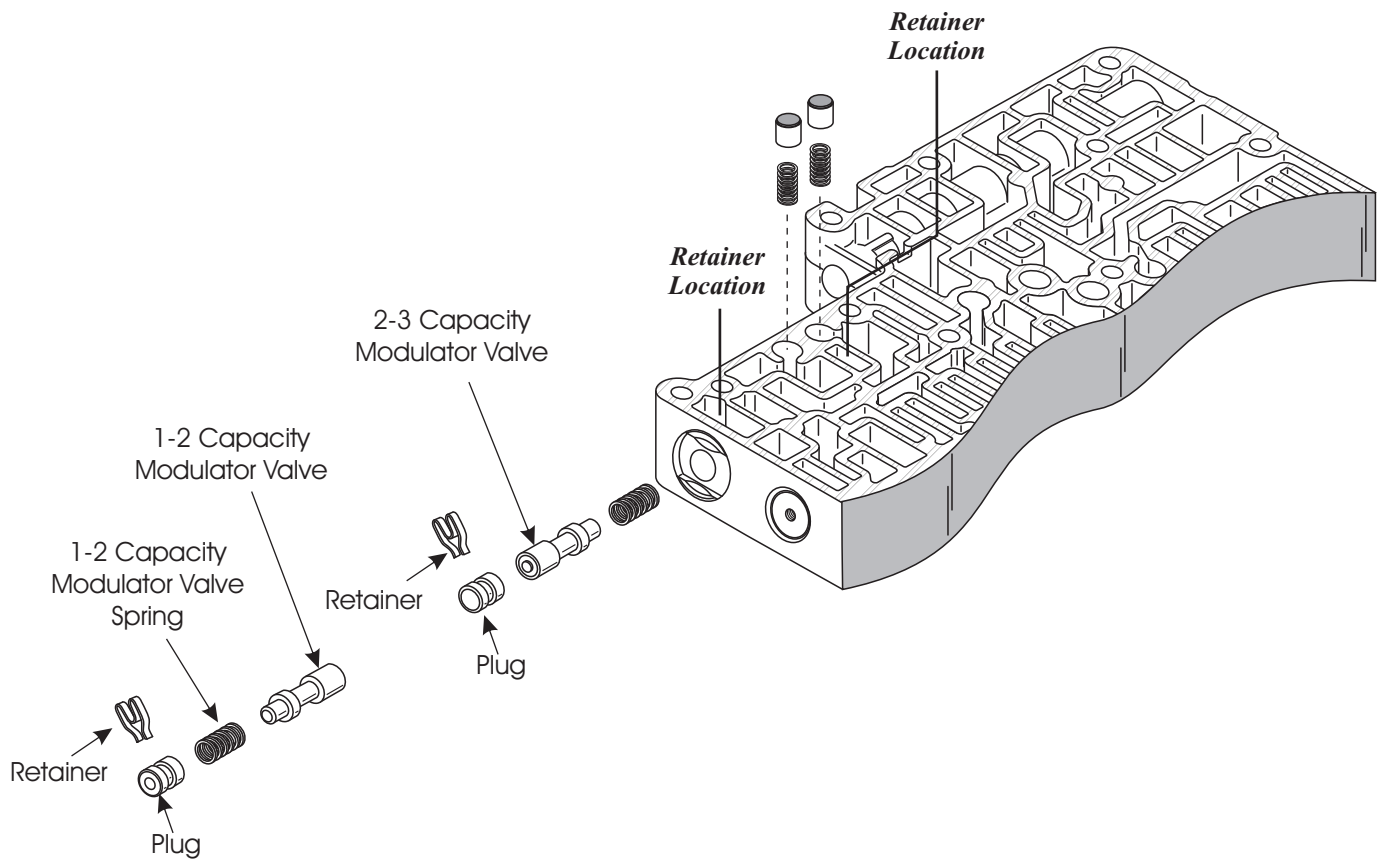
Figure 4

## 2004 AND UP 4F50N 1-2 CAPACITY MODULATOR VALVE SPRING LOCATION

*Note: The 1-2 and 2-3 Capacity Modulator valve springs are the same*

UPDATED INTERMEDIATE CLUTCH PISTON.....	4F1Z-7E005-AA
SUPERIOR 1-2/2-3 CAPACITY MODULATOR SPRING KIT.....	K084
SONNAX 1-2 CAPACITY MODULATOR SPRING.....	96201-27
