# Technical Service Information

## FORD AXOD

### SOFT 1-2 AND 2-3 SHIFT

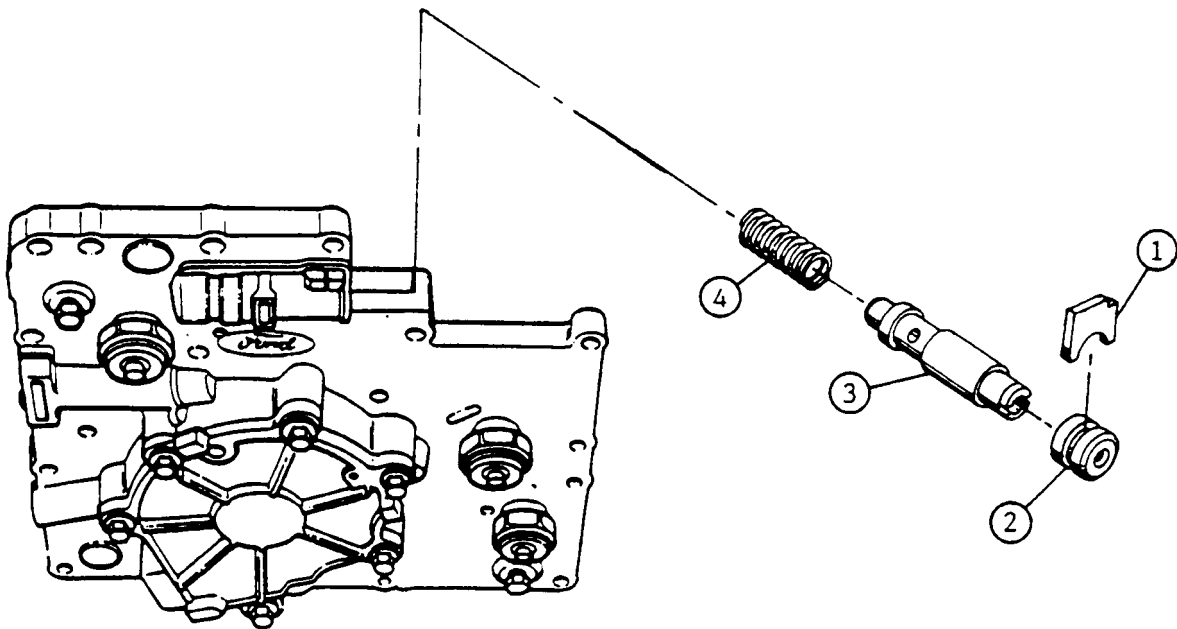
Figure 1

**COMPLAINT:** Soft or mushy 1-2 shift and/or 2-3 shift.

**CAUSE:** The cause may be a lack of oil volume to the intermediate and/or direct clutch packs.

**CORRECTION:** FOR SOFT 1-2 SHIFT:

Replace the 1-2 capacity modulator valve spring with the Red spring manufactured by Shift Technology Products (Part # K006). The kit also comes with a new style bore plug retaining clip. Assemble into the oil pump as shown in Figure 1.

- 1 - NEW STYLE RETAINING CLIP.
- 2 - 1-2 CAPACITY MODULATOR VALVE BORE PLUG.
- 3 - 1-2 CAPACITY MODULATOR VALVE.
- 4 - 1-2 CAPACITY MODULATOR VALVE SPRING.
