Technical Service Information

ISUZU & BMW

4L30-E

PARTIAL ENGINE STALL / TORQUE CONVERTER FAILURE

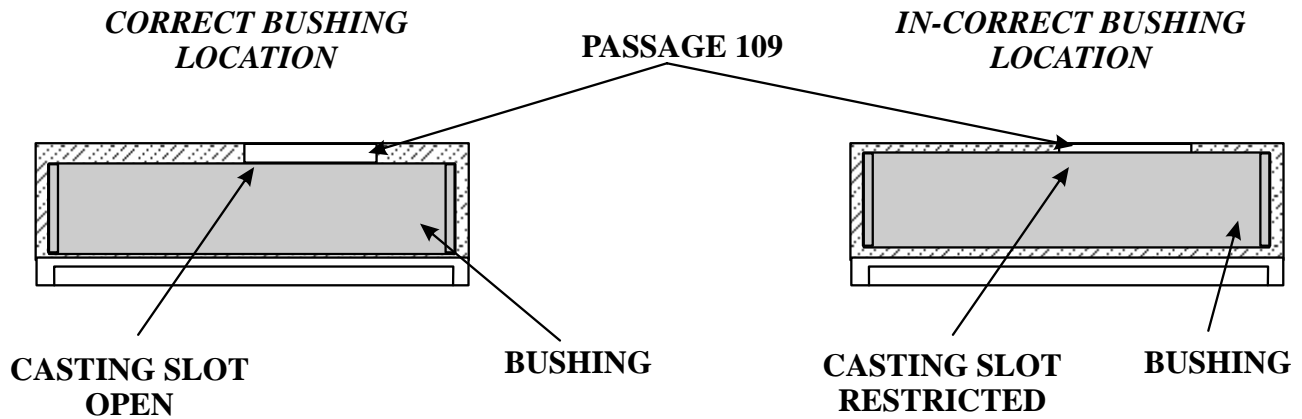
Figure 1

CAUSE: The Cause may be, that during bushing installation, a THM 350 bushing was used and was placed too deep into the bellhousing, as shown in Figure 1. When this happens, and the Torque Converter Clutch is commanded "Off," the bushing will partially block the passage that is connected "To Cooler", which will act as a cooler restriction, creating the partial engine stall. See Figure 3 For a partial hydraulic circuit diagram of TCC OFF. When the Torque Converter Clutch is commanded "On," the "Converter Apply circuit" is restricted creating low apply pressure and premature Torque Converter Failure as well as discoloring of the Torque Converter. Refer to Figure 4 for a partial hydraulic circuit of TCC ON. Refer to Figures 1 and 2 to see the dimensional difference between the Sonnax bushing and the THM 350 bushing and to identify the previously mentioned passage in the bellhousing. One other cause may be a partially stuck Converter Clutch Control Valve, as shown in Figure 5.

NOTE: The Sonnax 54253-01 Bellhousing bushing width is .560"
 The THM 350 Bellhousing bushing width is .610"
 Passage 109 slot is .095" from the top of the bushing to the mating surface
 of the pump when the bushing is installed correctly.

CORRECTION: Replace the bushing with the Sonnax Bellhousing bushing or when using a THM 350 bushing use a die grinder to remove the excess material to ensure no restrictions in the passage shown in Figures 1 and 2. **Note: a babbitt 727 pump bushing has also be used.** Refer to Figure 5 and ensure the Converter Clutch Control Valve is not sticking in the pump.

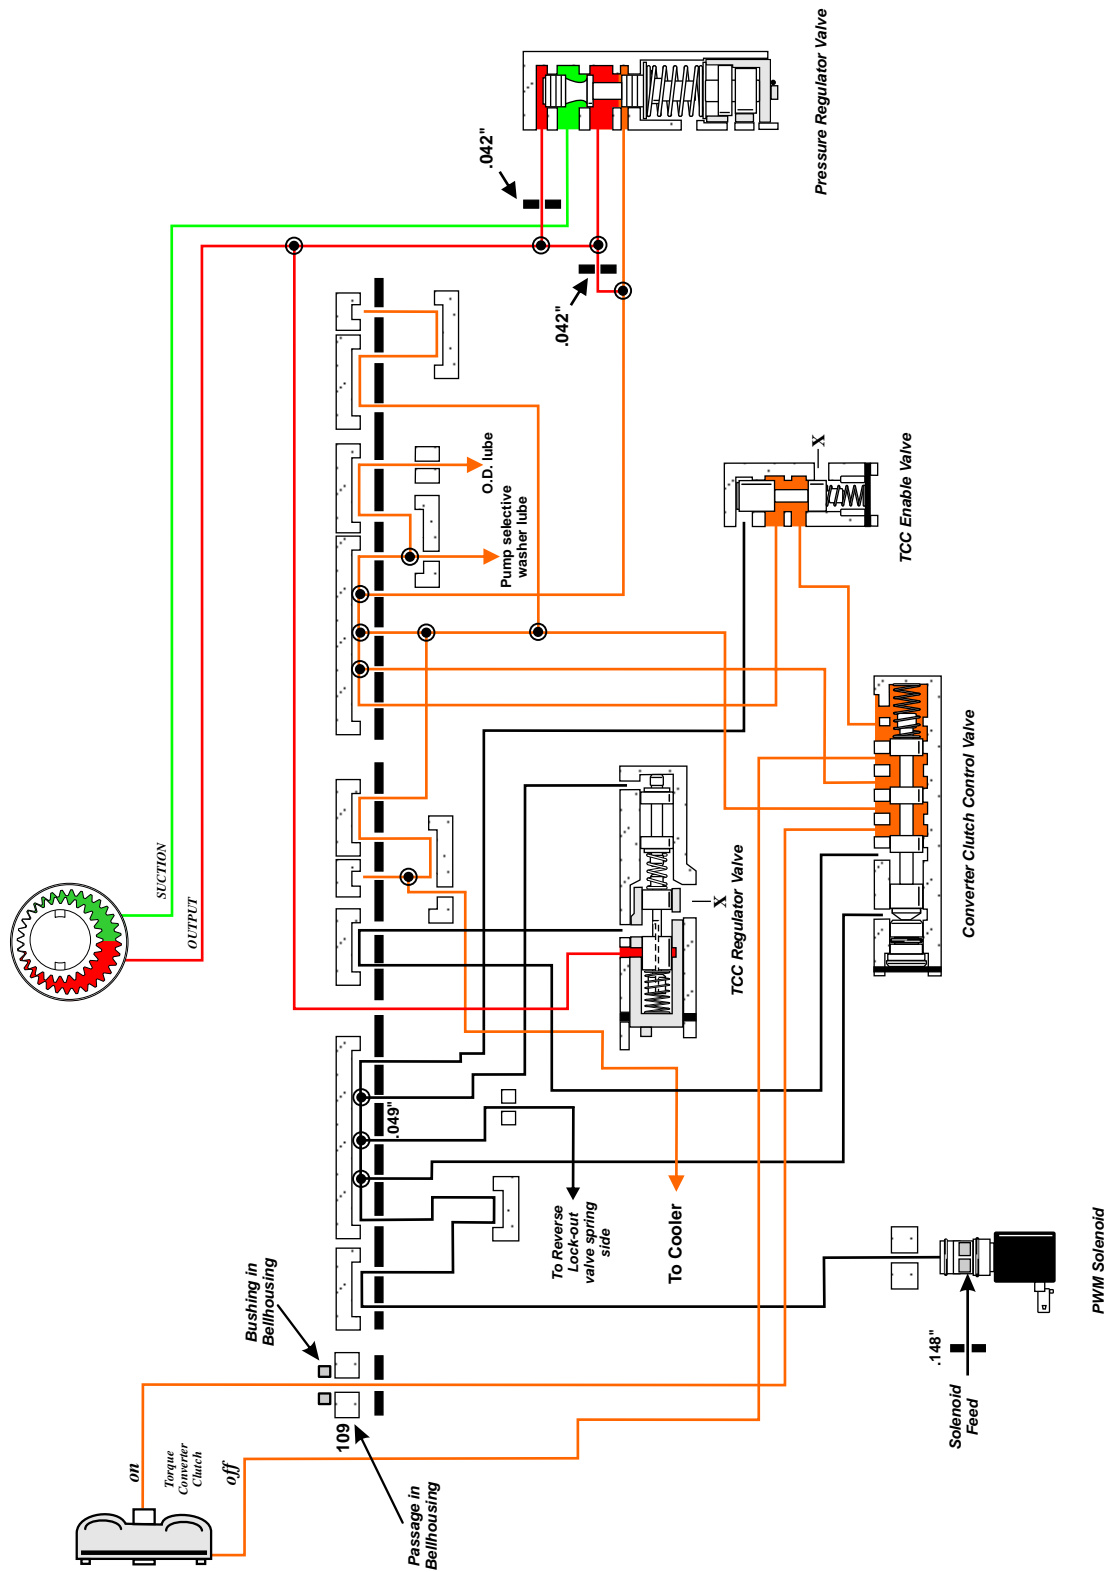
Figure 3

PWM TCC "OFF" PARTIAL SCHEMATIC
