Technical Service Information

FORD E4OD WILL NOT HOLD IN PARK

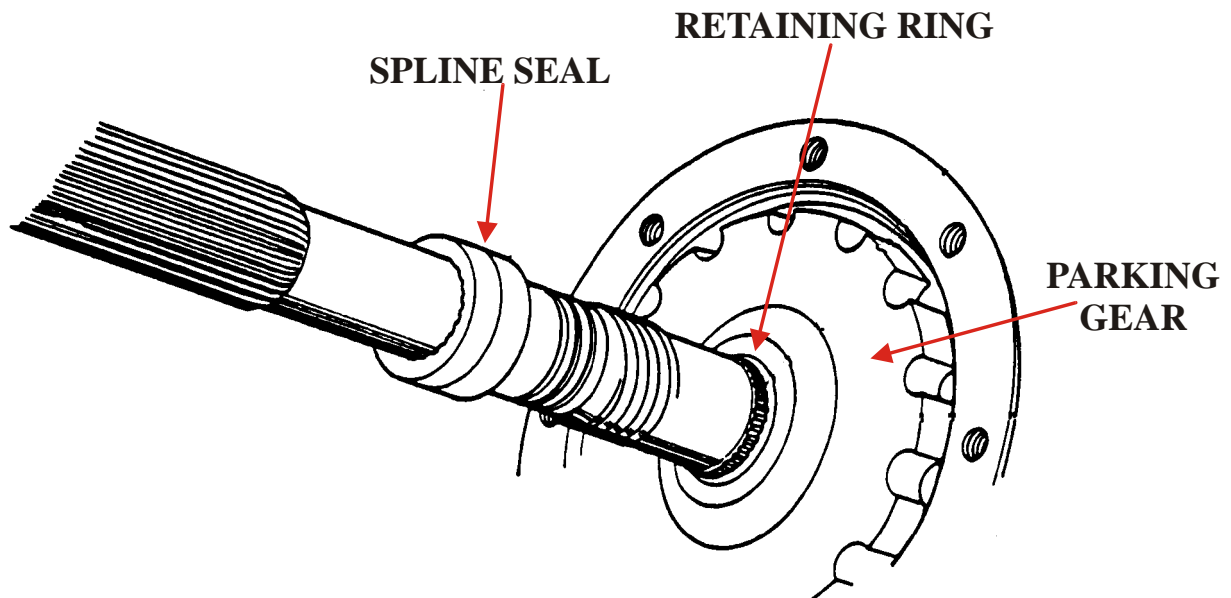
COMPLAINT: Vehicle will still move, or roll, after shift lever is placed in the PARK position.

CAUSE: The cause *may* be a broken snap ring on the output shaft, allowing the parking *gear* to move rearward, and then the parking pawl cannot engage into the parking gear (See Figure 1). Action must be taken based on the build date as identified on the transmission I.D. tag. Refer to Figure 2 for build date identification. Ford Safety Recall Number 90S10.

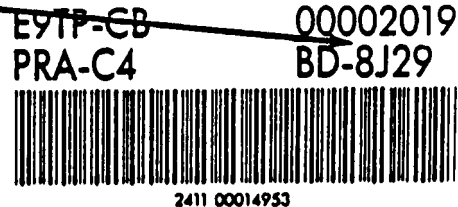
- 1988 — 8 before the letter
REPAIR ALL

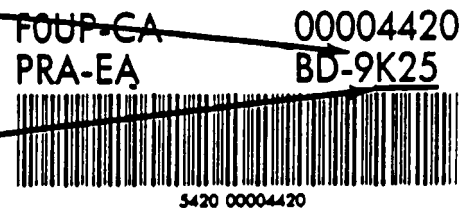
- 1989 — 9 before the letter

E250-E350 7.3L Diesel —
A01 thru K26 • REPAIR
All Other — (except 5.0L)
A01 thru L30 • REPAIR

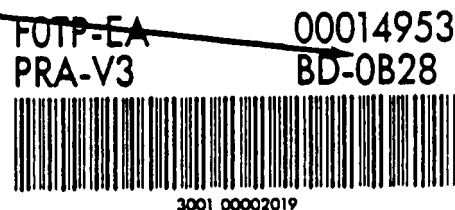
- 1990 — 0 before the letter
Does Not Need Repair
