# Technical Service Information

## CHRYSLER A604 PLANETARY FAILURE

**COMPLAINT:** Before or after overhaul, premature planetary gear failure occurs.

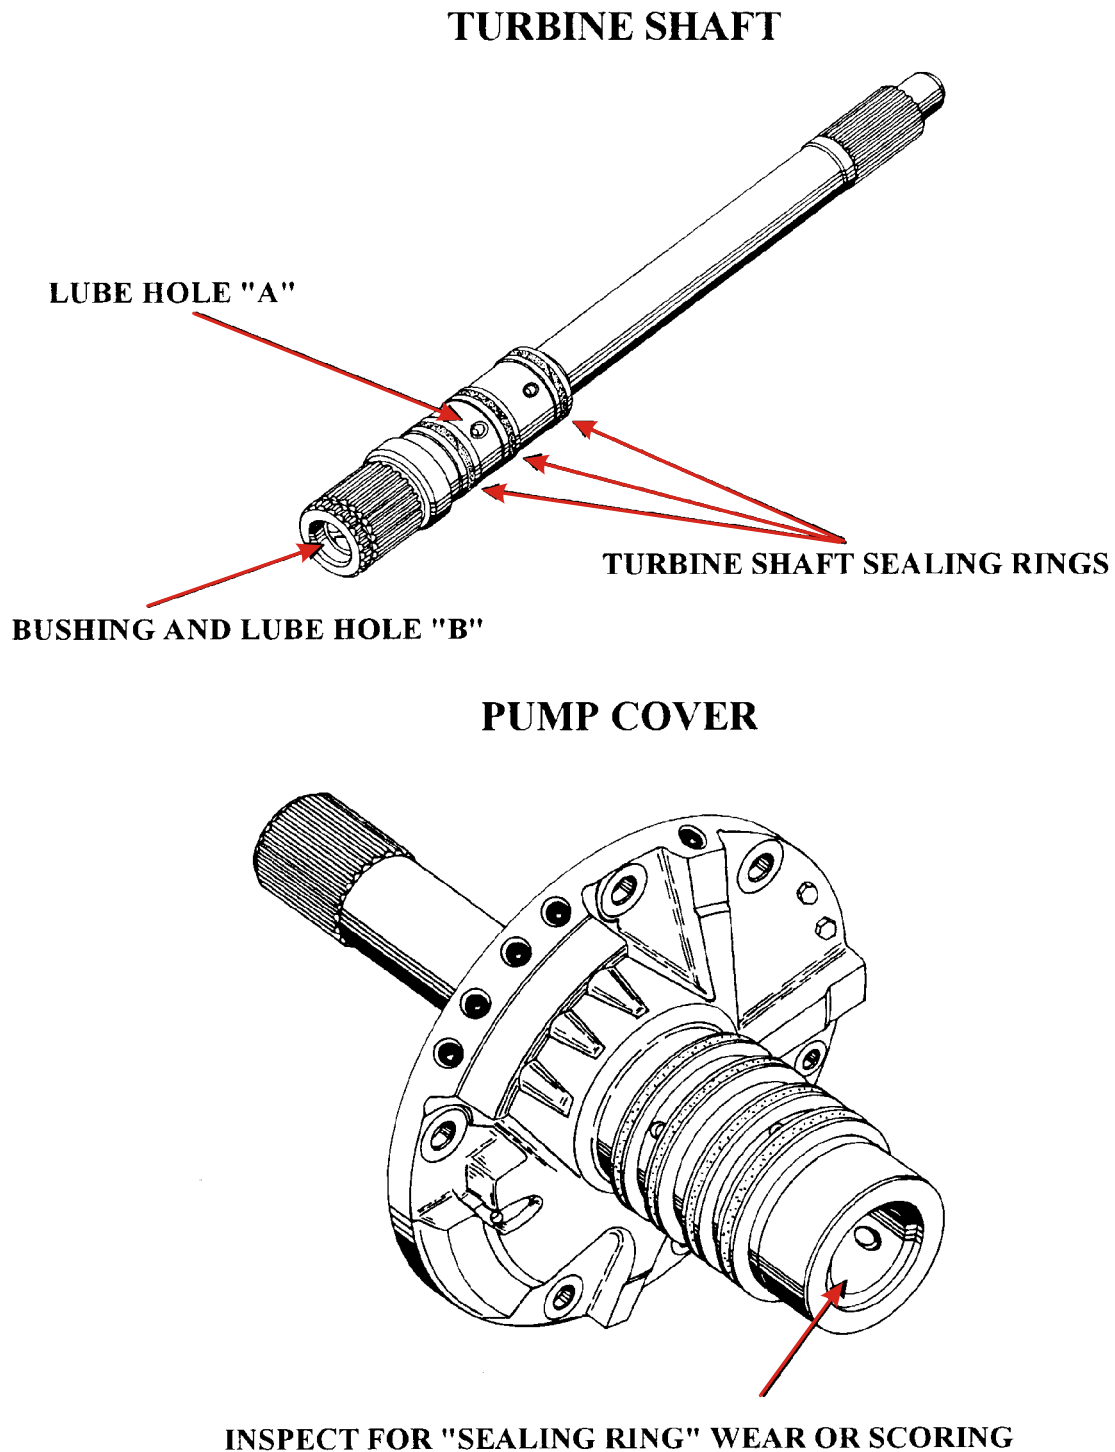
**Figure 1**

1. Damaged turbine shaft sealing rings or a scored surface where they ride in the rear of the pump cover.
2. A worn bushing in the rear of the turbine shaft where the underdrive clutch hub rides.
3. A restriction in the underdrive clutch hub lubrication holes.
4. Worn bushings in the overdrive clutch hub and shaft.
5. Worn or misplaced (moved) bushings in the 2-4 sun gear hub or a restriction in the two lube holes.
6. End clearance too loose allowing the input drum to "Walk" back and forth causing a loss of lube pressure because of a possible mis-alignment of the lubrication holes.
7. A restricted or blocked oil cooler restricting lubrication flow to the planetary gear train.

Inspect "Turbine Shaft" sealing rings and the sleeve area in the rear of the pump cover for wear. Apply compressed air into hole "A" in turbine shaft and ensure the air exit's through hole "B" freely. (See Figure 1)

Inspect the bushing in the rear of the turbine shaft for wear or scoring. Ensure that the bushing clearance to the Underdrive clutch hub shaft is no more than .003" to .006." (See Figure 1)

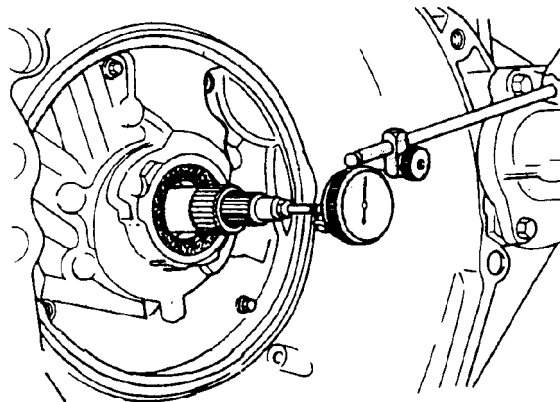
## END PLAY CHECK

"TURBINE SHAFT ENDPLAY" MUST BE BETWEEN .005"-.015"

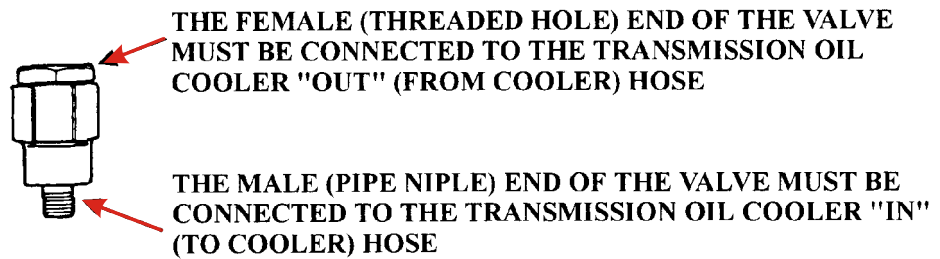
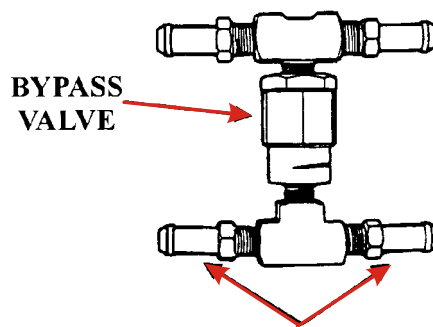
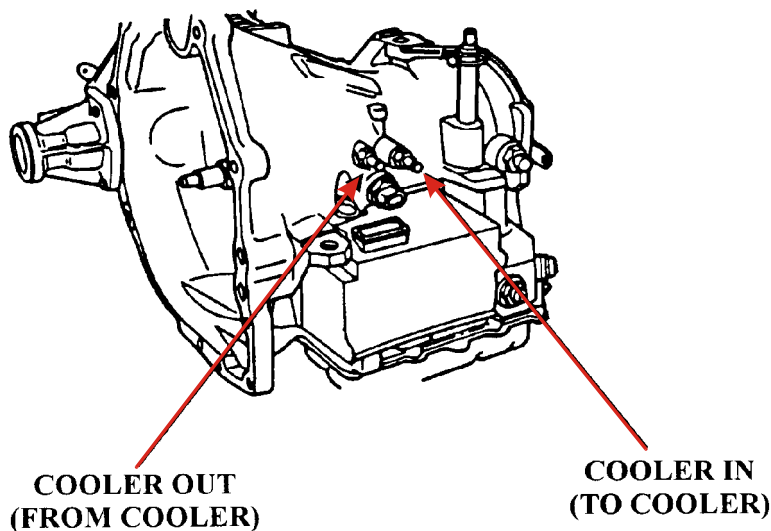
## EXTERNAL "COOLER BYPASS"

THIS SIDE OF THE BYPASS VALVE ASSEMBLY "MUST" BE CONNECTED TO THE TRANSMISSION OIL "IN" (TO COOLER) HOSE

**NOTE: THE BYPASS VALVE IS DIRECTIONAL. IF IT IS NOT CONNECTED TO THE TRANSAXLE OIL COOLER HOSES IN THE CORRECT OIL FLOW DIRECTION, THE BYPASS VALVE WILL NOT FUNCTION AND MAY CAUSE PLANETARY FAILURE.**

8. After the transaxle is installed into the vehicle check the amount of cooler flow entering the front cooler fitting by removing the cooler line and placing it into a container. Start the engine and ensure that **more** than 1 quart of fluid is flowing into the container every 20 seconds minimum. If there are any restrictions or not enough flow, the radiator or factory external cooler may require replacement. If the vehicle is equipped with the external "Cooler Bypass," refer to Figure 7 to ensure that the cooler lines are installed correctly onto the transaxle. If the transmission is equipped with the internal cooler bypass valve, refer to Figure 8 to ensure that the bypass valve is assembled correctly into the case.

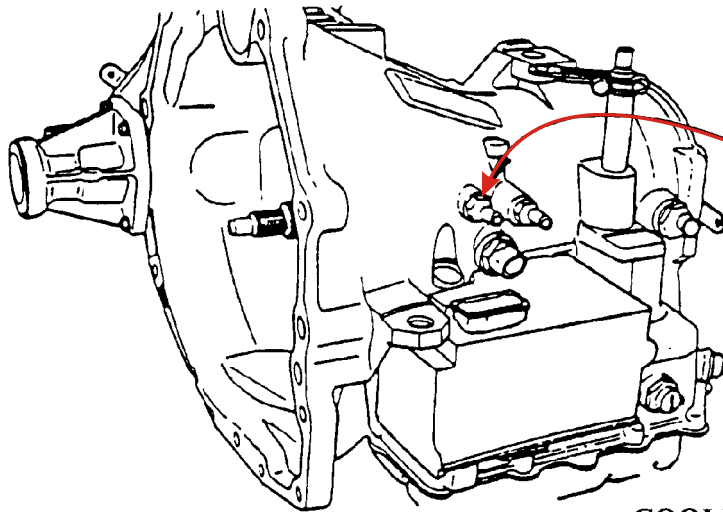
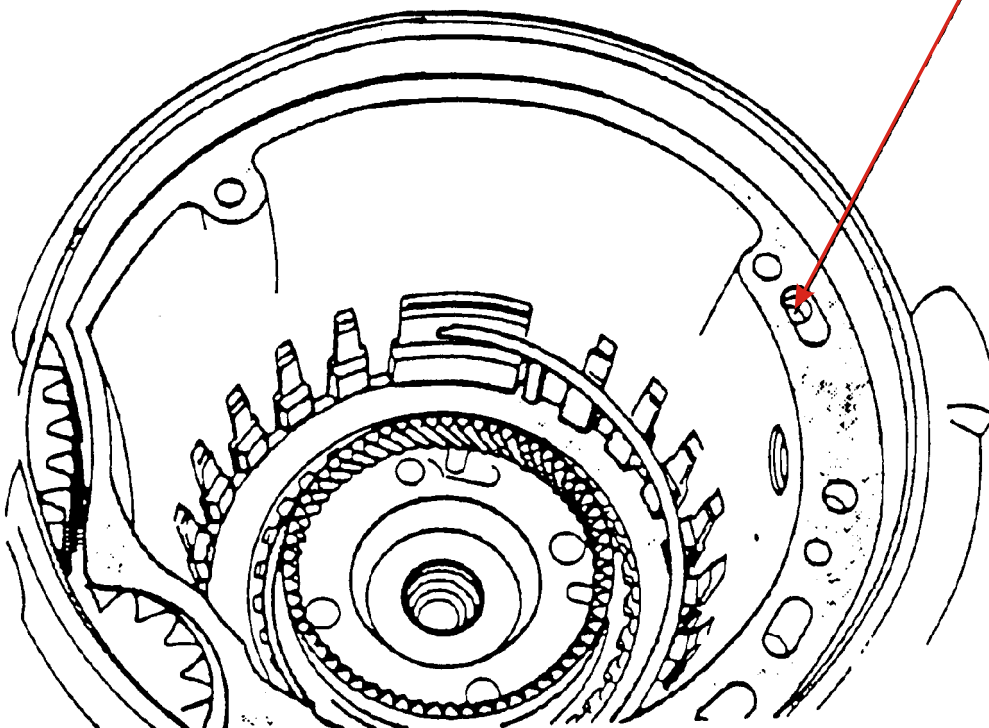
## INTERNAL COOLER BYPASS

THE CASE FOR THE INTERNAL COOLER BYPASS HAS ADDED MATERIAL BETWEEN COOLER FITTINGS TO ACCOMMODATE THE NEW COOLER BYPASS VALVE

INSTALL IN THE CASE PASSAGE UNDER THE OIL PUMP IN THE DIRECTION SHOWN
