Technical Service Information

THM 3T40 (125C) NO CONVERTER CLUTCH APPLY

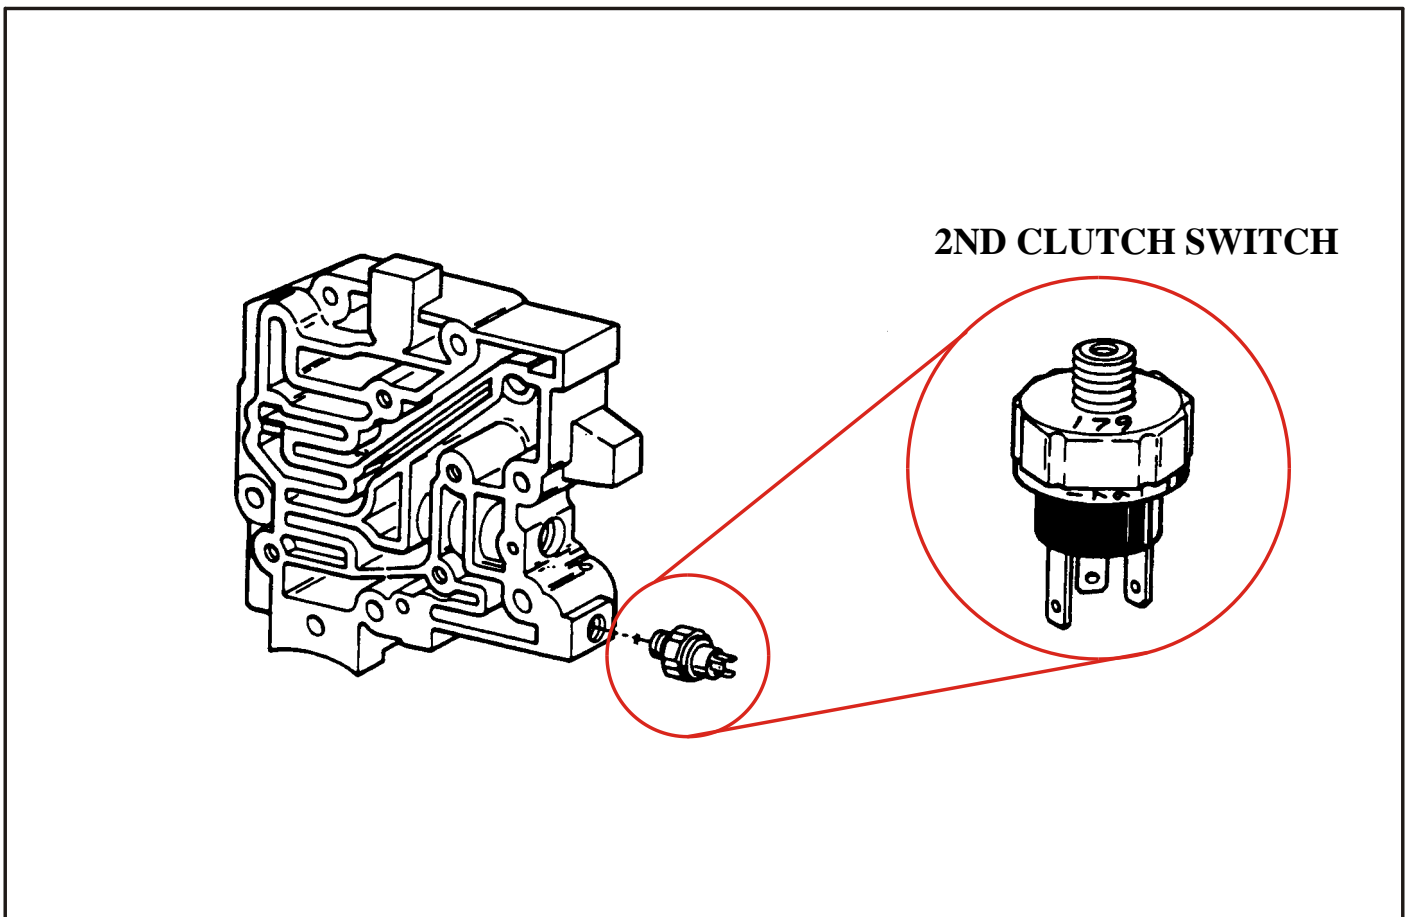
Figure 1

COMPLAINT: Torque converter clutch does not apply on 1988 or 1989 models only. The vehicle may also exhibit intermittent "Service Soon" light and/or trouble code 62 or 26 stored in the ECM.

CAUSE: The cause may be a defective 2nd clutch switch located on the auxillary valve body (See Figure 1). The 2nd gear switch has a 3 digit code stamped on the metal portion of the switch (See Figure 1). The first 2 digits in the code represent the week in which the switch manufactured, and the 3rd digit represents the year manufactured. All switches built with number 179 or lower, will not carry the amperage required to operate the converter clutch solenoid, and should be replaced. Terminals will appear black in color and may be loose in the switch.

CORRECTION: Replace the 2nd clutch switch with OEM Part Number 8664388. Inspect the converter clutch solenoid, 3rd gear switch, and entire wiring harness for excessive heat.
