# THE SEMINAR TO SEE IV '93

Automatic Transmission Service Group  
9200 South Dadeland Blvd.  
Suite 720  
Miami, FL 33156  
(305) 661-4161

# **TRANSMISSION SEMINAR 1993**

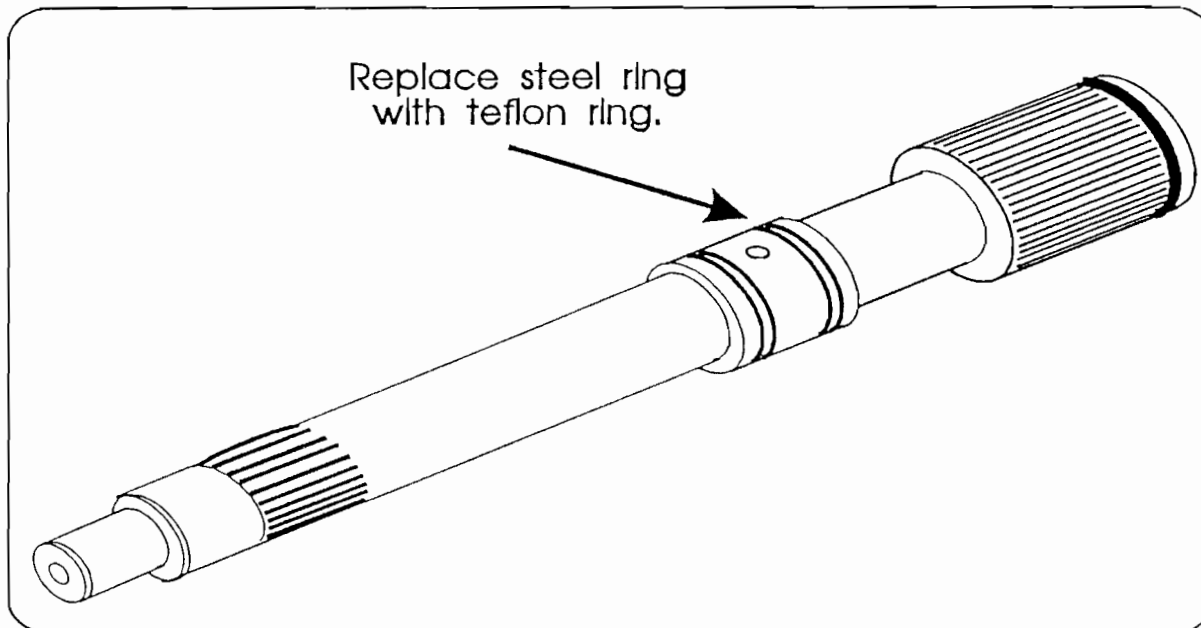
Figure 1.

**CAUSE:** The turbine shaft has two sealing rings that direct oil to the converter. A worn stator support bore can cause a cross leak of converter oil into the forward clutch. Also the rear metal sealing ring on the turbine shaft can leak causing partial forward clutch apply.

**STEP #2.** Remove the rear metal turbine shaft ring and discard it. Replace the ring with one made of teflon. Make your own if neccessary. (See Figure 1.)

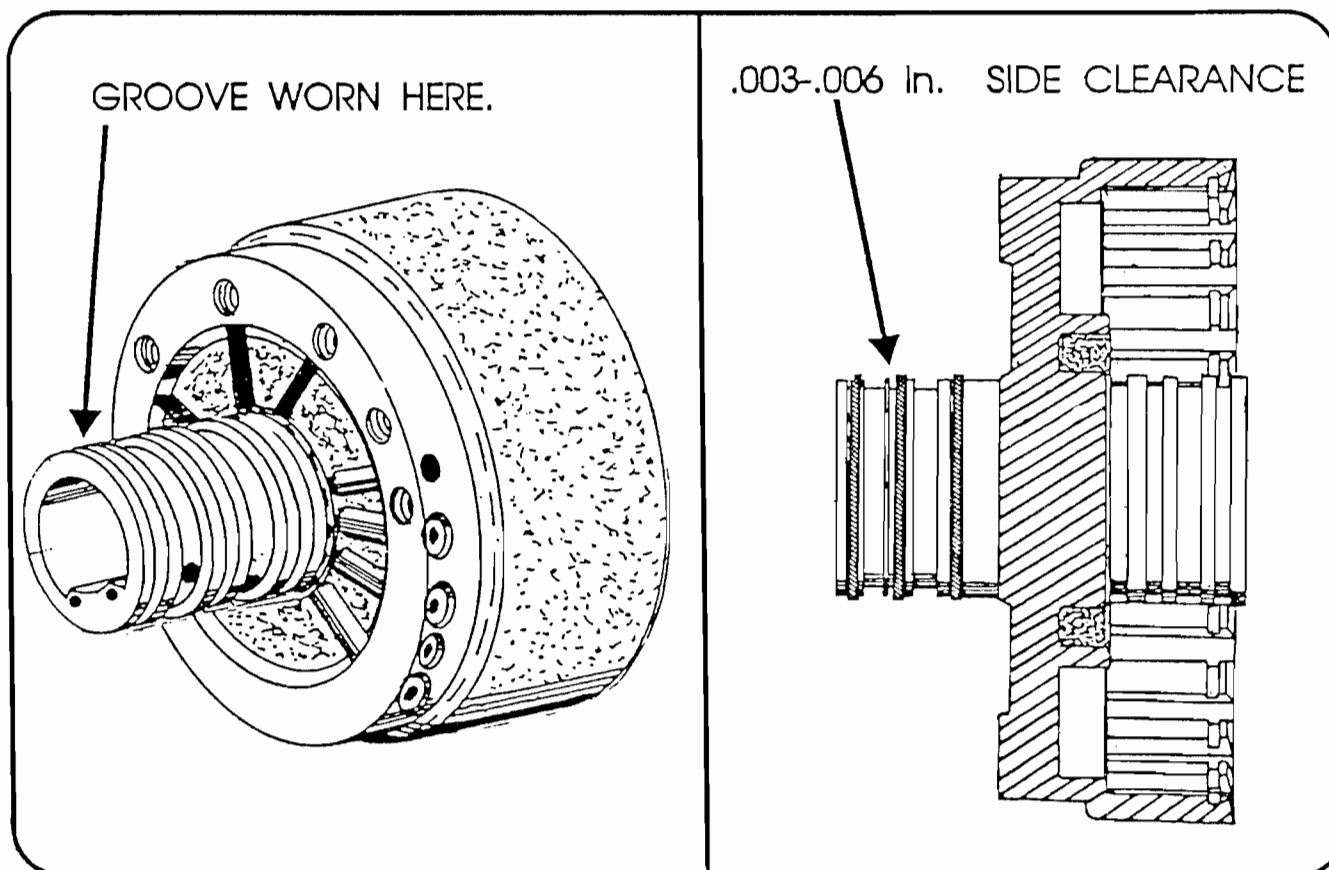
**CAUSE:** During an internal inspection, close examination of the (F) clutch cylinder that bolts into the case will be necessary. Abnormal ring groove wear on the drum where the governor rides will cause the loss of governor pressure (SEE FIGURE 1). With a new ring installed on the drum, side clearance should be .003-.006 in. (SEE FIGURE 2).

**CORRECTION:** A new (F) clutch cylinder must be installed if any wear or damage is found. New sealing rings must also be installed. Rubber sealing rings will work, but steel rings are the preferred choice. The part number for the (F) clutch cylinder is **24-23-1217-088**.

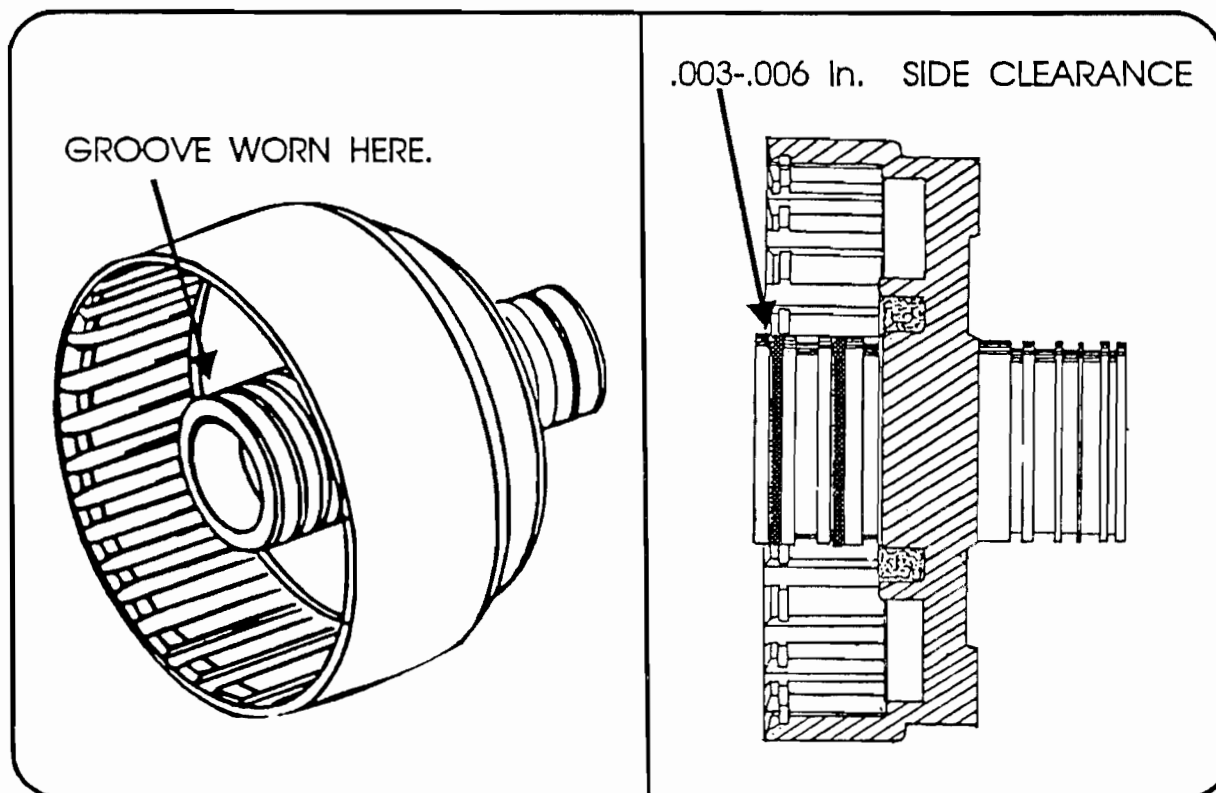
**CAUSE:** If an examination of the valve body fails to pinpoint the problem, an internal inspection will be necessary. Severe ring groove wear on the (F) clutch cylinder where the (E) clutch rides or even ring grooves missing because of wear is possible (SEE FIGURE 1). with a new ring installed on the drum, side clearance should be .003-.006 in. (SEE FIGURE 2).

**CORRECTION:** A new F clutch cylinder must be installed if any wear or damage is found. New sealing rings must also be installed. Steel rings must be used for the E clutch sealing grooves. The part number for the F clutch cylinder is 24-23-1217-088.

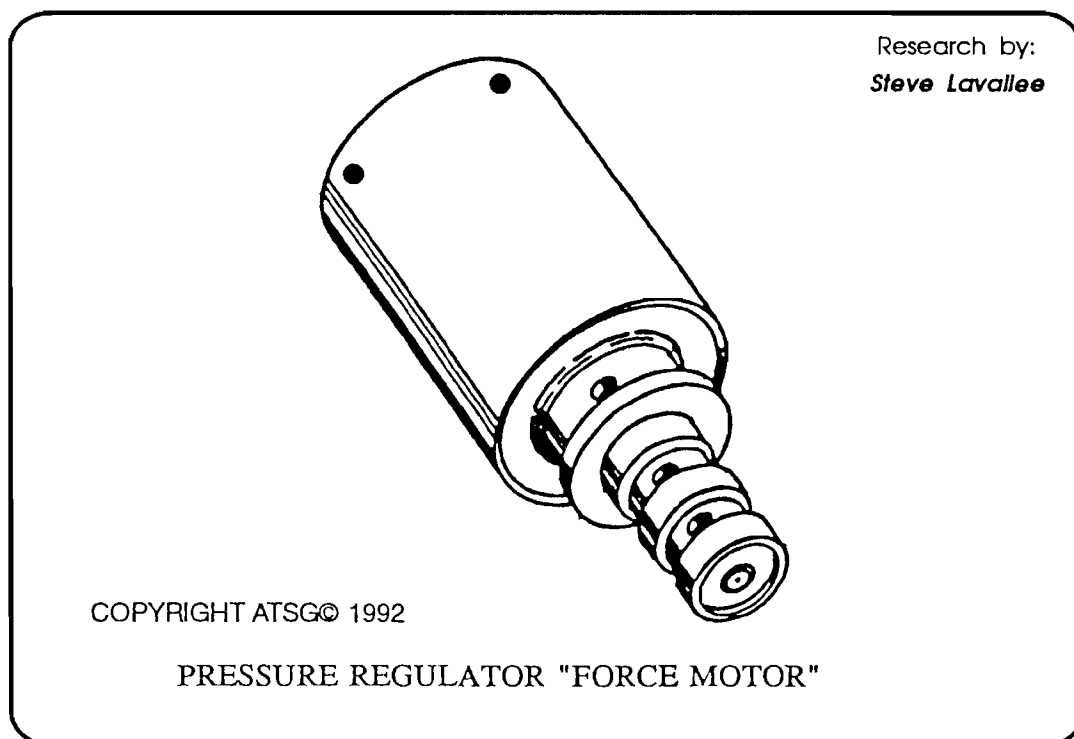
Figure 1.

**CAUSE:** Pressure Regulator "Force Motor" failure (See Figure 1). Extremely high pressure will result. This cannot always be diagnosed with an ohms test as the failure may be mechanical.

Pressure Regulator ohms test across both terminals should be 2.5 - 4.0 ohms resistance. This ohms test should be done near room temperature. Do not energize this force motor with full battery voltage as damage may result.

**CORRECTION:** Replace the Pressure Regulator "Force Motor".

**Note:** A new Pressure Regulator from BMW is just under \$600.00 and is usually available in less than two weeks. There is, however, a suitable alternative that has proved most effective. The G.M. 4L80-E Force Motor is manufactured by the same company and aside from a few minor differences does the same job. Most of the overall dimensions are the same except that the G.M. 4L80-E Force Motor uses screens in the plunger and port areas (See Figure 2). Those differences are insignificant. A new 4L80-E Force Motor will cost you about \$133.00. The G.M. part # is 8677314.

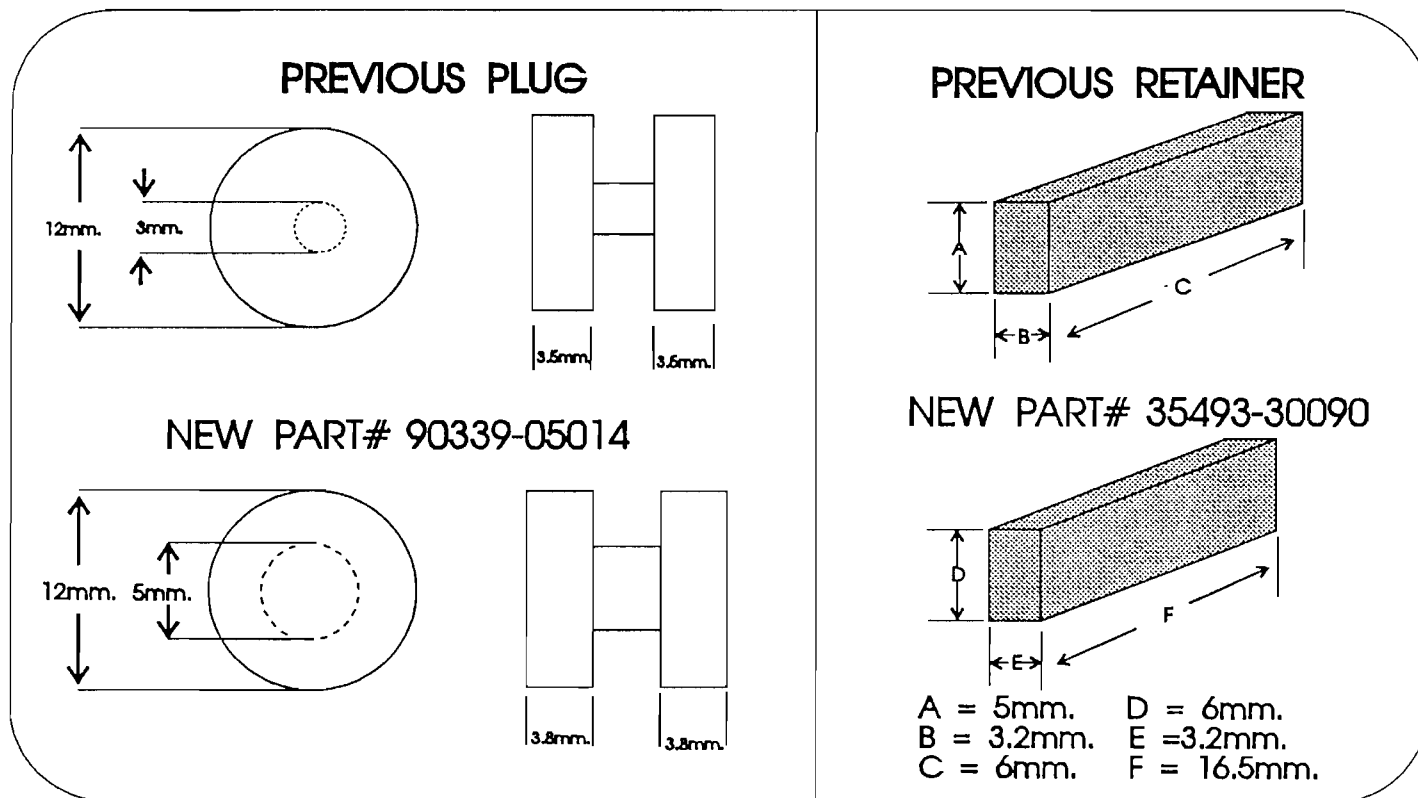
**Cause:** Broken or cracked end plugs. Problem may not be visible unless valves are removed

**Correction:** Install updated (stronger) end plugs, also replace retainers designed to accommodate the new end plugs (see figures 1 & 2).

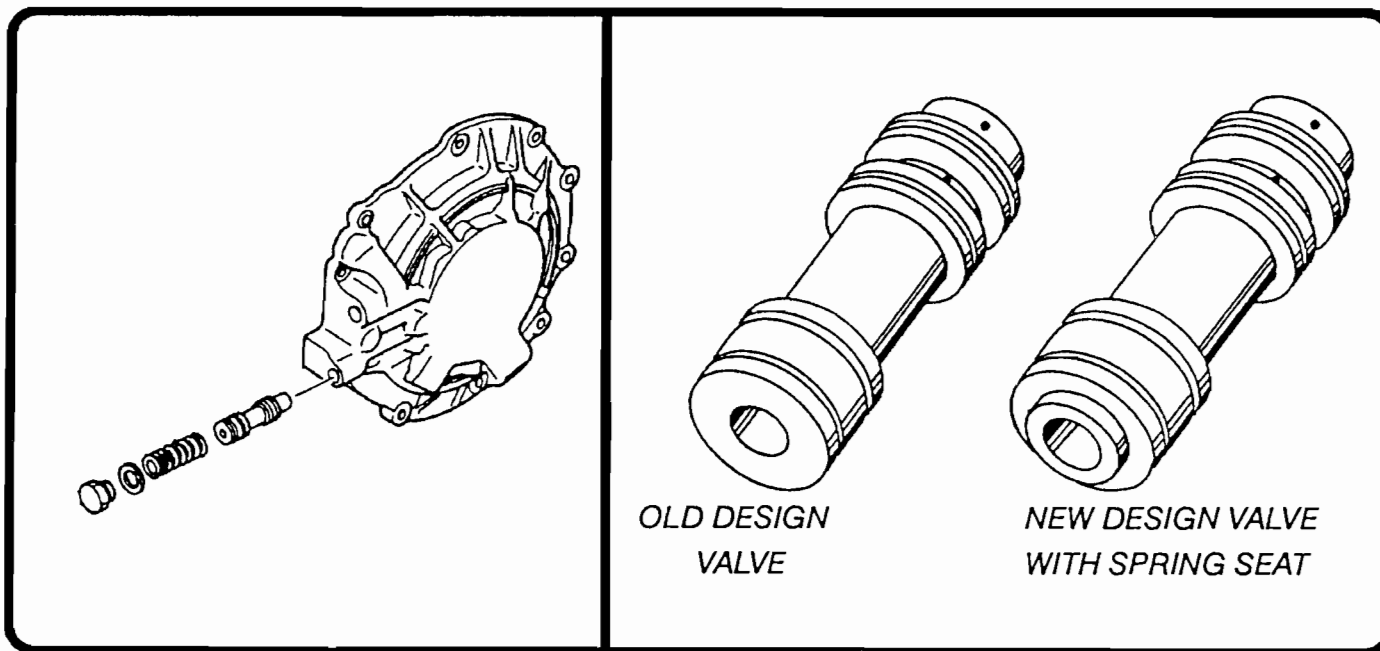
FIGURE 1

**CAUSE:** *The spool valve in the pump did not have a seat for the spring. The spring will hang the valve and cause low line pressure (figure 1).*

**CORRECTION:** *Order updated valve from Ford. It has a seat formed on the valve for the spring and will work on both units (figure 2) part # FO2Z-7Z306-A.*

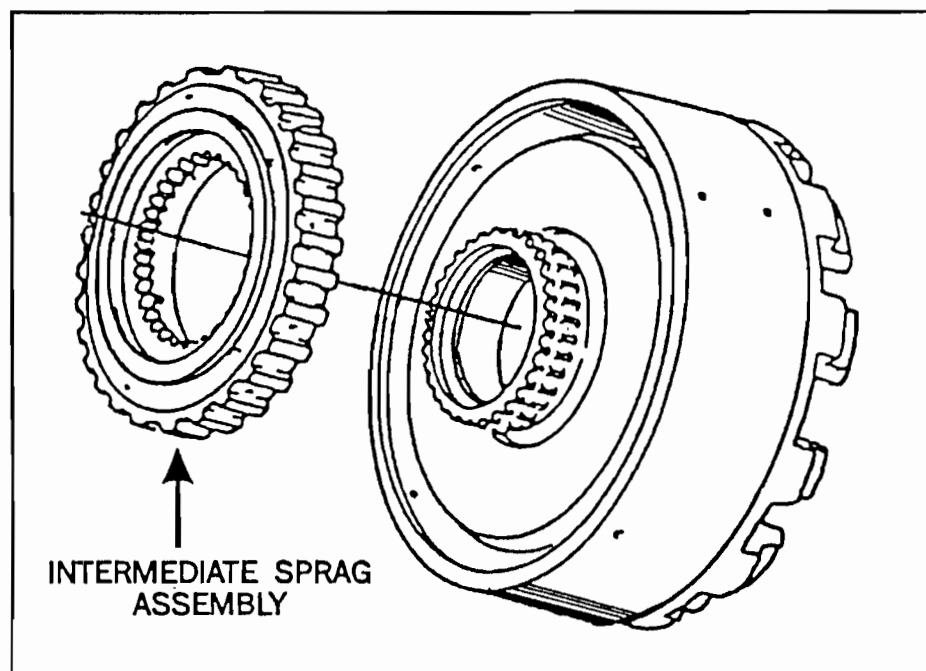
- COMPLAINT:** INTERMITTANT FLARE ON A 2-3 SHIFT. THE FLUID IS CLEAN AND DOES NOT HAVE A BURNT ODER TO IT.
- CAUSE:** THE INTERMEDIATE SPRAG IS FAILING TO HOLD THE INTERMEDIATE CLUTCHES CAUSING A FLARE UNTIL THE 3-4 CLUTCHES APPLY.
- CORRECTION:** REPLACE THE INTERMEDIATE SPRAG ASSEMBLY, REFER TO FIGURE 1 BELOW.

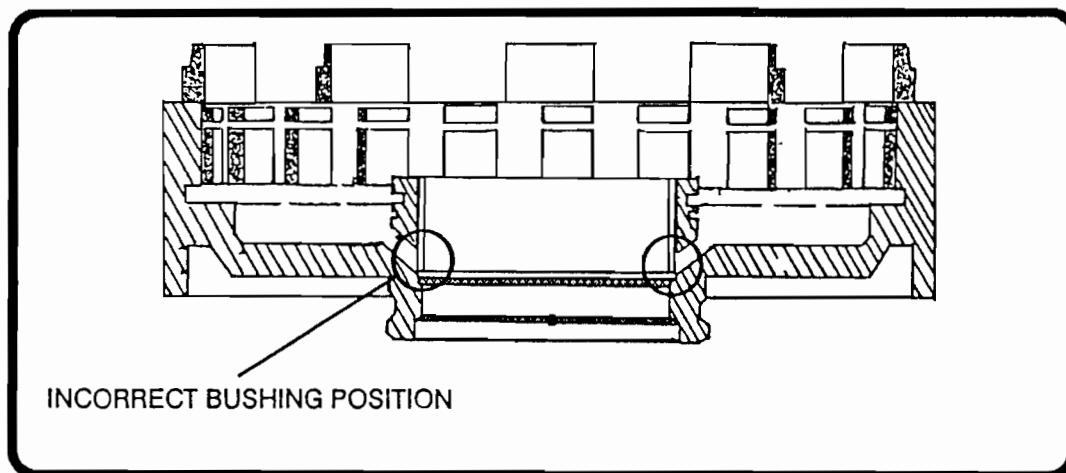
FIGURE 1

**CAUSE:** The reverse drum sleeve has moved forward in the drum and blocks the two oil feed holes (see figure 1). The normal position of the sleeve is about .060 in. above the drum surface and covers 50% of the feed holes (see figure 2).

**CORRECTION:** Replace the reverse drum.

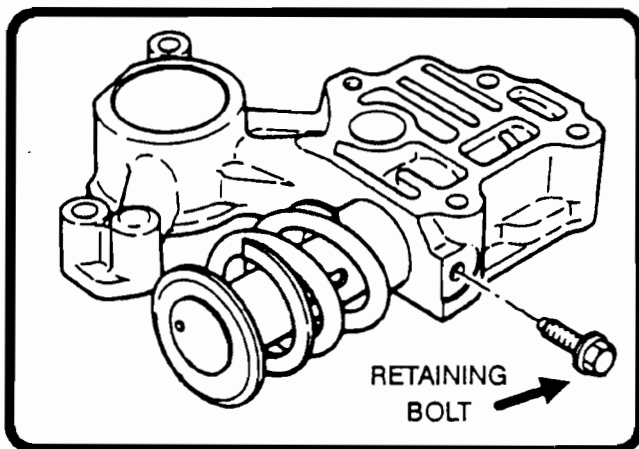
FIGURE 1

- COMPLAINT:** Harsh engagement, harsh shifts, high line pressure.
- CAUSE:** Pressure regulator retaining bolt jamming spring retainer (figure 1).
- CORRECTION:** When installing retainer and bolt make sure that the slot on the retainer lines up with the bolt hole before installing the bolt (figure 2).

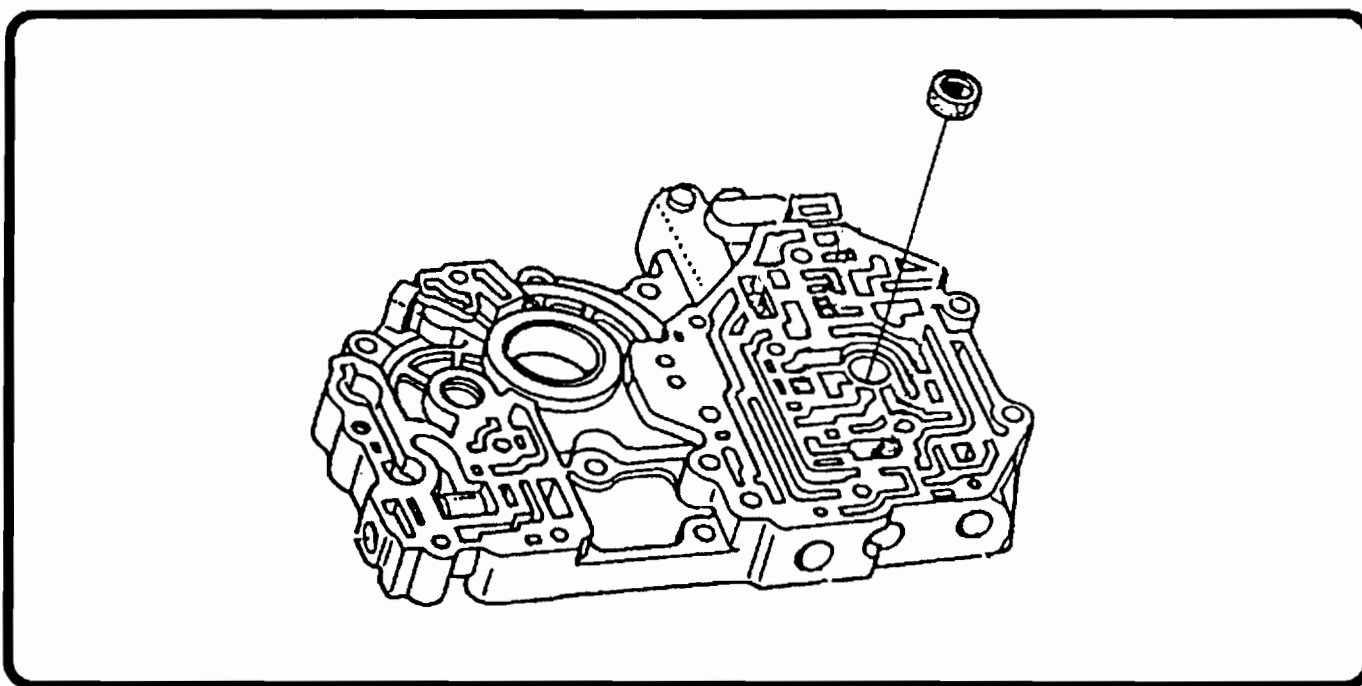
Figure 1

**CAUSE:** *Filter located in main portion of valve body damaged or restricted with foreign material causing pressure loss to the shift solenoids.*

**CORRECTION:** *Clean or replace filter (see figure 1).*

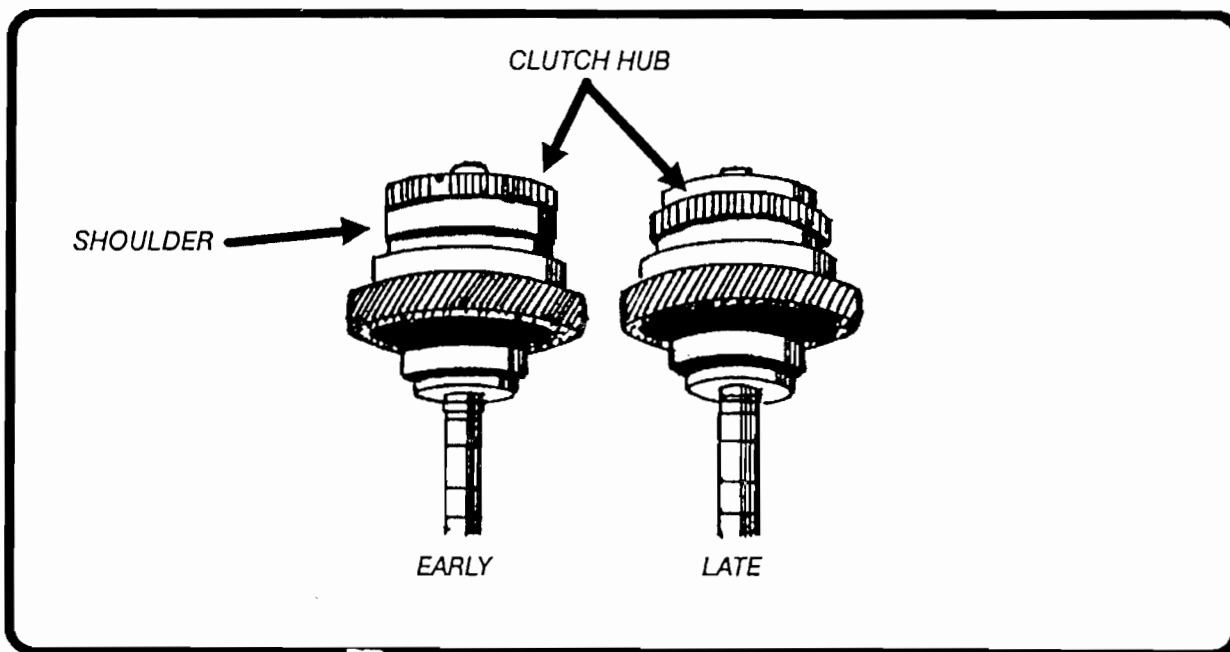
**CAUSE:** *One cause may be a late planetary assembly installed in an early transaxle. The over-run clutches can no longer hold the planetary assembly as the hub for the clutches are in different location.*

**CORRECTION:** *Install the correct planetary assembly.*

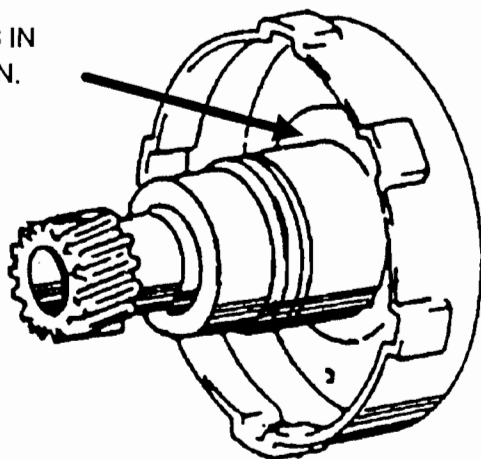
WELD BREAKS IN  
THIS LOCATION.

**CORRECTION:** Replace drum.

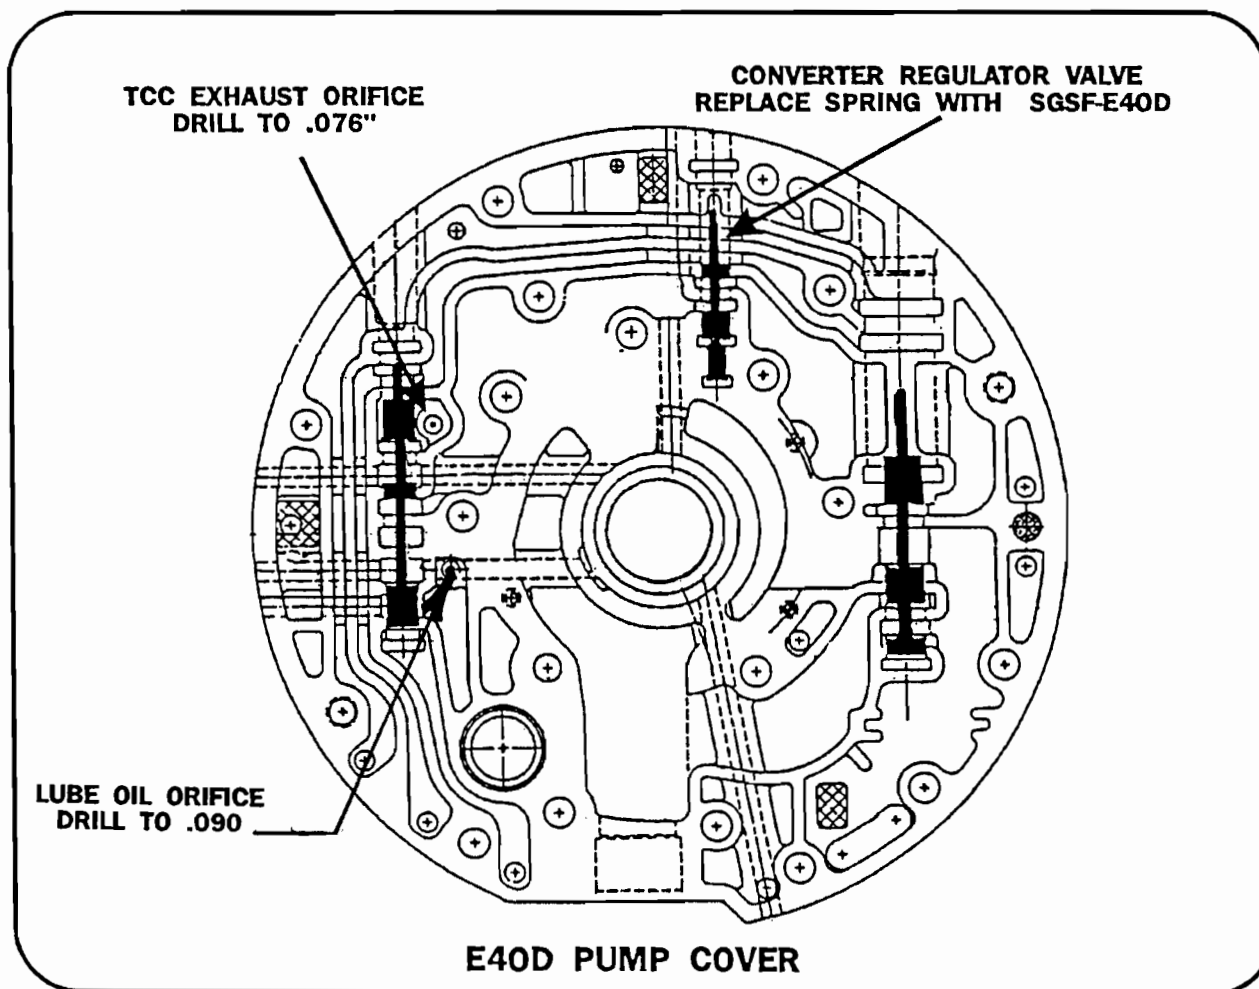
Figure 1

- COMPLAINT:** Soft converter clutch engagement or shudder on hard acceleration
- CAUSE:** Low converter pressure and/or limited ability of the converter exhaust orifice to control converter clutch apply.
- CORRECTION:** Replace the converter regulator valve spring in the pump cover with a "SGSF E4OD" shudder fix spring (see figure 1), Drill the converter clutch exhaust orifice to .076 in. (see figure 1).

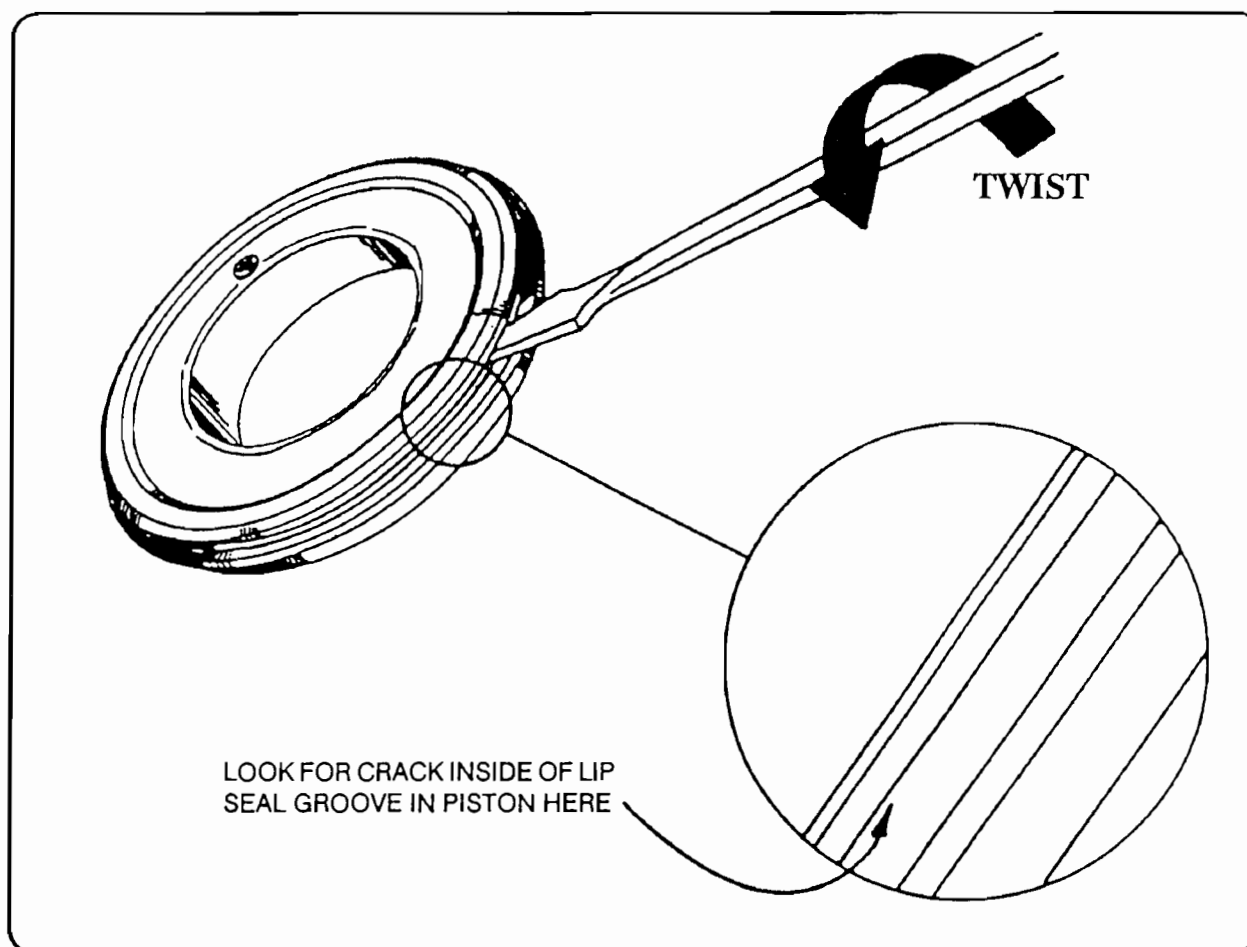
Figure 33

- COMPLAINT: Flare or slip on 2-3 shift, or premature failure of direct clutches.
- CAUSE: The cause may be cracked direct clutch piston. For procedure to check the piston, (see figure 33).
- CORRECTION: Replaced the direct clutch piston.

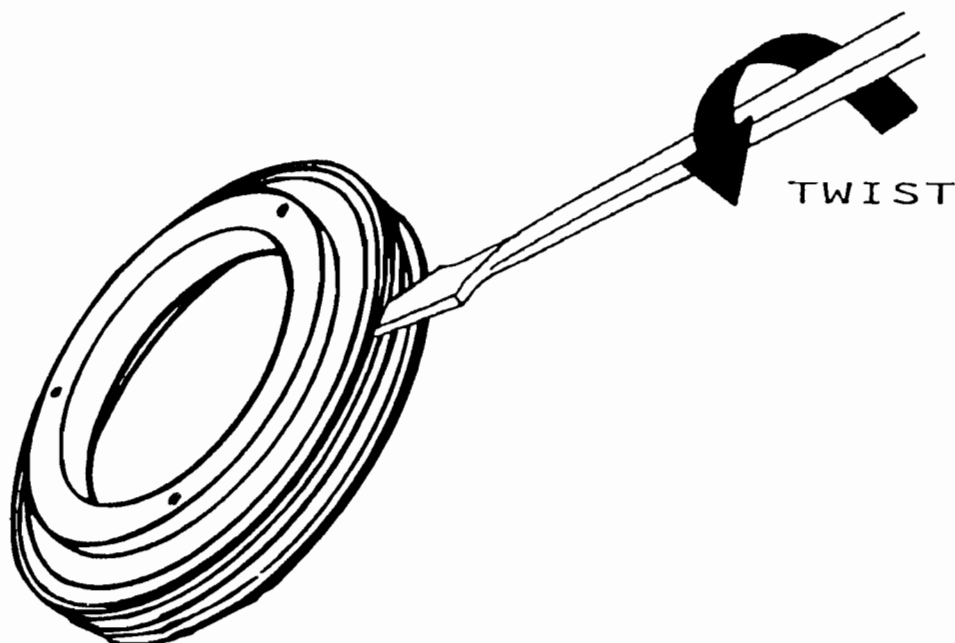
FIGURE 1

<b>COMPLAINT:</b>	<b>NO MOVEMENT OR SLIPS FORWARD &amp; REVERSE WHEN HOT.</b>
<b>CAUSE:</b>	<b>CRACKED FORWARD CLUTCH PISTON. PROCEDURE FOR CHECKING PISTON IS SHOWN IN FIGURE 1.</b>
<b>CORRECTION:</b>	<b>REPLACE PISTON WITH PART NUMBER F1DZ-7A262-A.</b>

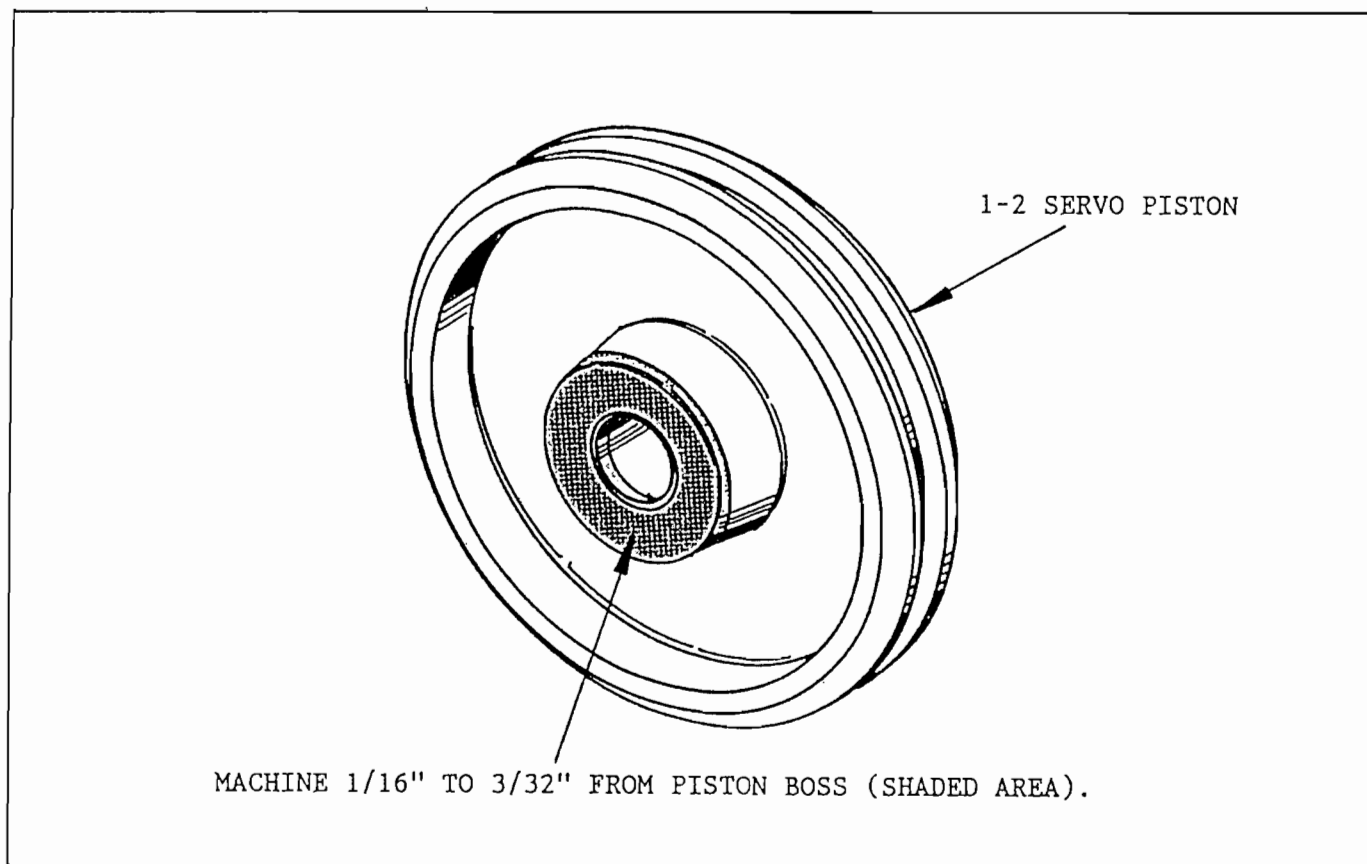
Figure 1

- COMPLAINT: Harsh downshift when coasting to a stop at closed throttle.
- CAUSE: Insufficient travel of the 1-2 piston against the cushion spring.
- CORRECTION: Remove  $1/16"$  to  $3/32"$  from the boss on the inside of the 1-2 servo piston as shown in Figure 1. We have shaded the area to be machined.
