# Technical Service Information

## THM 4L80-E/4L80-EHD STUCK IN 1ST GEAR NO VEHICLE SPEED SIGNAL

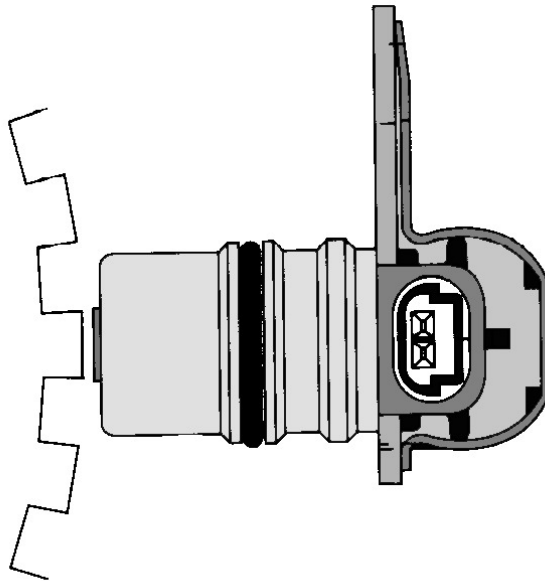
Figure 1

**COMPLAINT:** The vehicle displays a "No Upshift" condition, and when scanning for codes on 1991-93 vehicles, there are no codes stored. However, on 1994 vehicles, a code 74 *may* be stored for "No Input Speed Sensor Signal".

**CAUSE:** On all 1991-94 Trucks and Vans equipped with the THM 4L80-E, the PCM has strategy that *will not allow the PCM to look at output RPM, if there is no input RPM signal.*

**CORRECTION:** When a "No Upshift" condition exists, do not assume that it is an output speed sensor and/or DRAC problem. On 1991-93 vehicles scan for data and ensure that you do have an input speed sensor signal. On 1994 vehicles, if code 74 is present with the above symptoms, that is a definite indicator that the input speed sensor is causing the problem.
