FORD, JAGUAR, MAZDA, ROVER, VW, EQUIPPED WITH JF506-E

2-3 FLARE OR, SLIPS 3RD, 4TH, 5TH

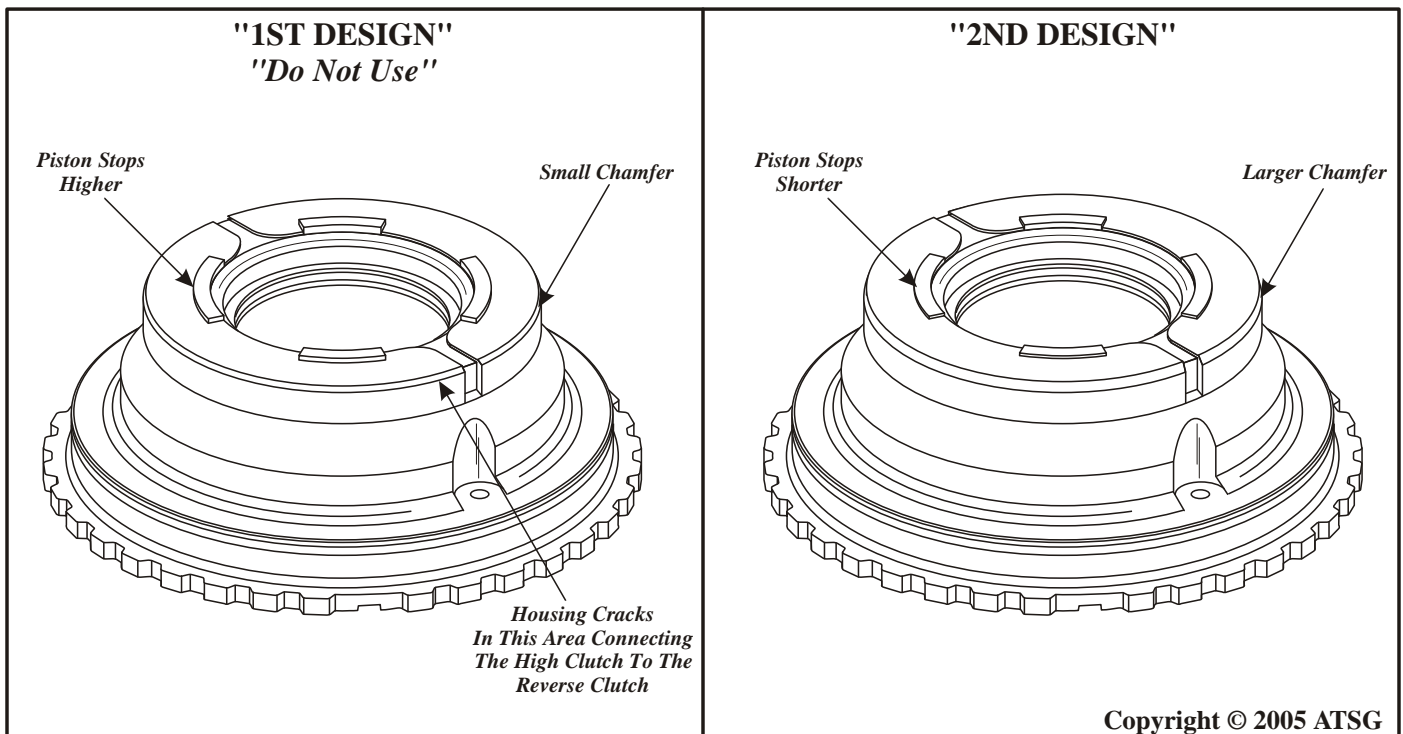
Figure 1

COMPLAINT: Before and/or after overhaul, vehicles listed above and equipped with the JF506-E transaxle, may exhibit a flare on the 2-3 upshift, or slips when in 3rd, 4th, or 5th gear.

CAUSE: The cause may be, high and reverse clutch piston housing, as shown in Figure 1.

CORRECTION: This crack is *extremely* difficult to detect visually, and if missed will create premature high clutch failure. This piston cracks in an area of the piston that allows the high clutch apply oil to bleed into the reverse clutch circuit, as shown in Figure 1. The reverse clutch circuit is basically an exhaust, when the transaxle is in 3rd, 4th, or 5th gear.

Replace the high and reverse clutch piston housing, as shown in Figure 1. There is now a 2nd design piston available from Mazda. Refer to Figure 2 for an exploded view of the high and reverse drum showing the housing location.
