THM 440-T4 HARSH DRIVE ENGAGEMENT

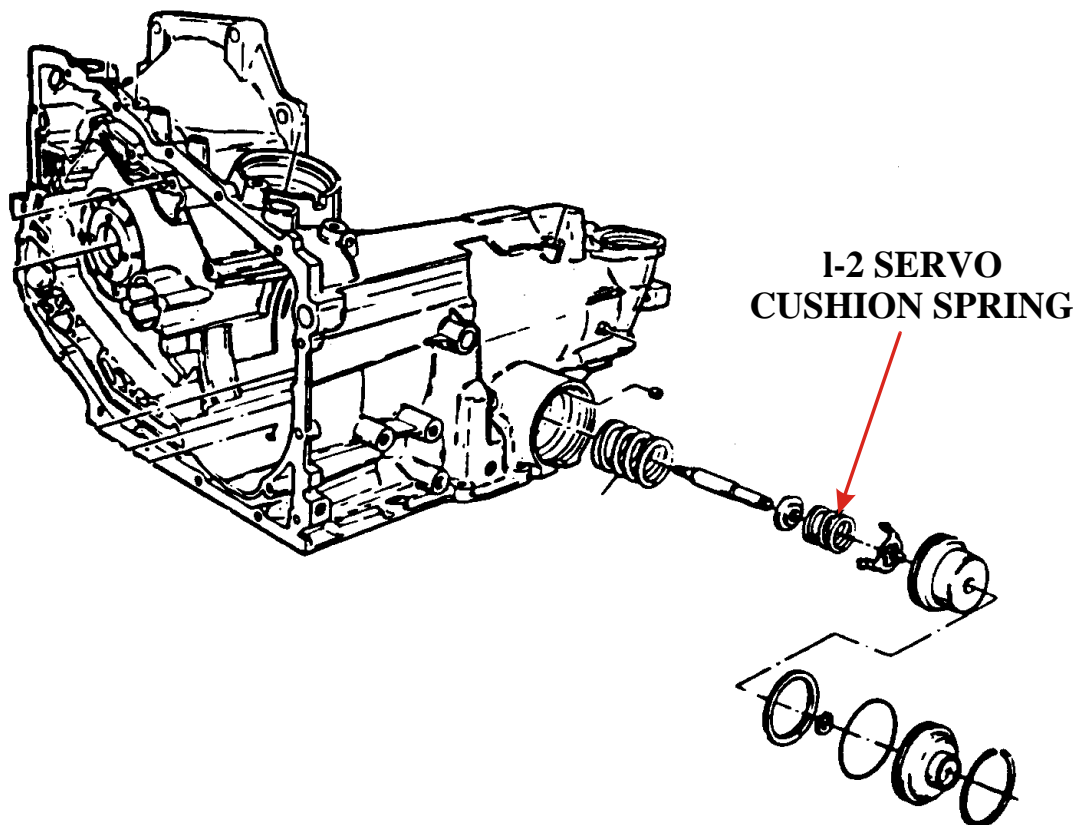
Figure 1

COMPLAINT: Harsh garage shift from Park/Neutral to Drive.

CAUSE: The cause may be:

1. Low vacuum supply to vacuum modulator.
2. Stuck modulator valve in case.
3. No. 12 checkball missing or off location.

CORRECTION: AFTER ALL OF THE ABOVE ARE ELIMINATED:
There is now available a new 1-2 Servo Cushion Spring. Replacing this spring should correct the harsh drive condition (See Figure 1).
Spring, 1-2 Servo Cushion (All).....8668123
