# Technical Service Information

## EAGLE 4HP-18 HARSH 4-3 COAST DOWNSHIFT

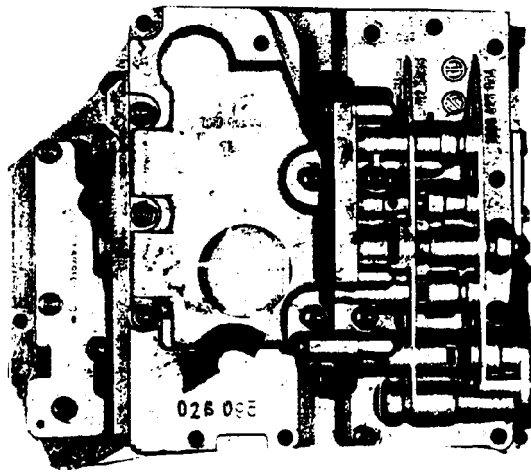
Figure 1

See arrow on cover to locate identification numbers.  
Production numbers beginning with 026 or 132 are early model.  
Production numbers beginning with 052, 068, or higher are late model.

**CORRECTION:** The Forward (A) clutch accumulator orifice has been reduced in later valve bodies. To determine the update level of the valve body, refer to the first three numbers stamped on the filter cover. **See Figure 1.** If the valve body is the early style with either the 026 or 032 filter cover, check the valve body orifice (A) and reduce it as necessary to .047 in. **See Figure 2.**

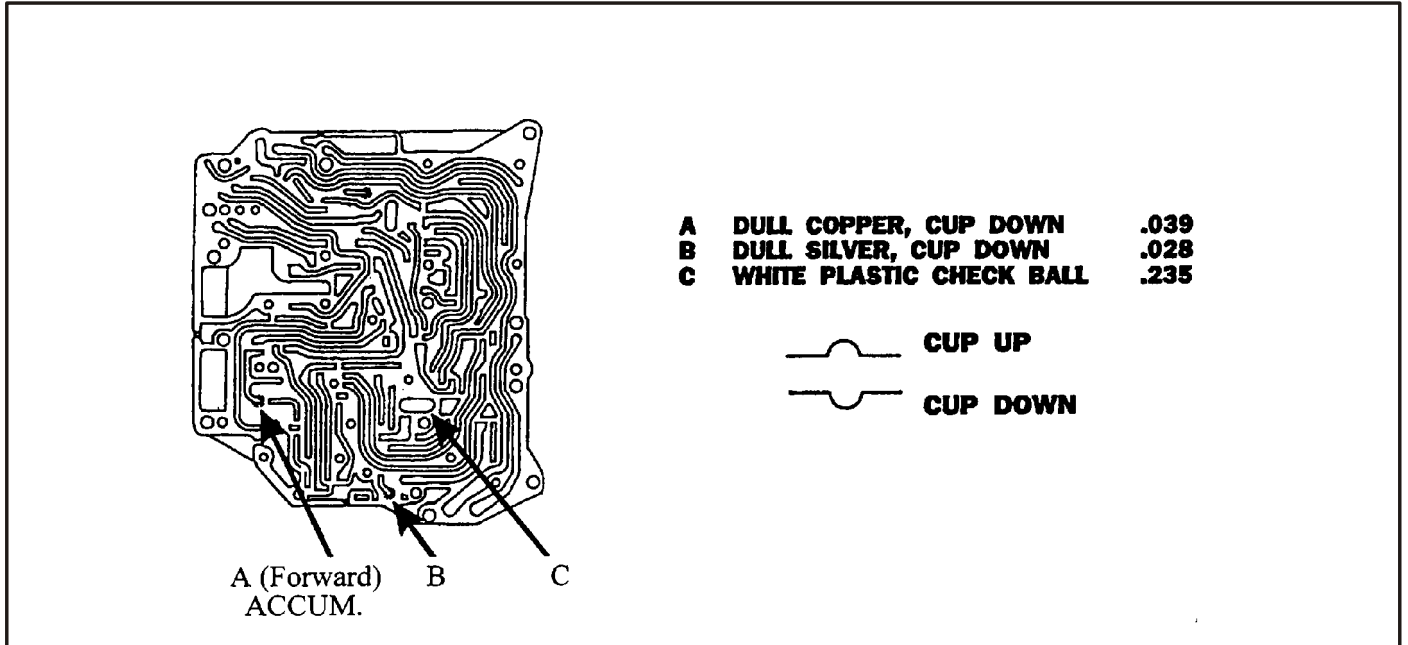
Figure 2

**CAUSE:** Because the Forward (A) clutch must be re-applied on the 4-3 downshift, the cause may be that the Forward clutch accumulator orifice may be too large or new clutch material differences may affect the rate of clutch application, causing a harsh feel.
