Technical Service Information

FORD 4R44E/4R55E/5R55E SLIPPING AND/OR NO LOCKUP AND DTC 628 OR P0741

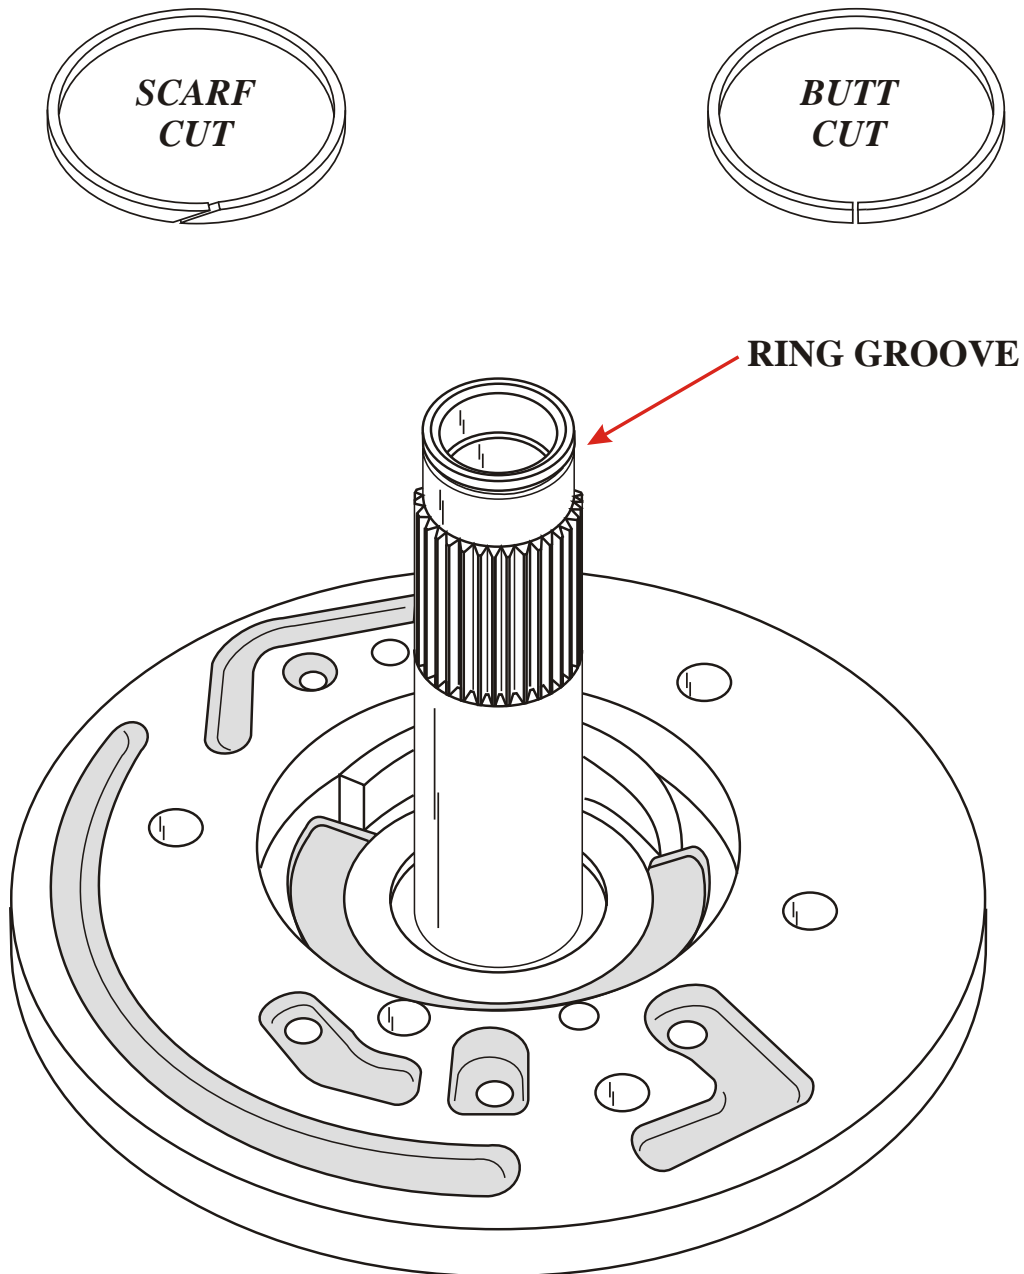
Figure 1

- (1) The incorrect "Scarf Cut" sealing ring was installed on the pump stator (Refer to Figure 1).
- (2) An A4LD inner pump gear used in a 4R44E/4R55E pump body as shown in Figure 2.
- (3) The "O" ring inside the 4R44E/4R55E inner pump gear may be missing or damaged.

**FORD 4R44E/4R55E/5R55E
STATOR SEALING RING IDENTIFICATION**

- (1) Replace the early style "Scarf Cut" sealing ring with the new design "Butt Cut" sealing ring, as shown in Figure 1.
- (2) Ensure that the inner pump gear is a 4R44E/4R55E gear, as shown in Figure 2.
- (3) During rebuild make sure the "O" ring on the inside diameter of the inner pump gear is replaced and use care not to damage the "O" ring when installing the converter.

TCC Butt Cut Sealing Ring..... F77Z-7L323-AA
