# Technical Service Information

## THM 4L60 (700-R4) HARSH DOWNSHIFT CLUNK IN D3 ONLY

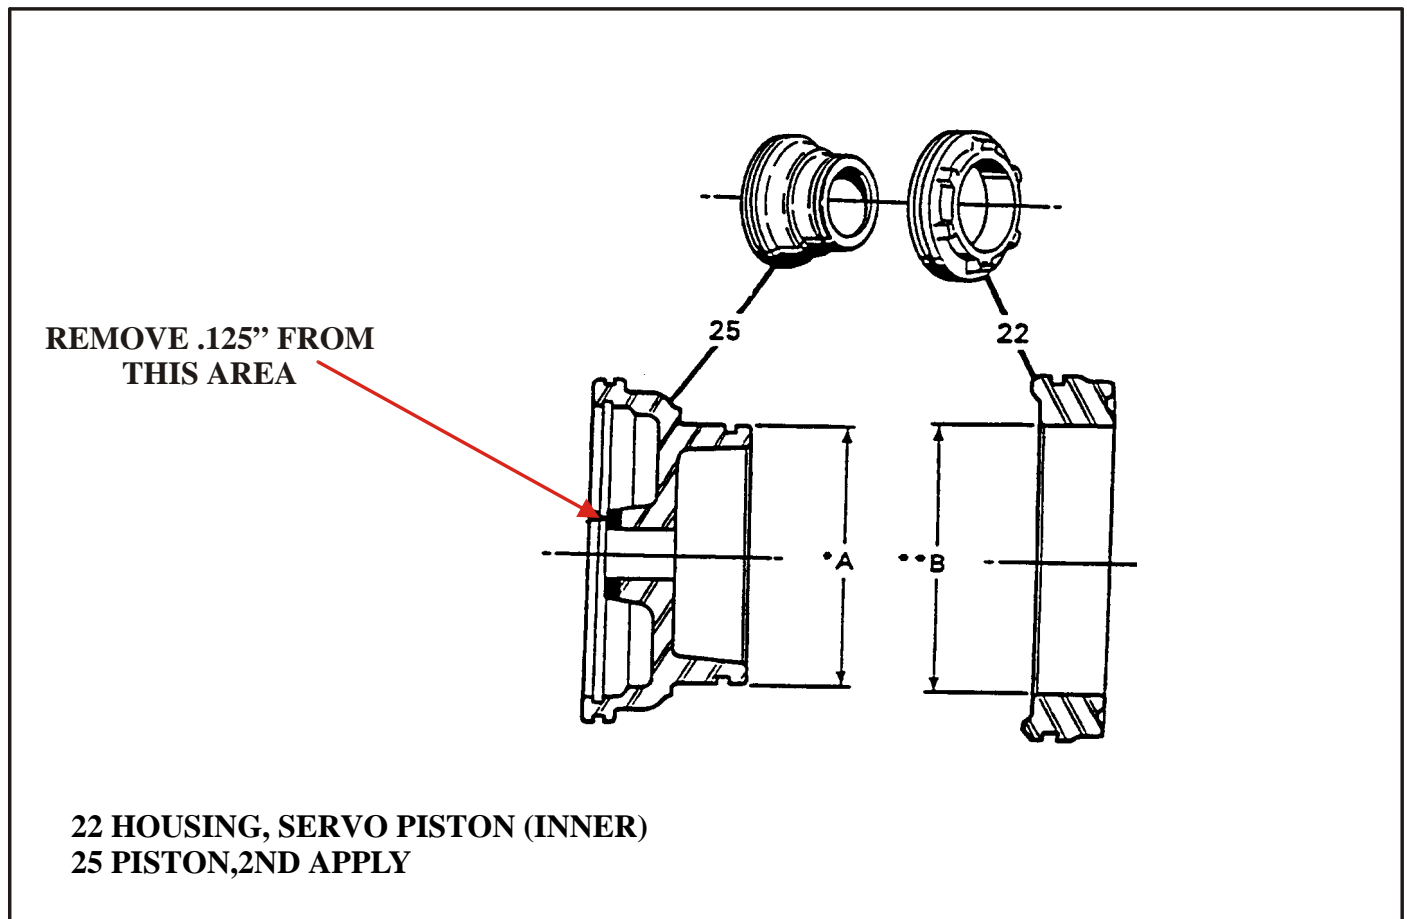
Figure 1

**COMPLAINT:** Harsh downshift clunk with selector in D3 only.

**CAUSE:** The cause could be the 2nd apply piston.

**CORRECTION:** Modify the 2nd apply piston by machining the inner hub and remove .125" (See Figure 1).
