Technical Service Information

THM 4L60-E

PREMATURE 3-4 CLUTCH FAILURE (LOAD RELEASE)

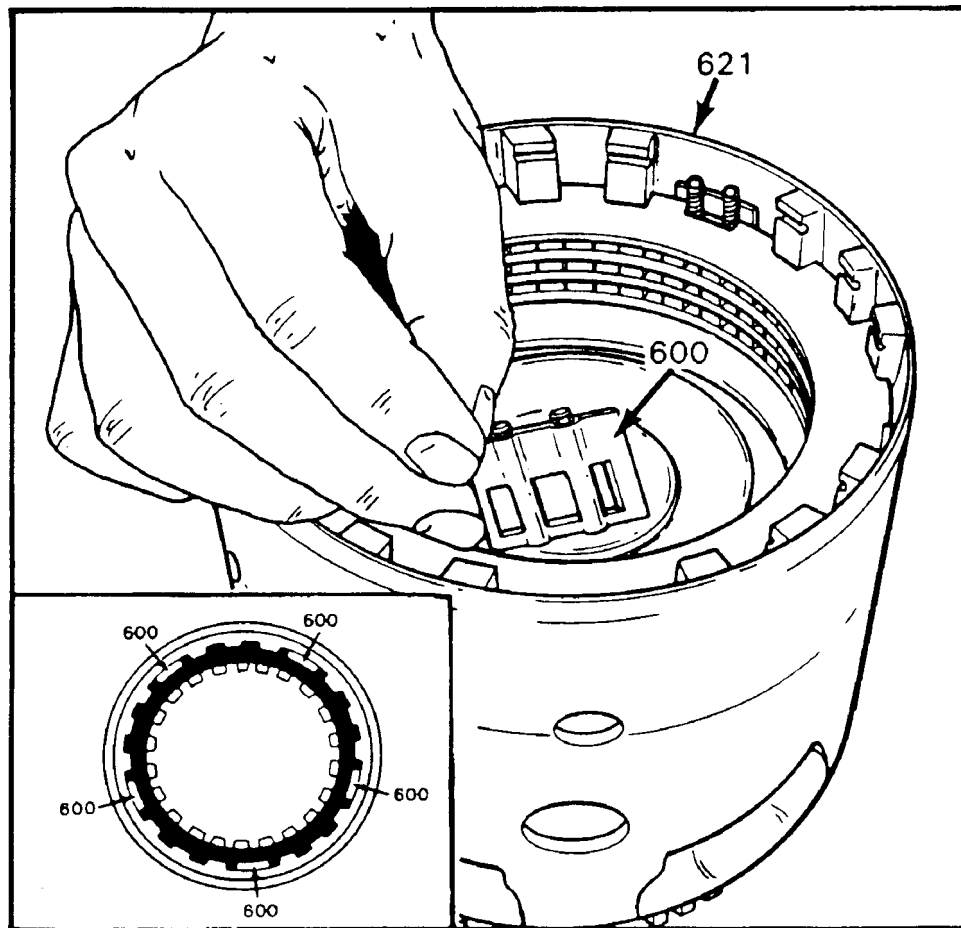
Figure 1

COMPLAINT: Premature failure of the 3-4 clutch pack and may happen in as 5000 miles. The vehicle may also exhibit a very soft 2-3 shift little

CAUSE: The cause may be, not enough clamping force for the 3-4 clutch due to the 3-4 load release spring assemblies. pack

Remove and discard the five 3-4 load release spring assemblies in the input housing and located between the steel plates and the input housing, as shown in Figure 1.
