Technical Service Information

FORD 4R44E/4R55E **INTERMITTENT OR NO TCC APPLY**

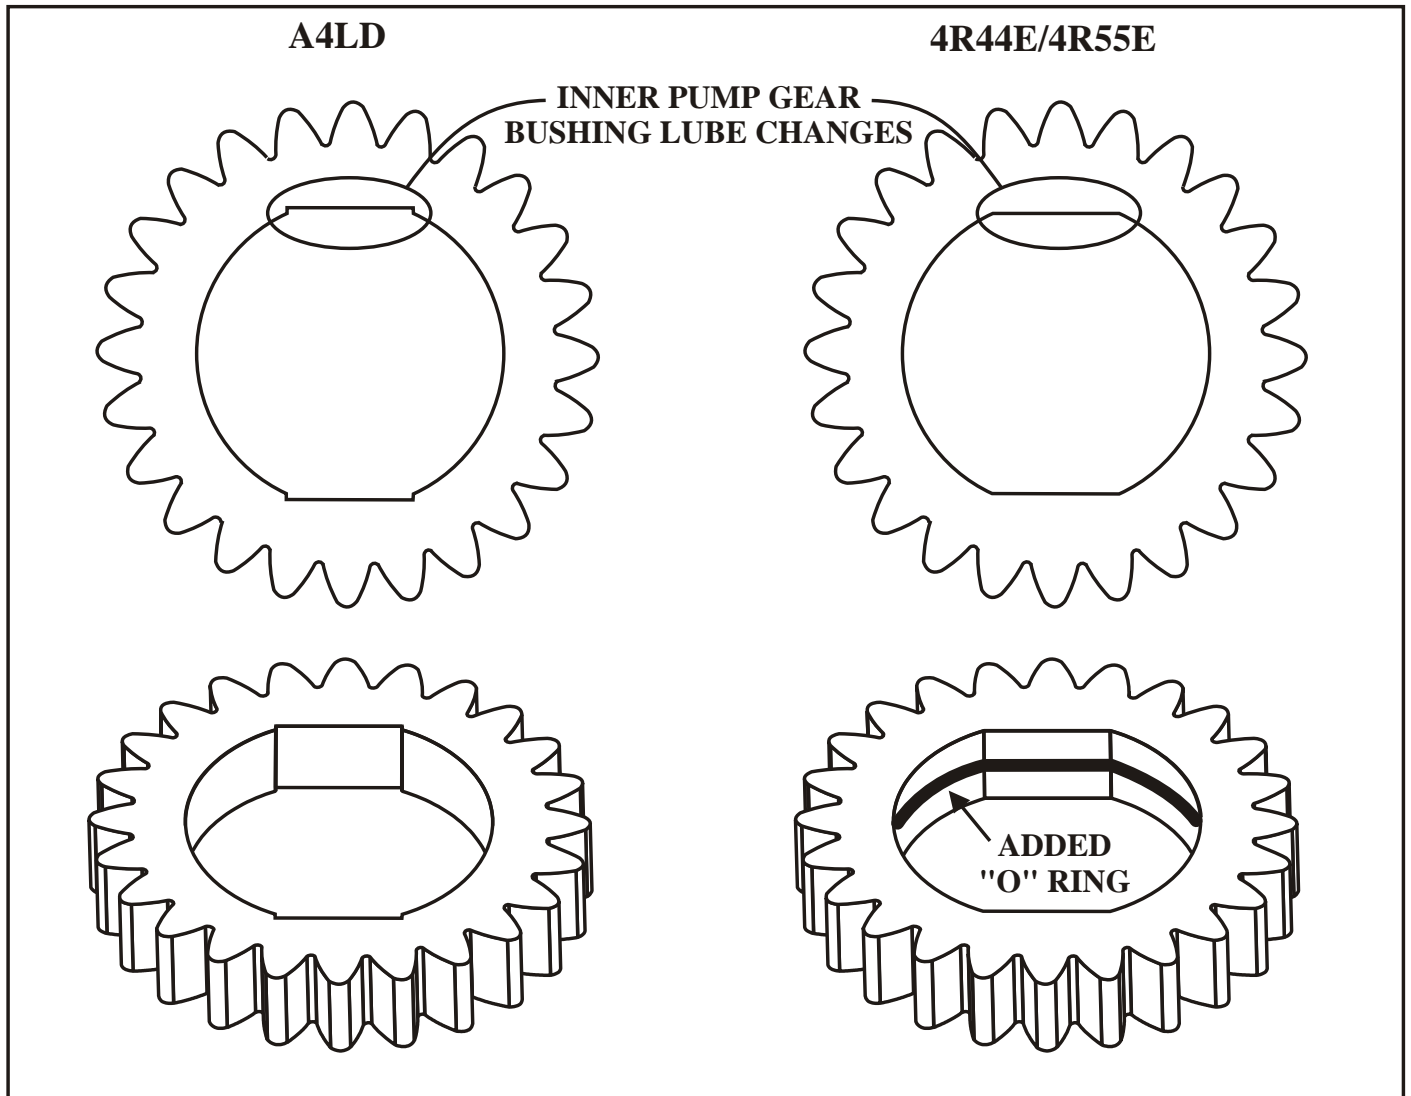
Figure 1

COMPLAINT: Vehicles equipped with 4R44E/4R55E may exhibit a slipping and/or no converter clutch apply condition along with codes 628 or P0741 stored in the PCM.

CAUSE: The cause may be,
(1) An A4LD inner pump gear used in a 4R44E/4R55E pump body as shown in Figure 1.
(2) The "O" ring inside the 4R44E/4R55E inner pump gear may be missing or damaged.

CORRECTION: (1) Ensure that the inner pump gear is a 4R44E/4R55E gear as shown in Figure 1.
(2) During rebuild make sure the "O" ring on the inside diameter of the inner pump gear is replaced and use care not to damage the "O" ring when installing the converter.
