"2005" SEMINAR INFORMATION

AUTOMATIC TRANSMISSION SERVICE GROUP

"Out by Five in 2005" *Seminar Information*

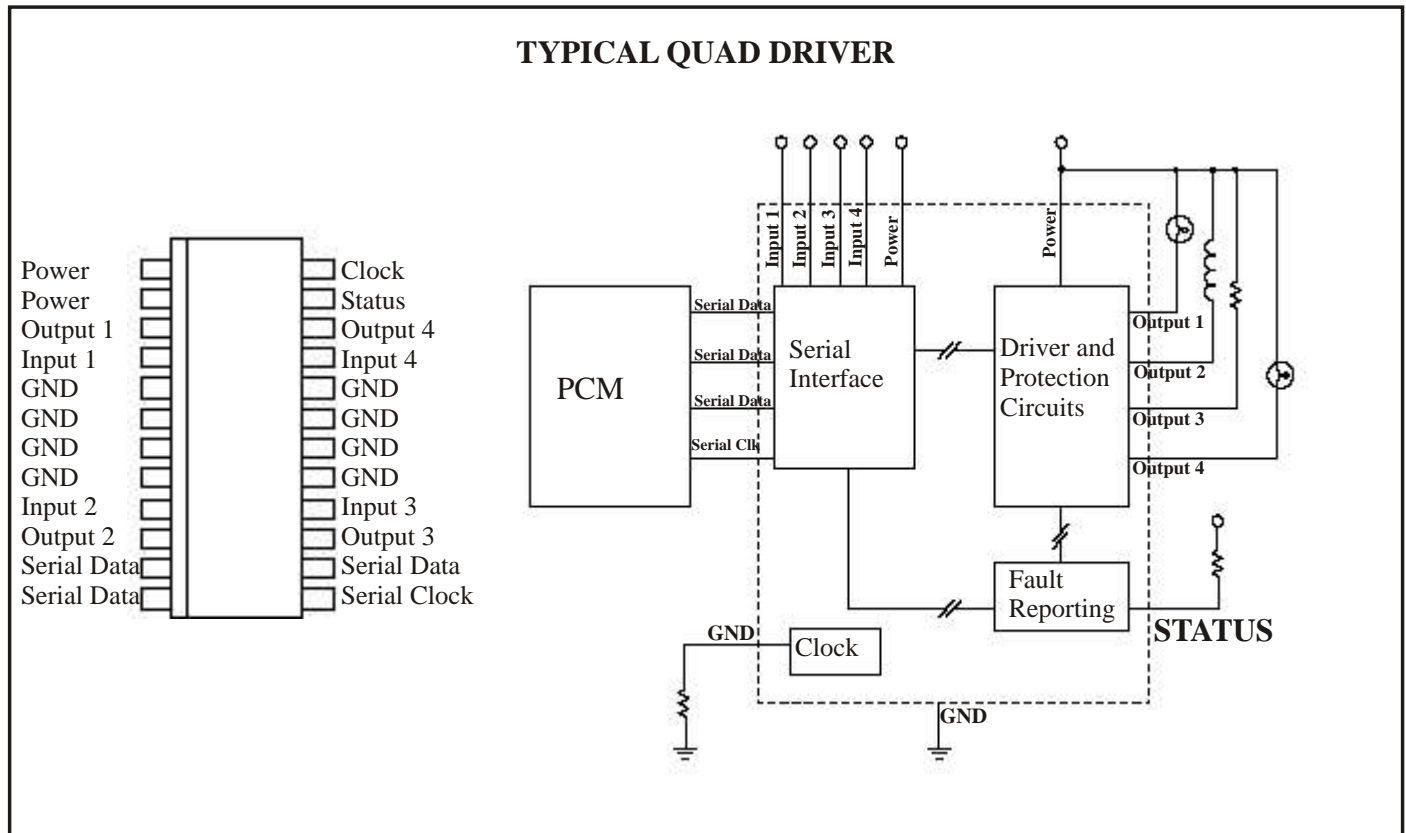
Figure 1

COMPLAINT: Quad Driver Faults can be difficult to troubleshoot and often cause unnecessary computer replacement.

CAUSE: A Quad Driver is an Integrated Circuit Chip ("IC") which is part of the computer and not a replaceable part. This chip has one signal called "status" or "fault" which becomes active whenever there is any overvoltage, undervoltage, or overcurrent condition on any of the four devices being driven by the quad driver (see figure 1). It is this signal which causes the Quad Driver error code. The Quad Driver error code does NOT tell you which device is causing the problem. In some older computers that is as far as the onboard diagnostics go. Most newer computers begin a more specific diagnostic routine when a Quad Driver error occurs in an attempt to determine which driven device is causing the error condition. The vast majority of the time, a Quad Driver Error is not a problem with the Quad Driver, but is a problem with one of the driven devices.

CORRECTION: Proper troubleshooting technique for a Quad Driver Error code is to follow the procedure for ANY OTHER CODES PRESENT FIRST. If the Quad Driver error code refers to a specific driven device, repair that device. If not, a performance code which normally would not be considered an electrical problem may be an electrical problem when accompanied by a Quad Driver error.

After all other codes have been repaired, and/or all driven devices have tested good or been repaired, computer replacement may be considered.

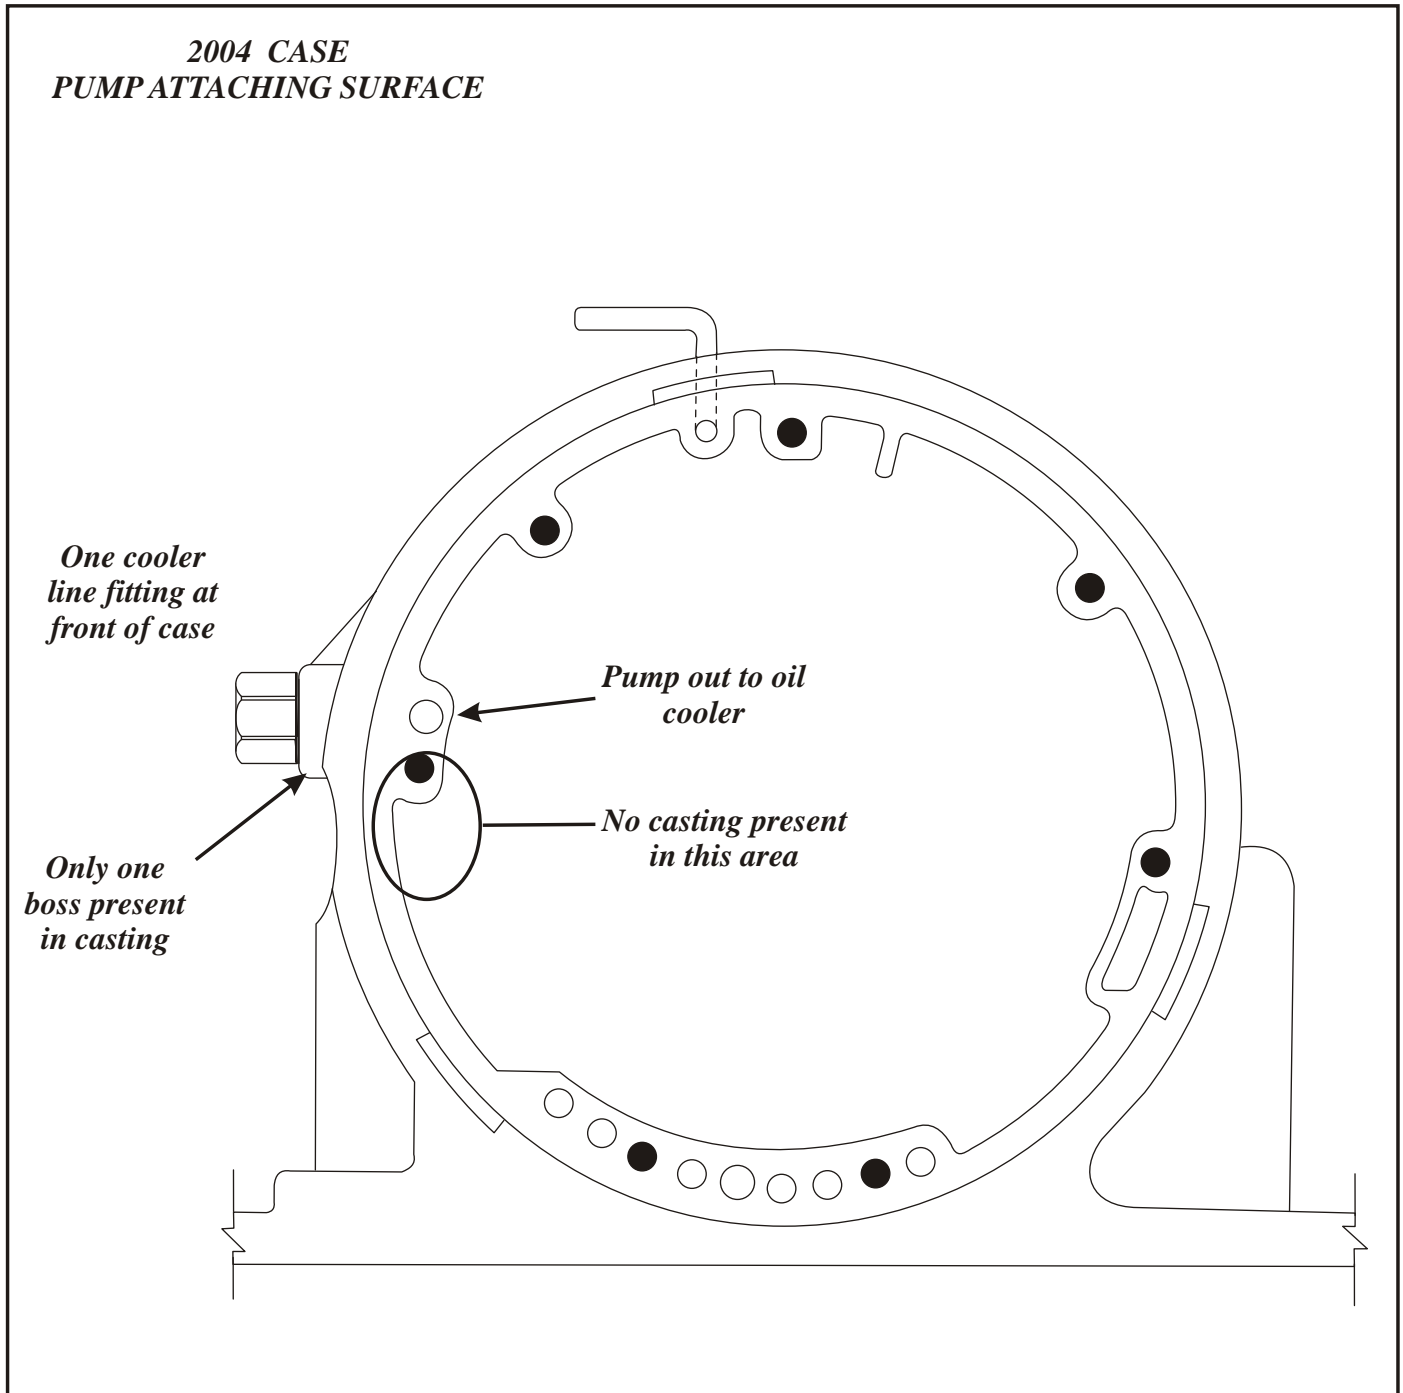
Figure 3

COMPLAINT: Immediately after overhaul the vehicle returns to the shop after a road test at hi-way speeds and a total failure of the overdrive planetary gear set is evident.

CAUSE: During the overhaul process either the transmission casing or the oil pump or pump cover was replaced using incompatible parts causing a loss of lube oil to the overdrive gear train.

CORRECTION: The transmission casing had a casting change for the 2004 model year. The oil pump cover has been modified with the addition of an aluminum plug. The change in the case casting will allow lube oil designated for the overdrive planetary gear set to exhaust back to the sump if the oil pump cover has not been modified with the installation of an aluminum plug to prevent this from happening. When the transmission casing or pump requires replacement then care must be taken to properly identify which case will be used for the repair and/or determine if a pump modification is necessary. The earlier design 1997 - 2003 "center lube" type casing can be identified externally by the presence of two bosses in the front cooler line fitting area. (See figure 1) The later design 2004 casing can be identified externally by the presence of only one boss at the front cooler line area. (See figure 2) ***This case must use the pump with the aluminum plug present in the pump cover.*** With the transmission on the bench and the oil pump removed, the most important difference in these castings can be observed. Notice that the later design case has no aluminum or "blind hole" area present in the casing (See figure 3) as there was in the previous design "center lube" case. (See figure 4)

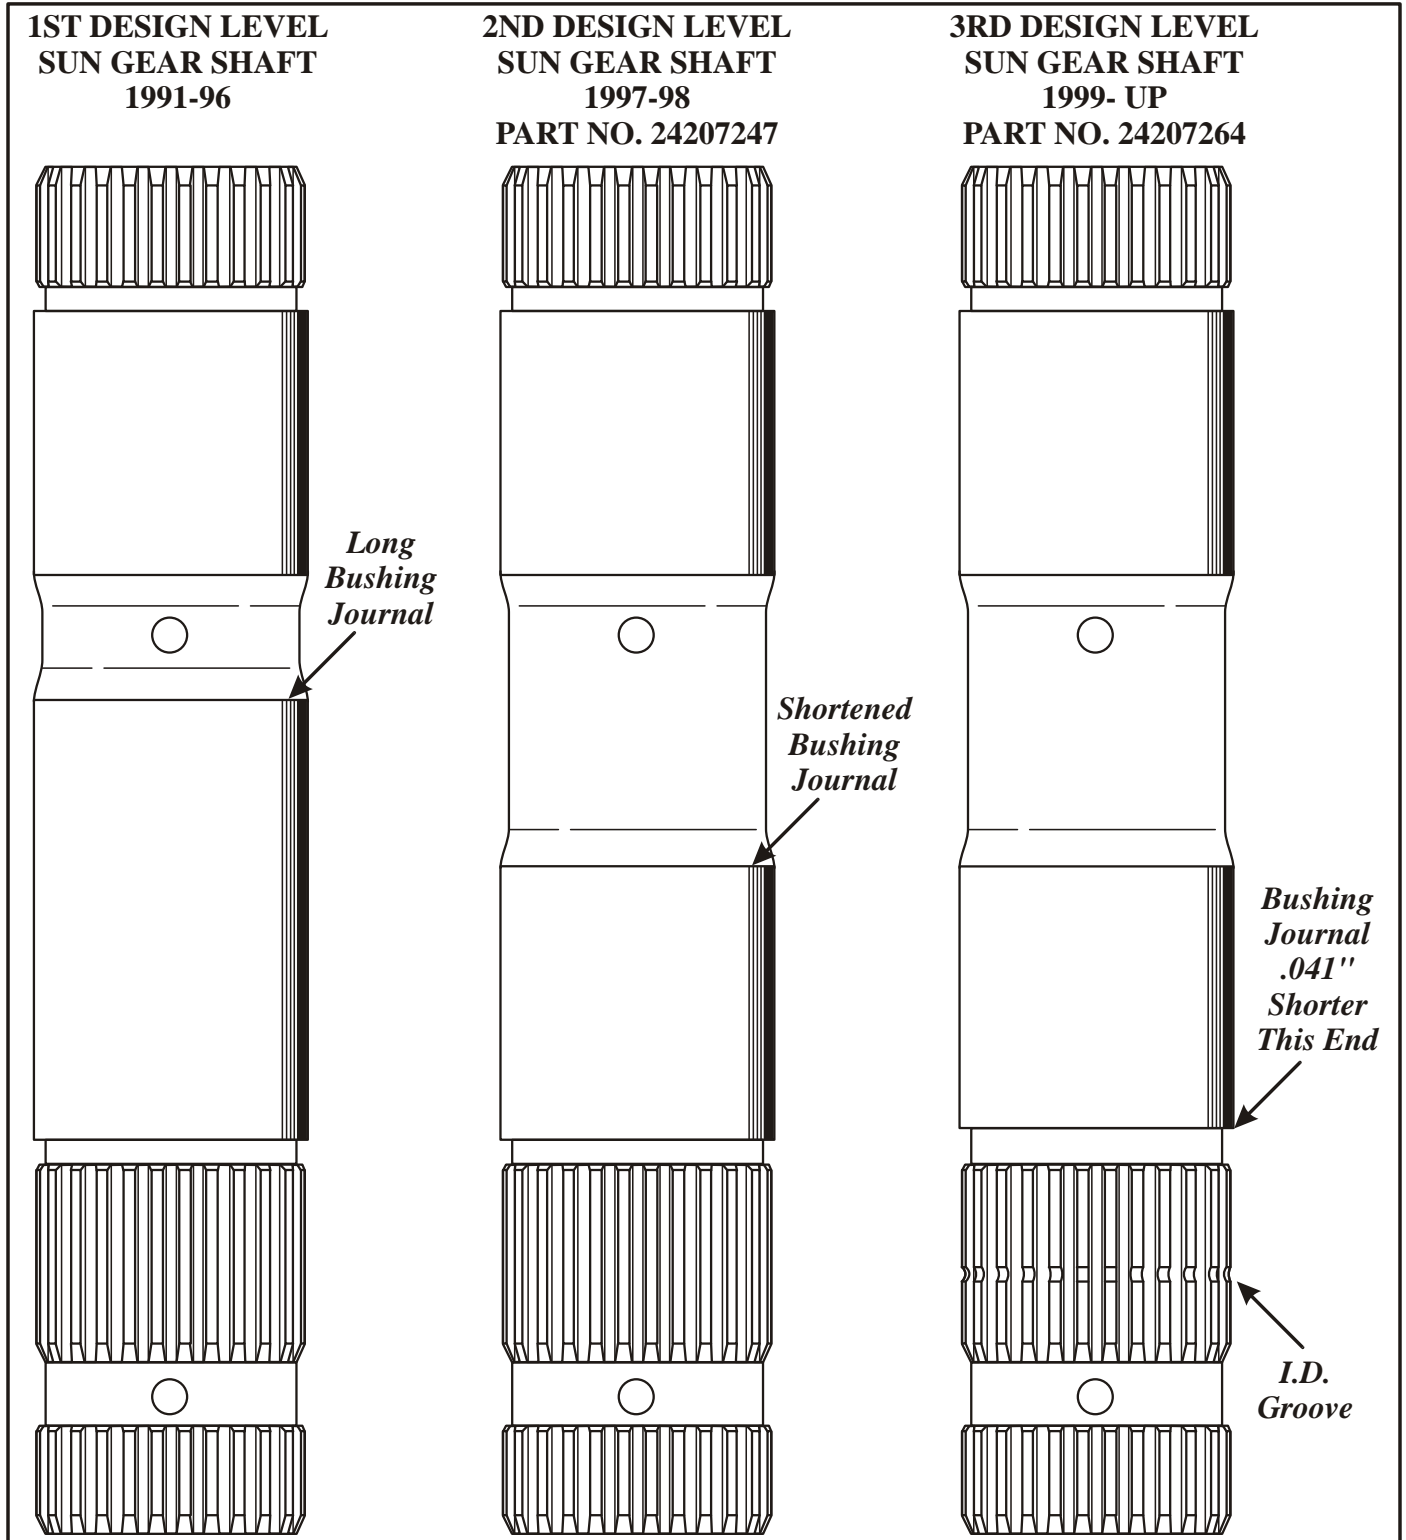
Figure 8

CAUSE: During the overhaul process the original 1997 or later design sun gear shaft was replaced with a 1996 or earlier design sun gear shaft. This was the only piece replaced in the main planetary gear train. All other related gear train parts remain original.

CORRECTION: The sun gear shafts used in 1997 and later center lube transmissions have a shortened bushing journal when compared to the earlier design. Using the earlier design shaft with the longer bushing journal will create a restriction in the oil cooler/lube circuit and cause the converter clutch to drag.

Replace the sun gear shaft with the proper part for your application. (See figure 8)

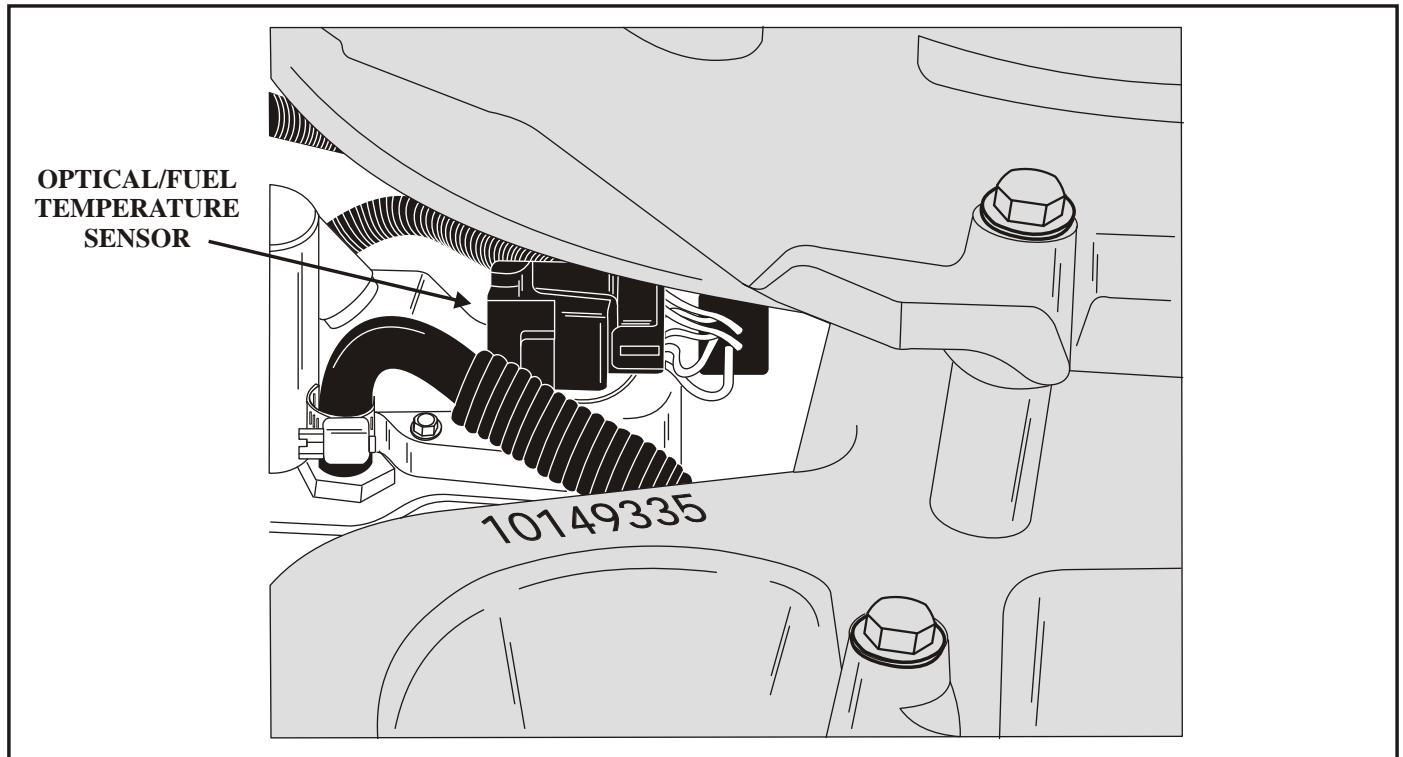
Figure 1

CAUSE: The Optical/Fuel Temperature Sensor was the cause of the above complaint as shown in Figure 1. This sensor is responsible for fuel metering as well as injector pump timing. Its signal is compared to the Crankshaft Sensor for diagnostic purposes.

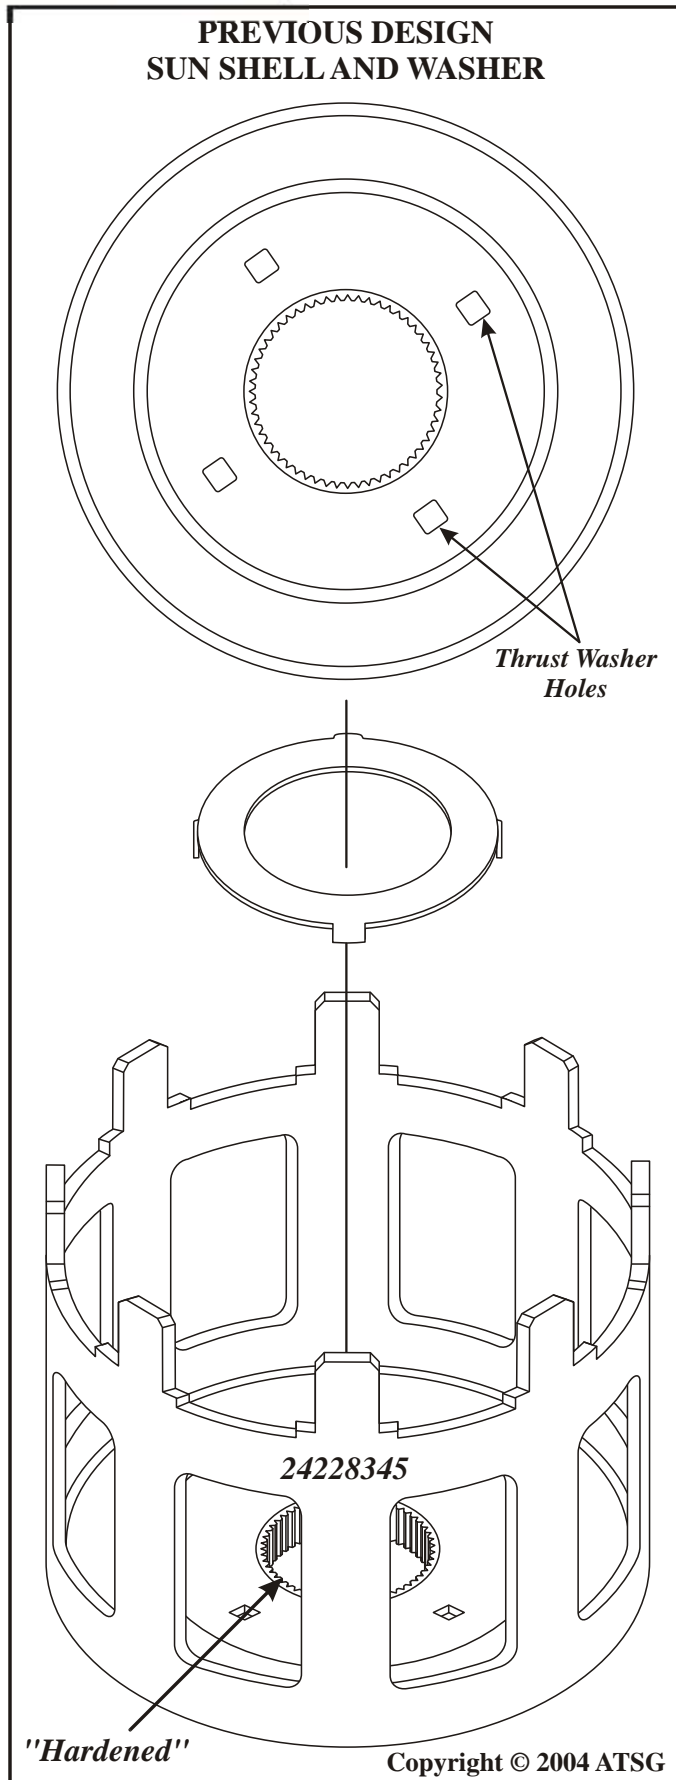
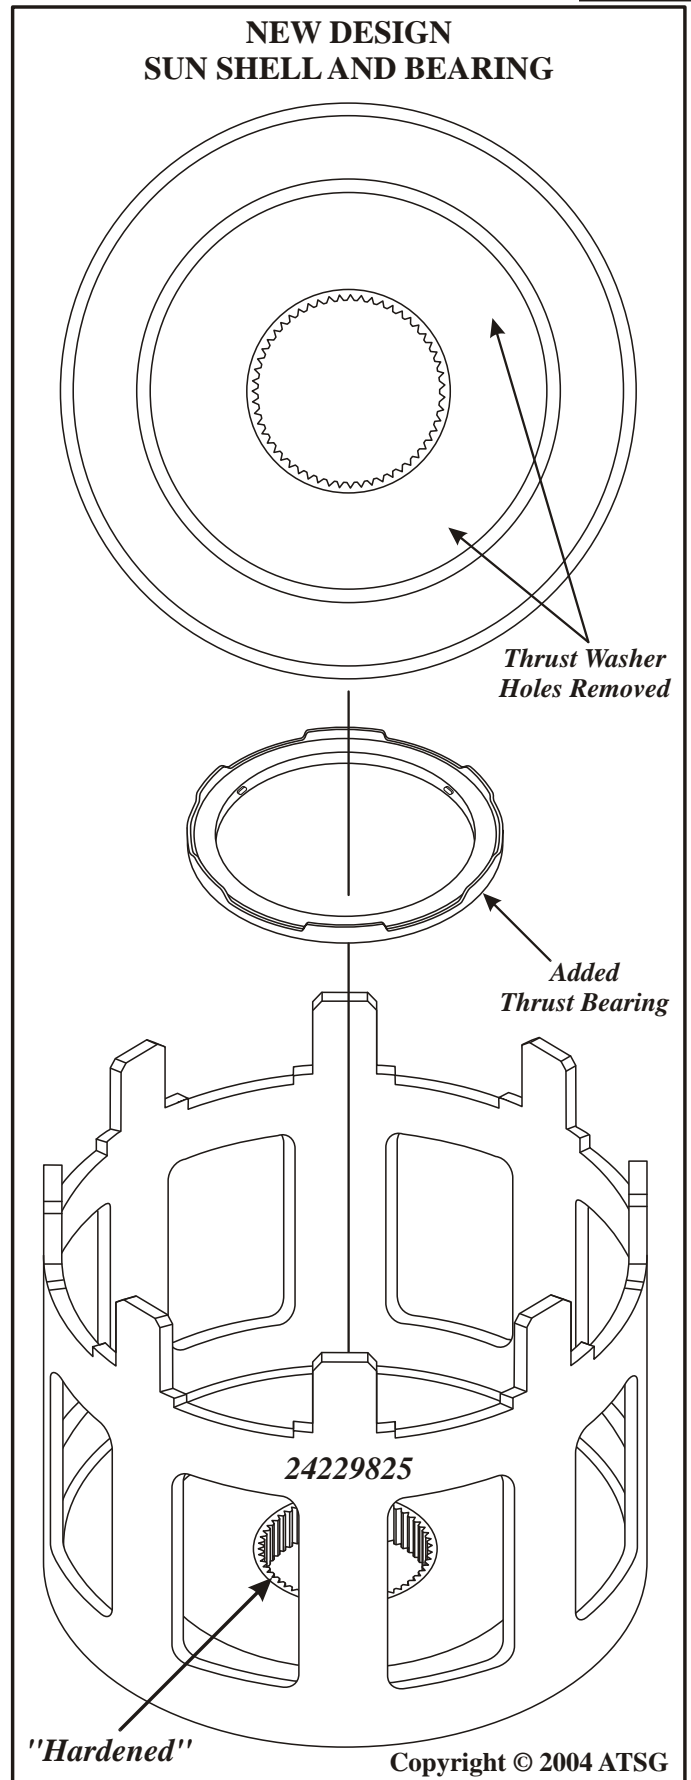
CHANGE: Beginning at the start of production for model year 2001, General Motors introduced a new transmission designated THM 4L60-EHD with many engineering changes. Currently this unit is found in all 2001 Cadillac Escalade and any vehicle with 6.0L engine or larger, that was previously equipped with the THM 4L60-E transmission. One of the changes includes a new design sun gear shell and thrust bearing to replace the previous design washer, as shown in Figures 1 and 2.

Sun Gear Shell (Bearing Design "Hardened")	24229825
Reaction Carrier Shaft (New Design)	24217157
Sun Shell Thrust Bearing (New Design)	24217328
Sun Gear Shell (Washer Design "Hardened")	24228345

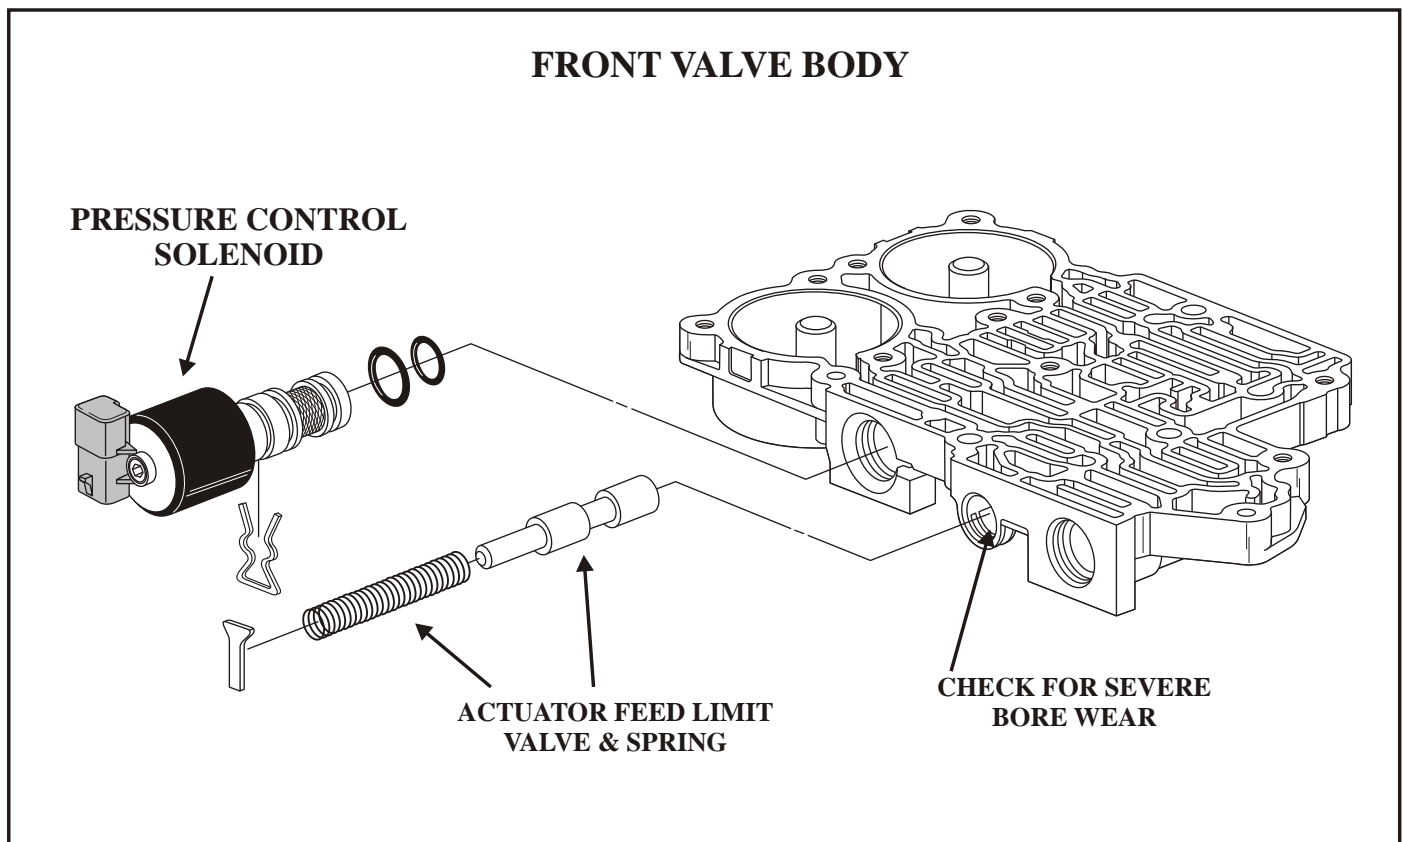
COMPLAINT: The transmission slips through the gears, line pressure is low and unstable. Inspection of the internal transmission parts indicates that clutch damage is present.

CAUSE: The Actuator Feed Limit Valve (AFL) bore is severely worn and the anodized valve is damaged, (Refer to Figure 1 Below).

The AFL valve regulates line pressure to the pressure control solenoid and the shift solenoids. The AFL valve keeps line pressure from flooding the solenoid circuits. At some point during normal operations line pressure and AFL pressure will be the same. When the valve wears the solenoids are starved for oil resulting in the above mentioned conditions.

CORRECTION: Since no repair kits are available at this time for this transmission a valve body will be required.

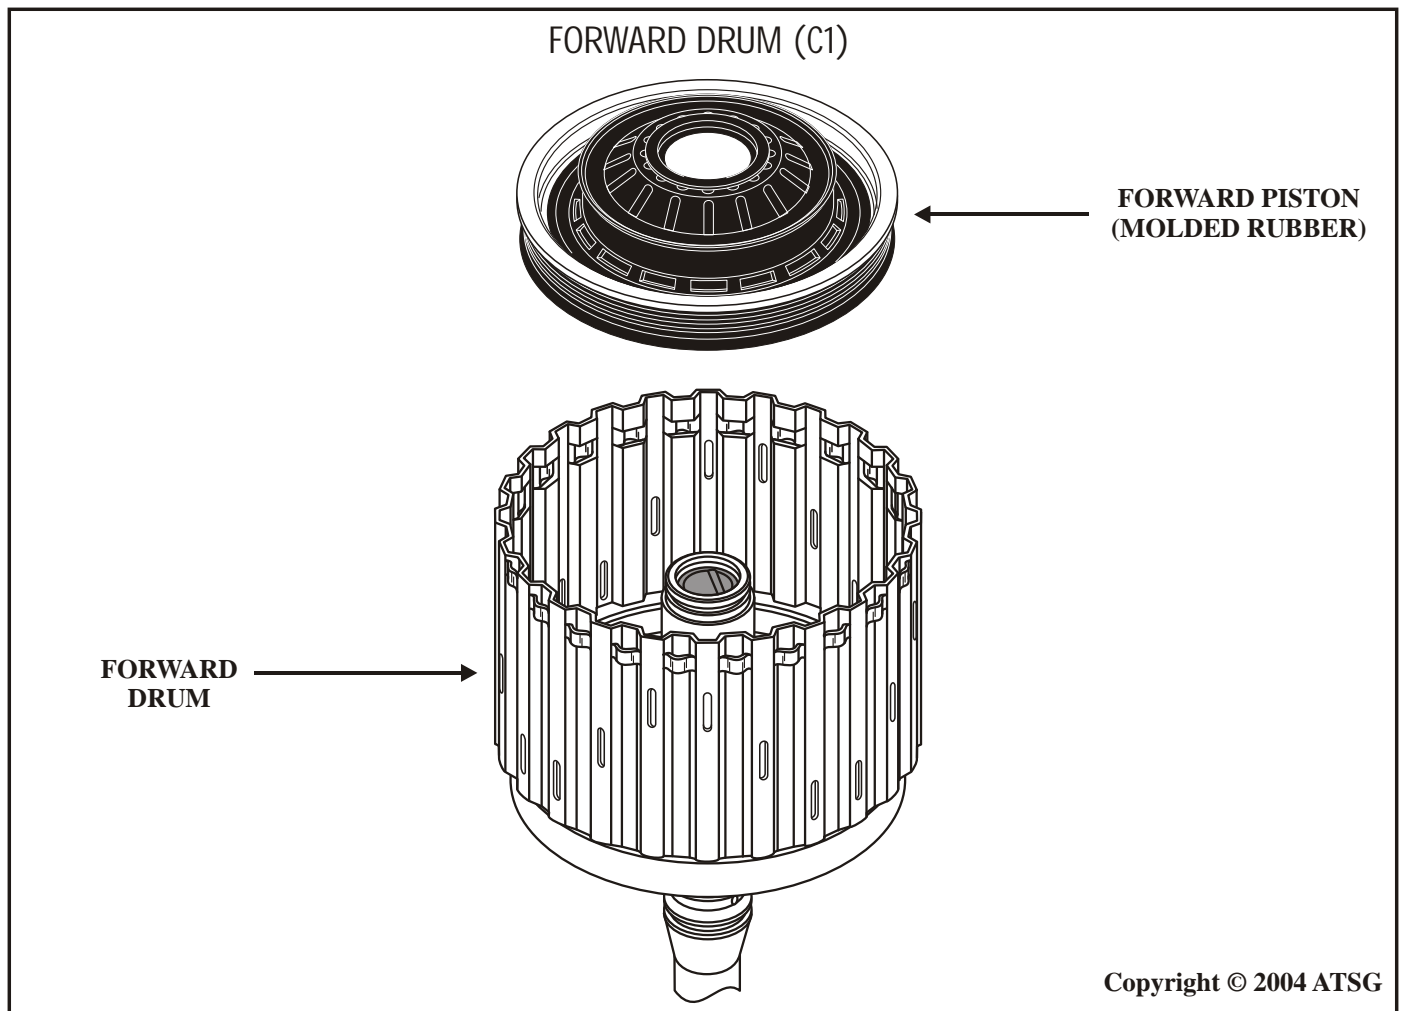
Figure 1

- COMPLAINT:** Some BMW "E" series and Cadillac CTS models built from 09/02 to 12/03 may exhibit a delayed engagement from park to drive when cold. The delay may last anywhere from two to thirty seconds.
- CAUSE:** The forward drum (C1) was manufactured with improper tolerances that cause the clutch piston to not make a good seal between it and the clutch housing when the vehicle is parked for a prolonged period of time, such as overnight. Therefore on the initial start, the forward clutch does not apply.
- CORRECTION:** Since internal parts are not available, a reman transmission will be necessary. Because the manufacturer does not disclose any build code information, it is impossible to tell which drum would be a good one if used parts are acquired.

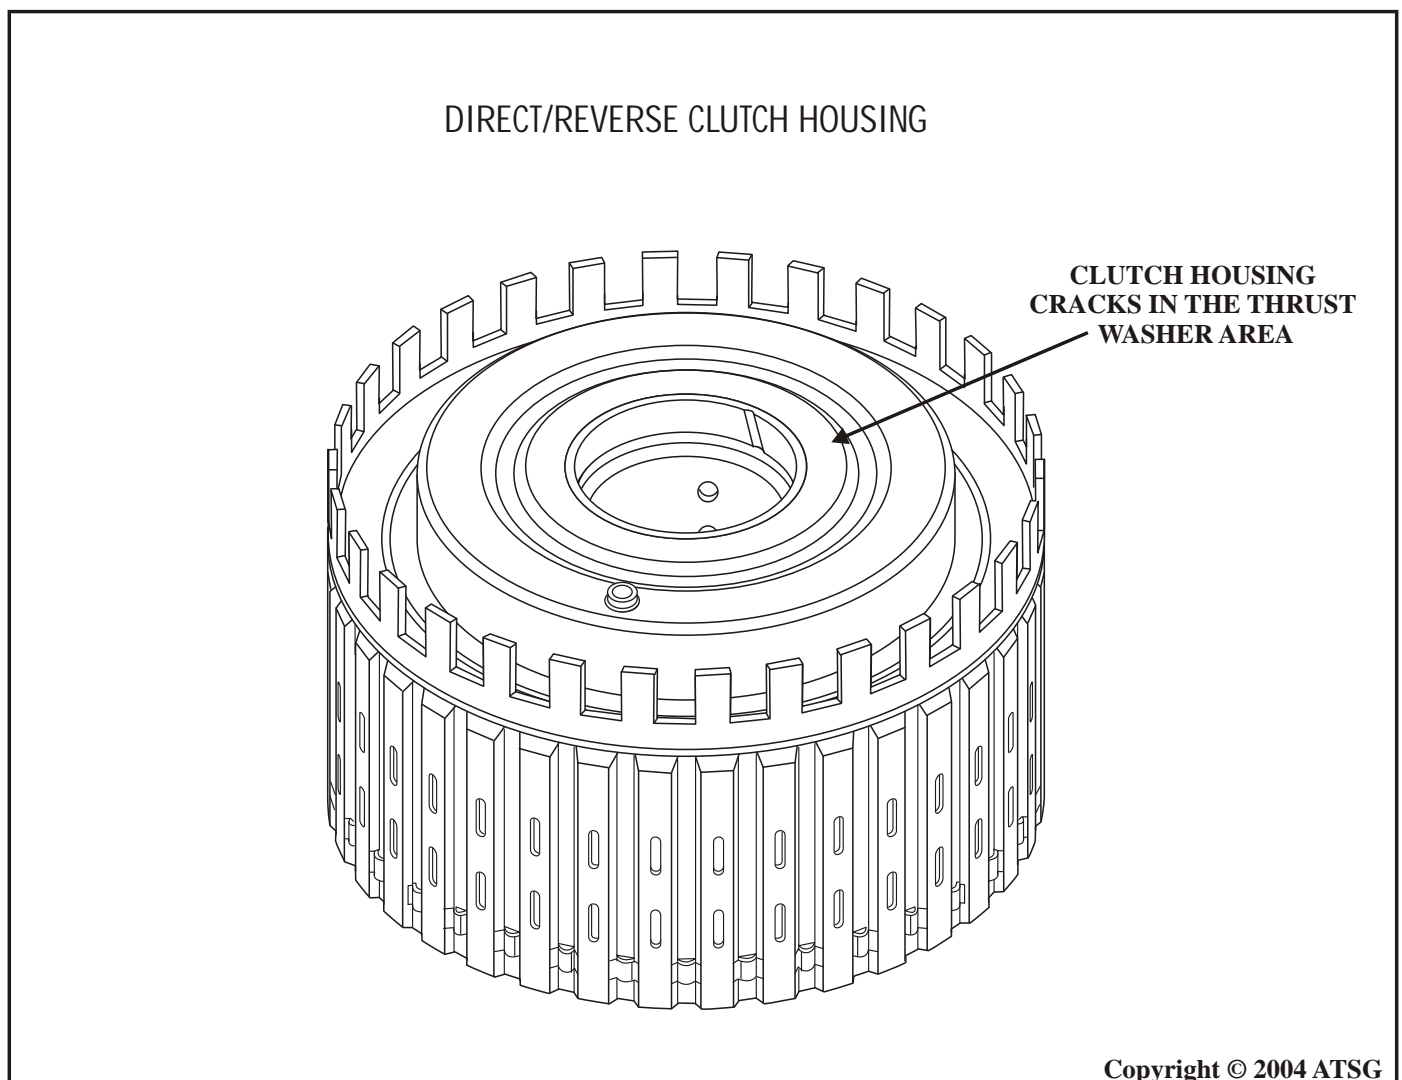
- COMPLAINT:** The "MIL" Lamp is illuminated with code 55 or P0735 stored for a "Gear Ratio Error in 5th Gear. There are no complaints of slipping or driveability.
- CAUSE:** The Direct/Reverse clutch housing has cracked in the thrust washer area where it contacts the pump (Refer to Figure 1 Below).
- CORRECTION:** Currently, no internal parts are available. A good used part or a remanufactured transmission will be required.

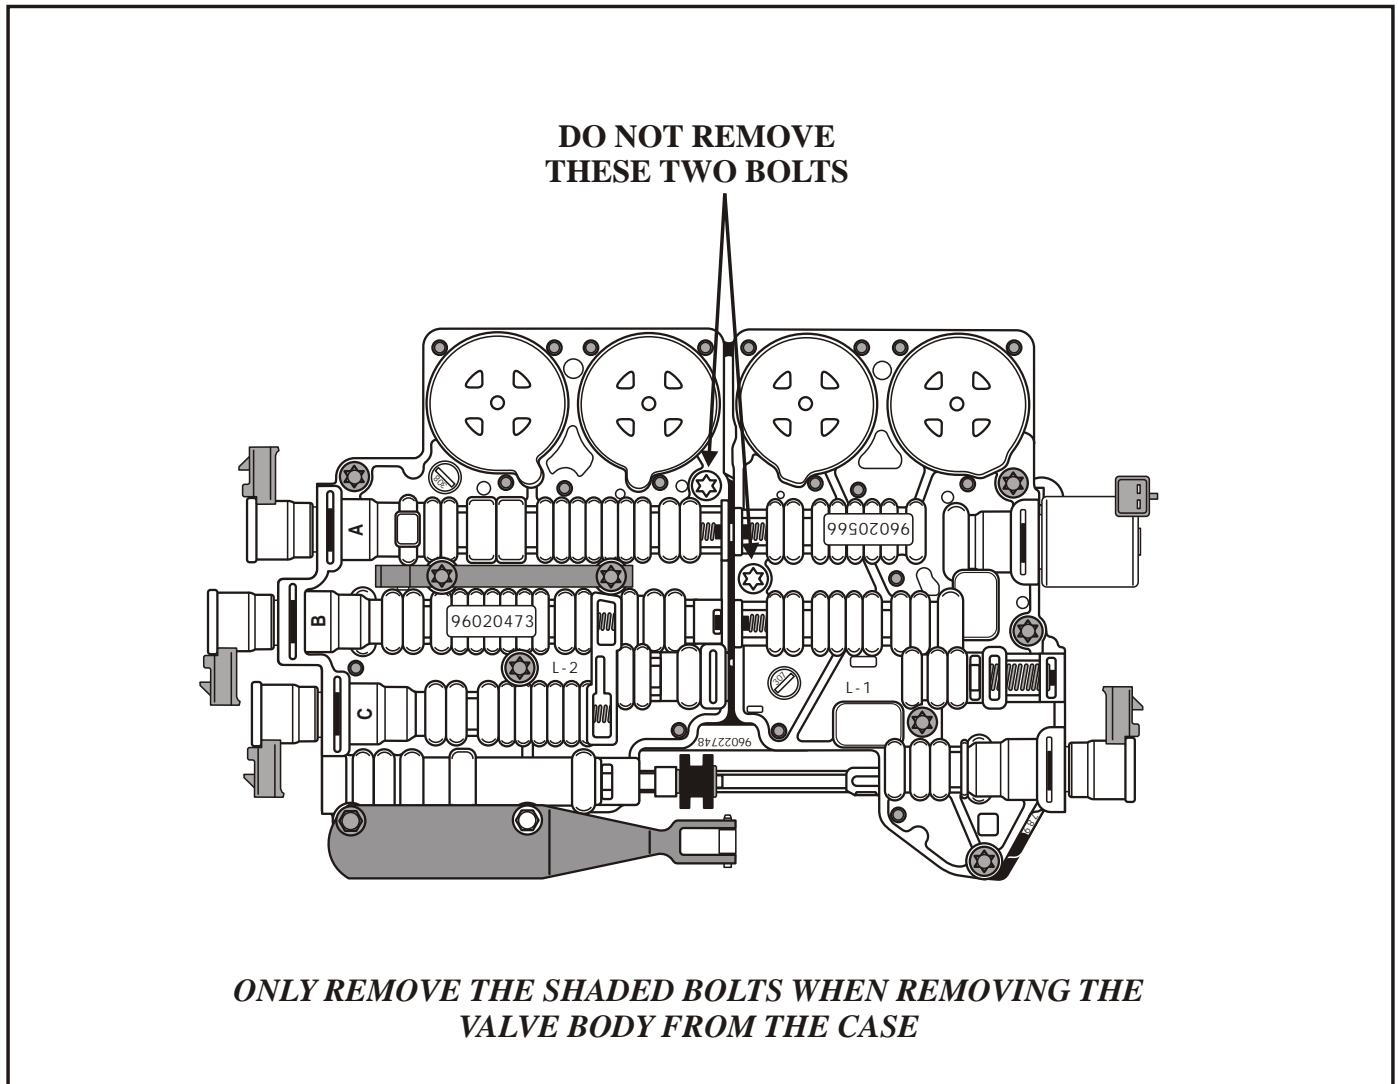
- COMPLAINT:** During removal of the valve body from the case, the upper and lower halves come apart causing the small parts to fall out.
- CAUSE:** The valve body bolts were incorrectly removed.
- CORRECTION:** DO NOT REMOVE the TWO BOLTS shown in Figure 1 until the valve body is on the bench for service.

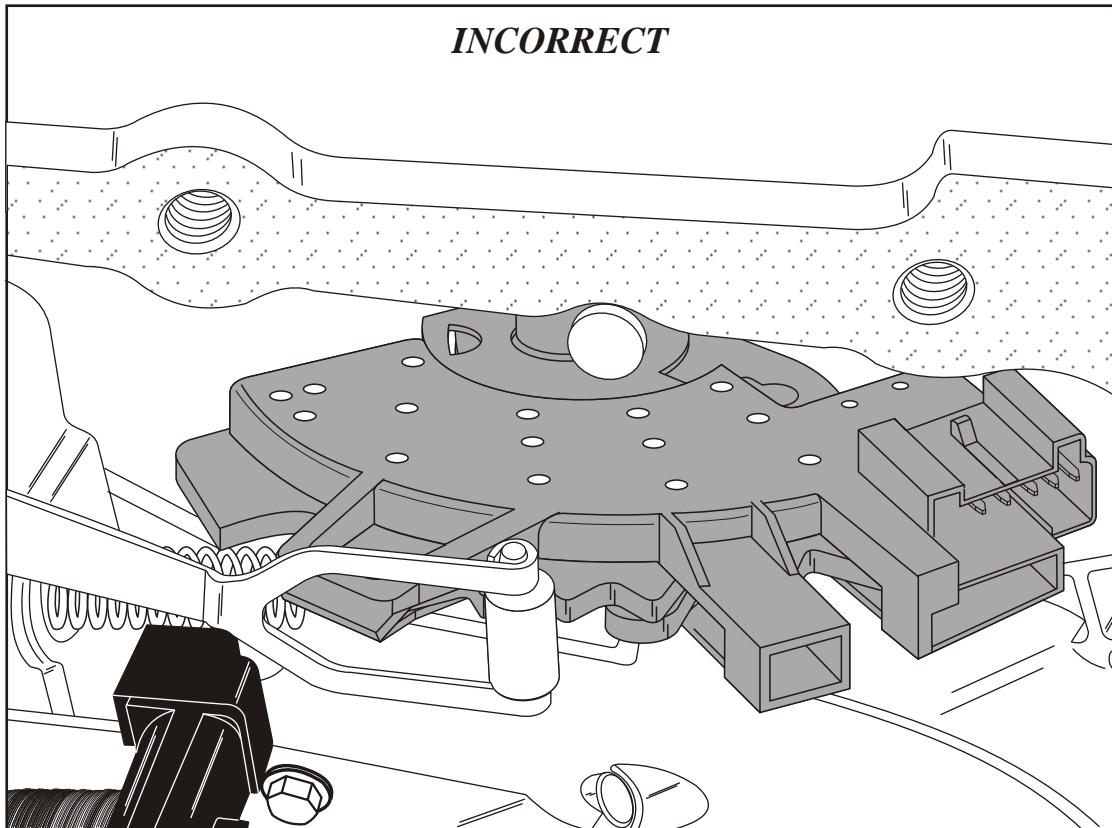
Figure 5

- CAUSE:** When the detent spring was installed during the overhaul, it was not indexed in its proper location at the IMS which can be seen in figure 5. When this is done the IMS can move across the detent lever $\frac{1}{4}$ " in either direction. therefore movement of the shift lever is not synchronized with the IMS causing the above complaints.

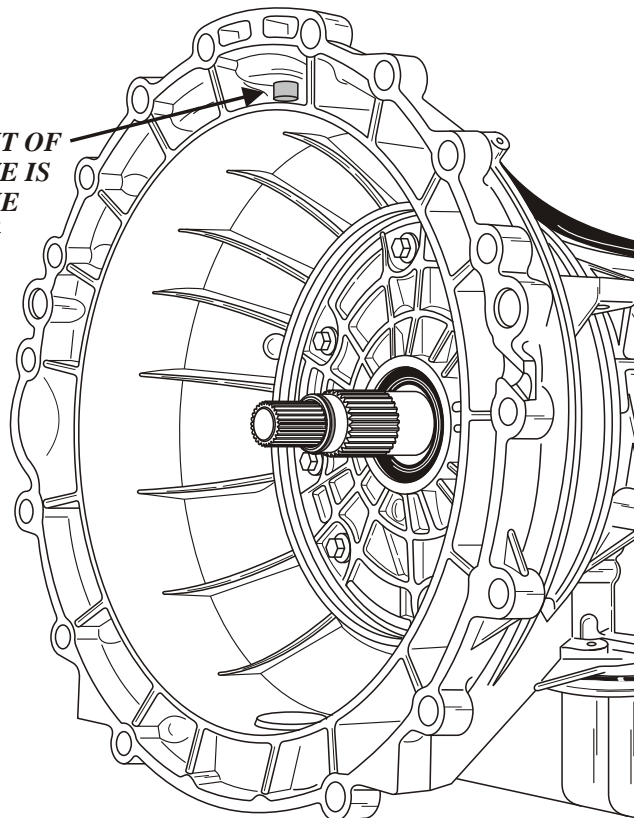
STEP 2

**IF AIR OR OIL COME OUT OF
VENT, THE FLOW VALVE IS
FAILED OPEN OR THE
O-RING IS MISSING**

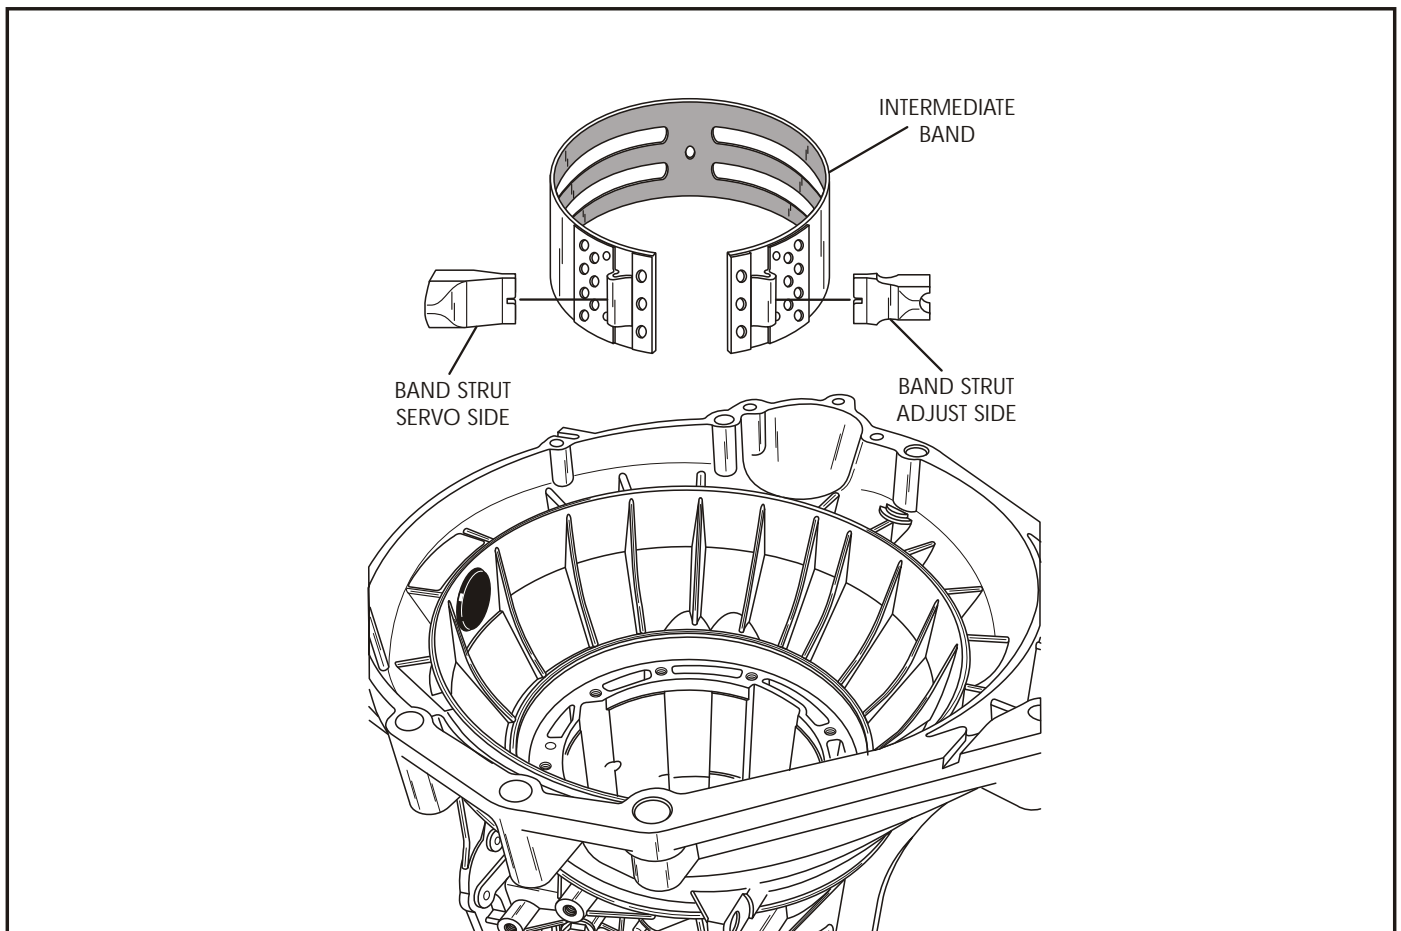
CAUSE: During assembly of the transmission, the overdrive and intermediate band struts were installed backwards. This causes the band struts to act as wedges between the case and the drums. This results in the bands not being able to make full contact with the drums and also damages the case in the servo bore areas.

CORRECTION: Refer to Figure 1 below for the correct band strut assembly.

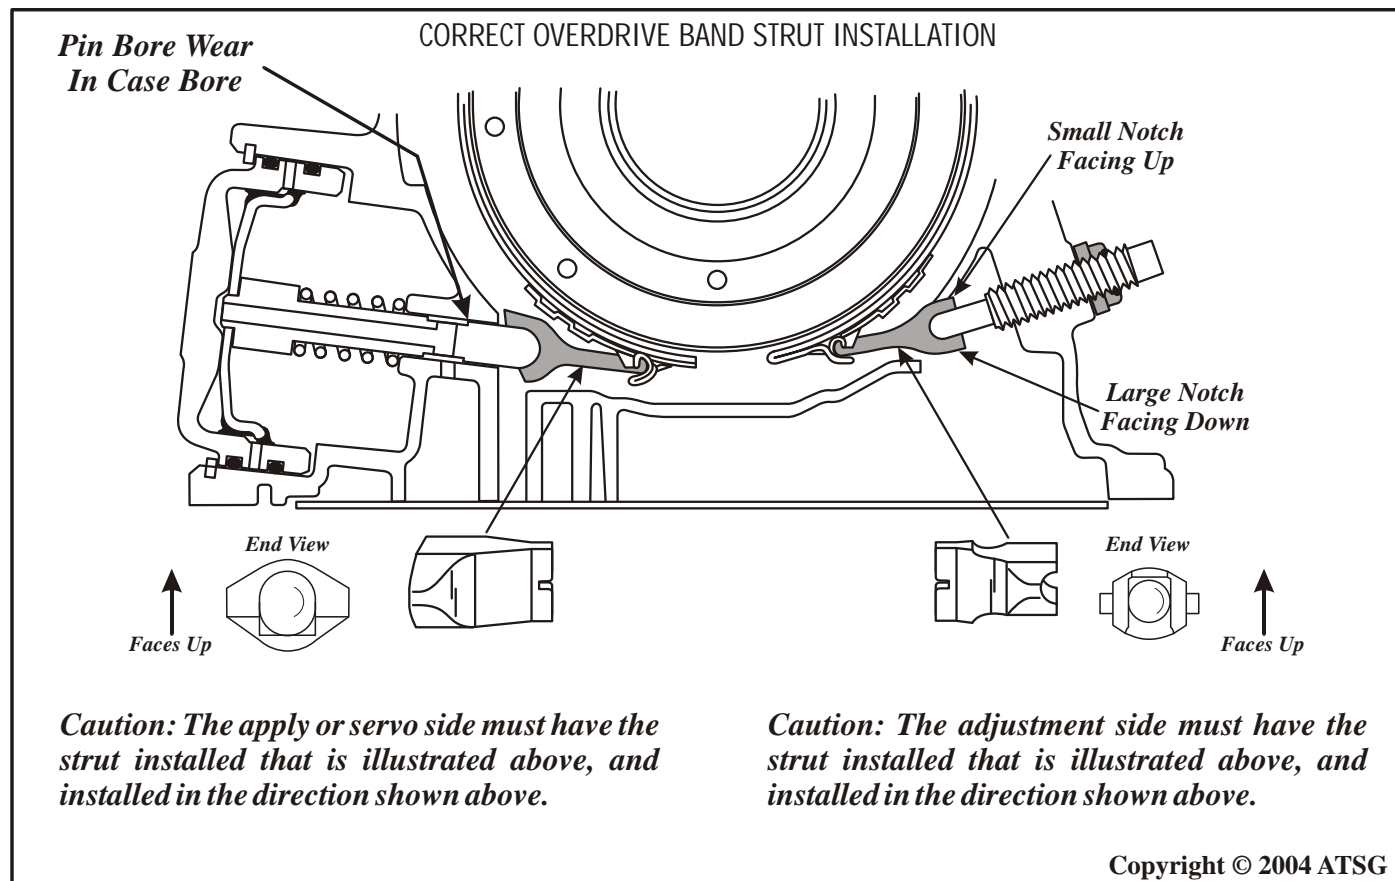
CAUSE: The cause may be, that the band struts were installed upside down, or the servo bore is worn. The Overdrive servo is fed thru the center of the apply pin. Wear in the case, where the servo pin rides, may cause a pressure loss, creating the band failure. See Figure 1.

CORRECTION: To correct this condition, refer to Figure 1 for the correct assembly of the band struts. Replace the case or re-sleeve the case where the pin rides and install a bushing for a new sealing surface. *Northland transmission Inc. has a Re-boring kit available to repair the case bore, with a bushing, to fix the leak.*
Phone: 715-458-2617
