Technical Service Information

MAZDA N4AEL STACKED SHIFTS

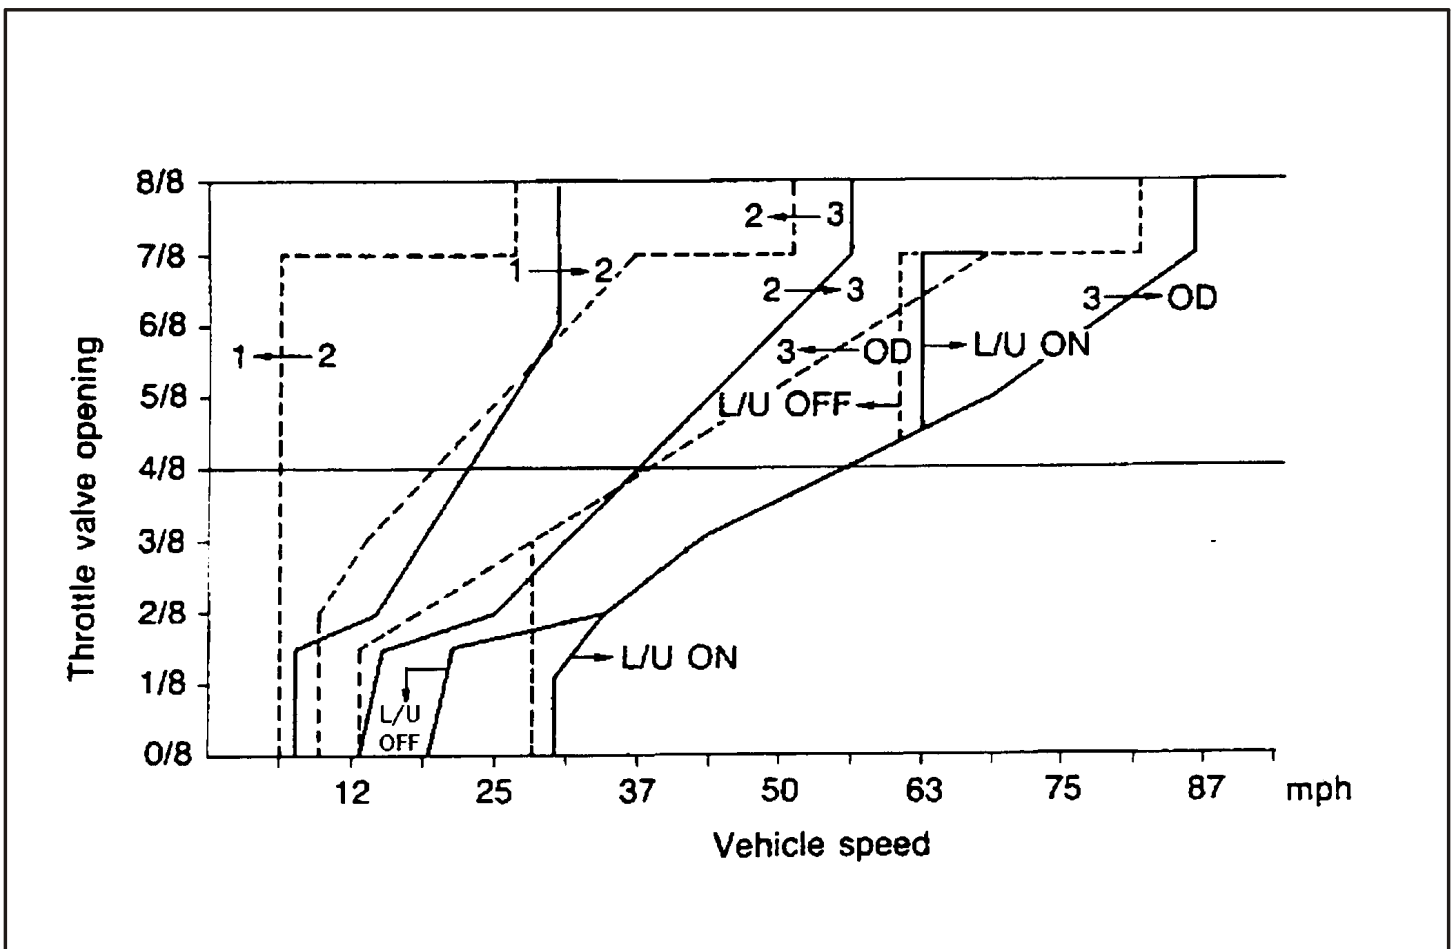
Figure 1

The EC-AT Computer strategy allows 1-2 upshifts as early as 7 mph at light throttle when the "normal" mode is selected. The shifts at 1/8 throttle or less occur at 7 mph, 13 mph, and 19 mph. See Figure 1. It is not until 1/4 throttle or more that the shifts are perceptibly spread out.

As long as other shift quality concerns have been addressed, (See ATSG Bulletin 92-28), no other action is necessary or possible. THIS IS NORMAL OPERATION.
