Technical Service Information

NISSAN RL4F02A FALLS OUT OF OVERDRIVE AT TIMES

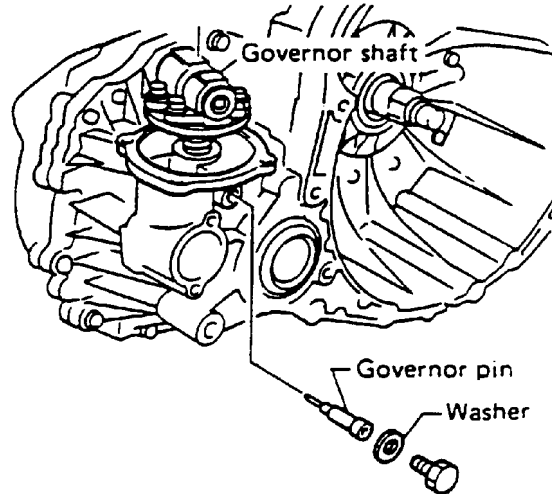
Figure 1

- COMPLAINT:** Transaxle upshifts ok, but downshifts 4-3 or 4-2 at highway speeds when you lift your foot off of the gas pedal.
- CAUSE:** The problem can be excessive end play in the governor shaft. This will cause the shaft to move upward on the spiral gear when coasting, and block governor feed oil.
- CORRECTION:** Remove the bolt and pin that holds the governor shaft into the case. Inspect the pin for wear and replace it if necessary. See figure 1
