Technical Service Information

FORD 4EAT PROBE LOW PUMP PRESSURE

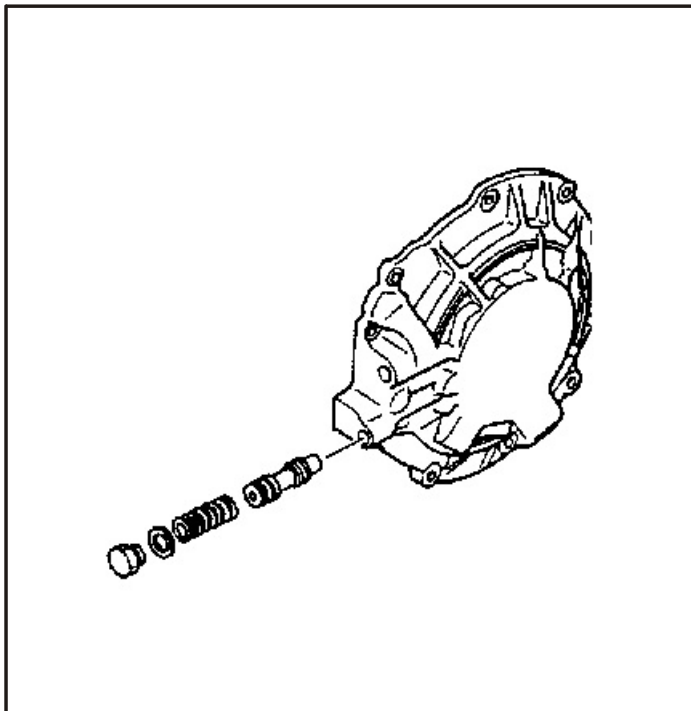
Figure 1

COMPLAINT: Low pump pressure.

CAUSE: The spool valve in the pump did not have a seat for the spring. The spring will hang the valve and cause low line pressure (figure 1).
