Technical Service Information

THM 4L60-E TRANSMISSION OVERHEATING AND/OR CONVERTER DISCOLORED

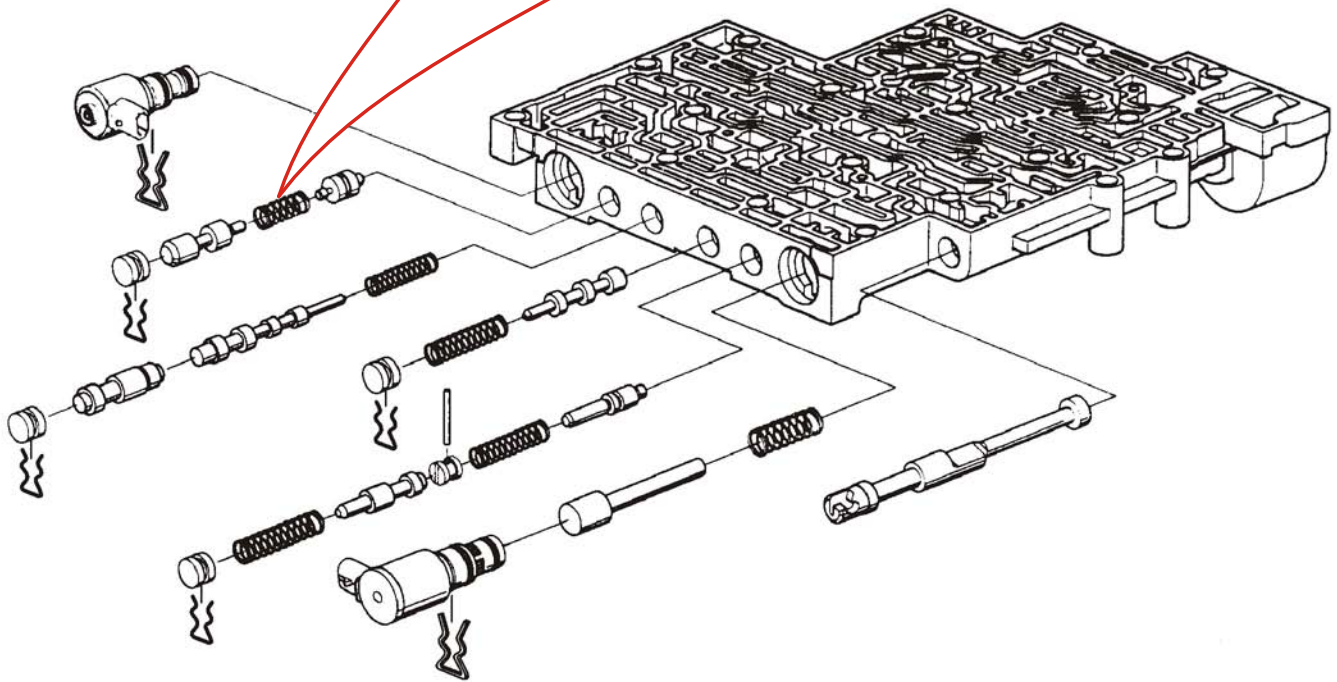
Figure 1

- COMPLAINT:** Before and/or after rebuild the torque converter is severely discolored from an overheating condition, and this sometimes happens on the road test, after installing a new torque converter.

- CAUSE:** The cause may be, no regulated apply oil available because of a TCC/PWM solenoid filled with debris that does not allow TCC Signal oil to stroke the TCC Regulator valve in the valve body. There are no codes stored, as the TCC/PWM Solenoid is still working electrically.

- CORRECTION:** To eliminate the possibility of this overheating condition happening to you or to your customer, we are recommending to replace the current spring between the valves in the TCC Regulator Valve line-up with a 700 inner pump slide spring, as shown in Figure 1. This will completely by-pass the TCC Regulator Valve, provide a more positive lock-up apply feel, and guarantee that you will always have apply oil available.

REPLACE THIS SPRING WITH AN INNER
PUMP SLIDE SPRING FROM THM 700-R4
OR THM 4L60-E TRANSMISSION
