Technical Service Information

FORD 4E0D REVISED DIRECT CLUTCH HOUSING FOR 1995 MODELS

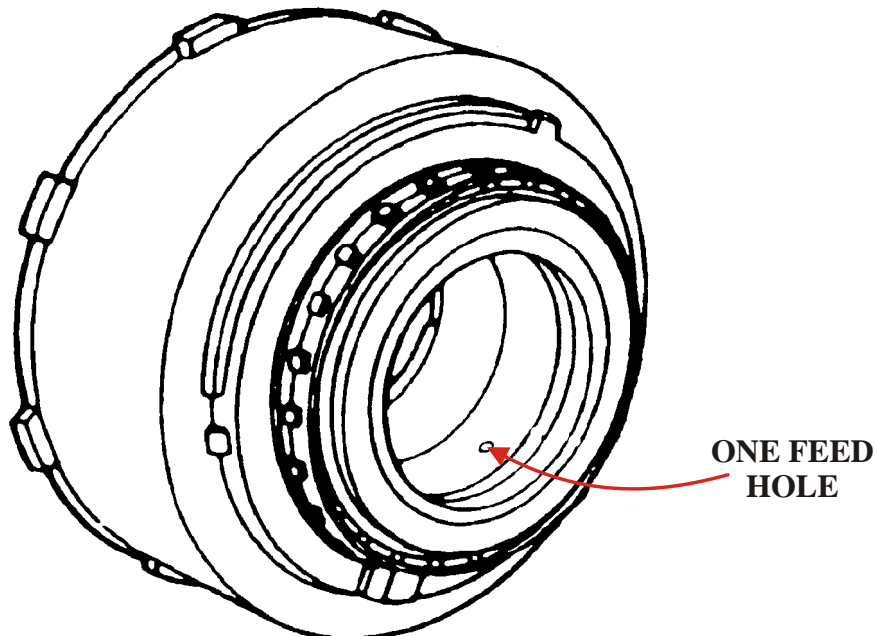
1995 DIRECT CLUTCH HOUSING

CHANGE: Beginning at the start of production for the 1995 model year, all E40D transmissions were built with a revised Direct Clutch Housing (Intermediate Brake Drum) as shown in Figure 1.

DIRECT CLUTCH HOUSING - 1995 models now have only *one* direct clutch apply pressure feed hole, instead of the two feed holes found in previous models (See Figure 1).

Usage of the revised 1995 Direct Clutch Housing with one feed hole, into any of the previous model units, may result in 2-3 shift concerns and/or reverse engagement concerns.

89-94 Direct Clutch Housing (2 Feed Holes - 3/4 Clutch)	E9TZ-7D044-A
1995 Direct Clutch Housing (1 Feed Hole - 3/4 Clutch)	F5TZ-7D044-A
1995 Direct Clutch Housing (1 Feed Hole - 5 Clutch)	F5TZ-7D044-B
