Technical Service Information

THM 4L80-E CENTER GEAR BOX CHANGES FOR 1999 MODELS ("REVISED INFORMATION")

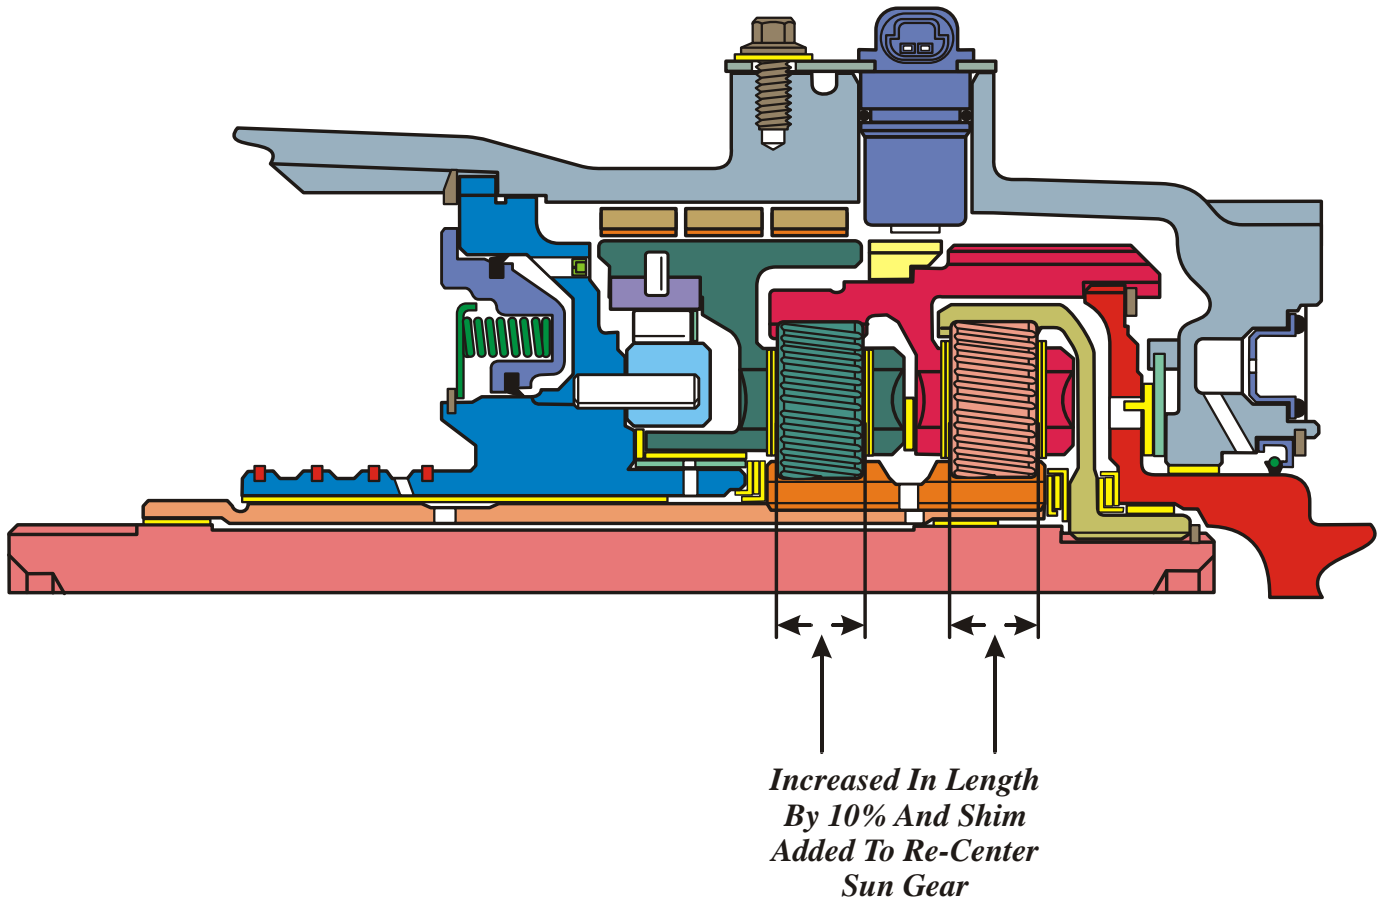
Figure 1

CHANGE: Beginning at the start of production for all 1999 model THM 4L80E transmissions, the planetary pinions on both carriers were produced 10% thicker than the previous models, as shown in Figure 1. This engineering change required the addition of a .041" shim in the gear train to re-center the sun gear in the new planetary pinions and affected several internal parts, that may create some confusion, and thus some mis-assembly concerns.

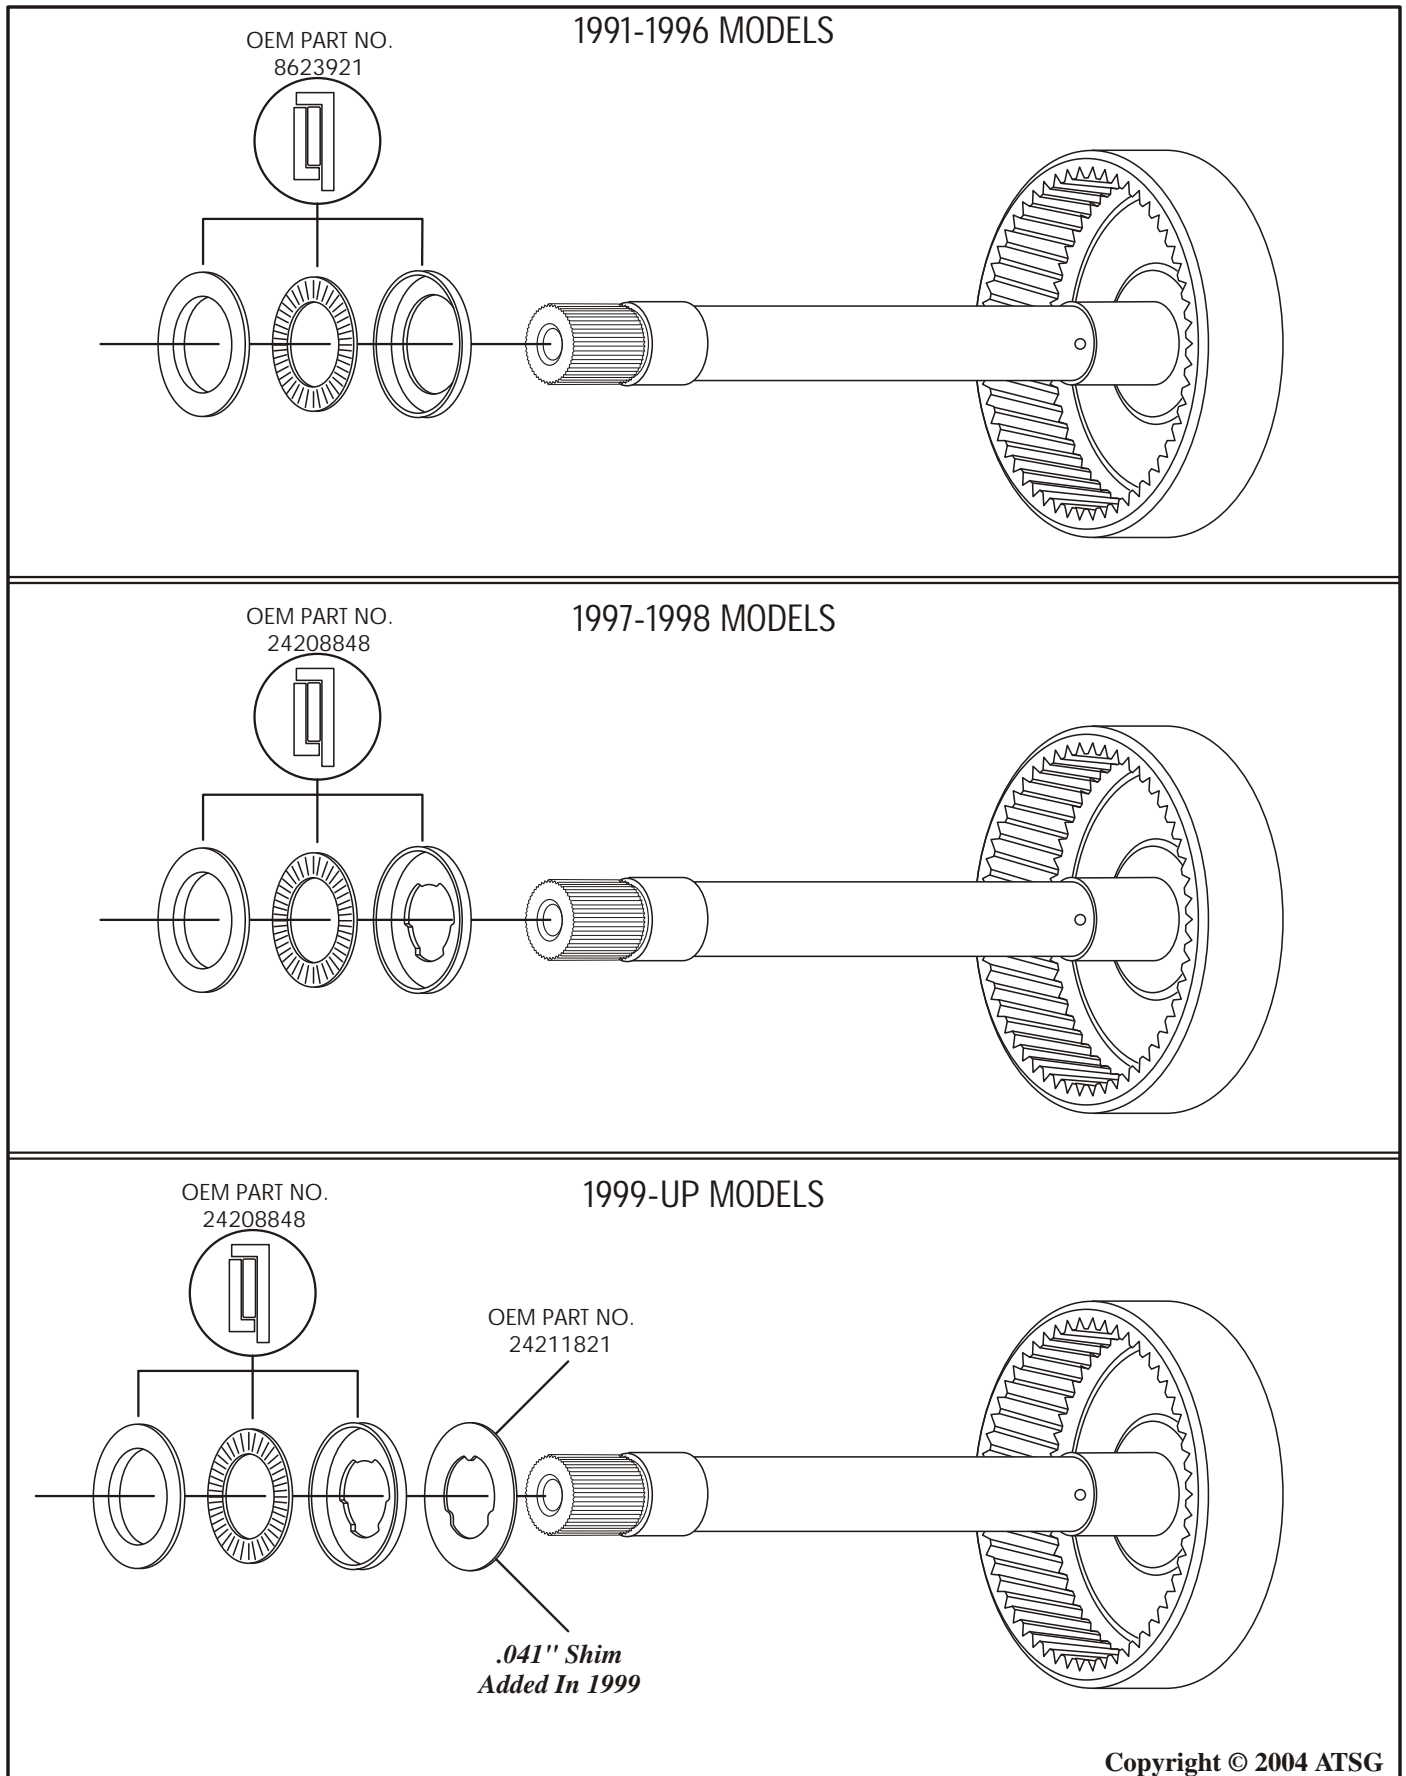
Figure 2

- (1) PLANETARY PINION GEARS - Were increased in length by approximately .075" in both front and rear carriers, as shown in Figure 1, for increased durability.
- (2) ADDED .041" SHIM - There was a .041" shim added between the thrust bearing and the rear internal ring gear, to re-center the sun gear in the revised planetary pinion gears, as shown in Figure 2.
- (3) CENTER SUPPORT - Required a .041" recess to be machined into the center support bearing surface, to accommodate the sun gear being re-centered in the revised planetary pinion gears, as shown in Figure 3.

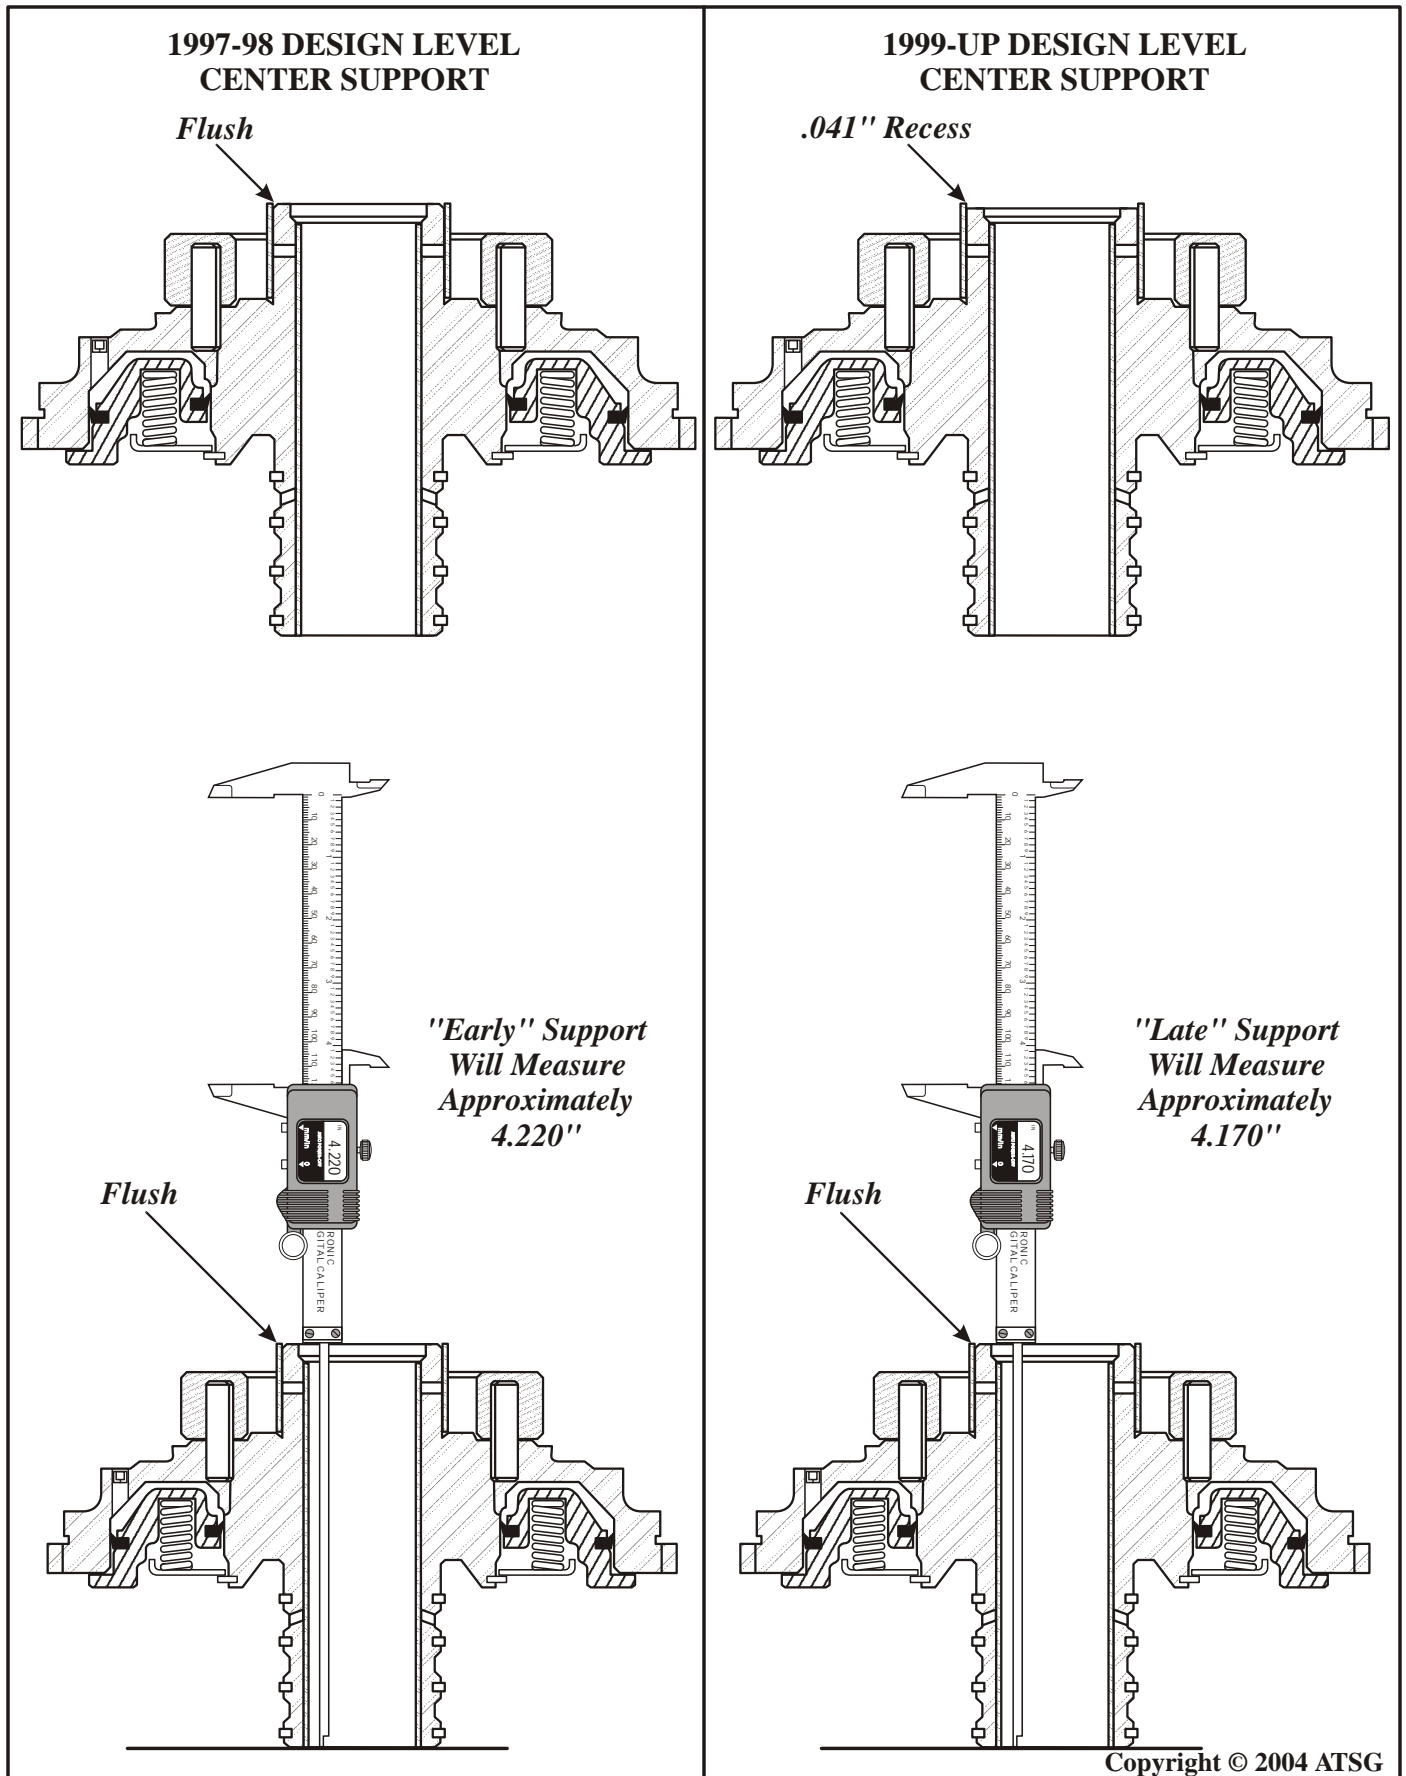
Figure 3

SPECIAL NOTE: Sometime in 2000 GM. eliminated the only visual identification from the updated center support and it now "Requires" measurement for identification, as shown Figure 3.

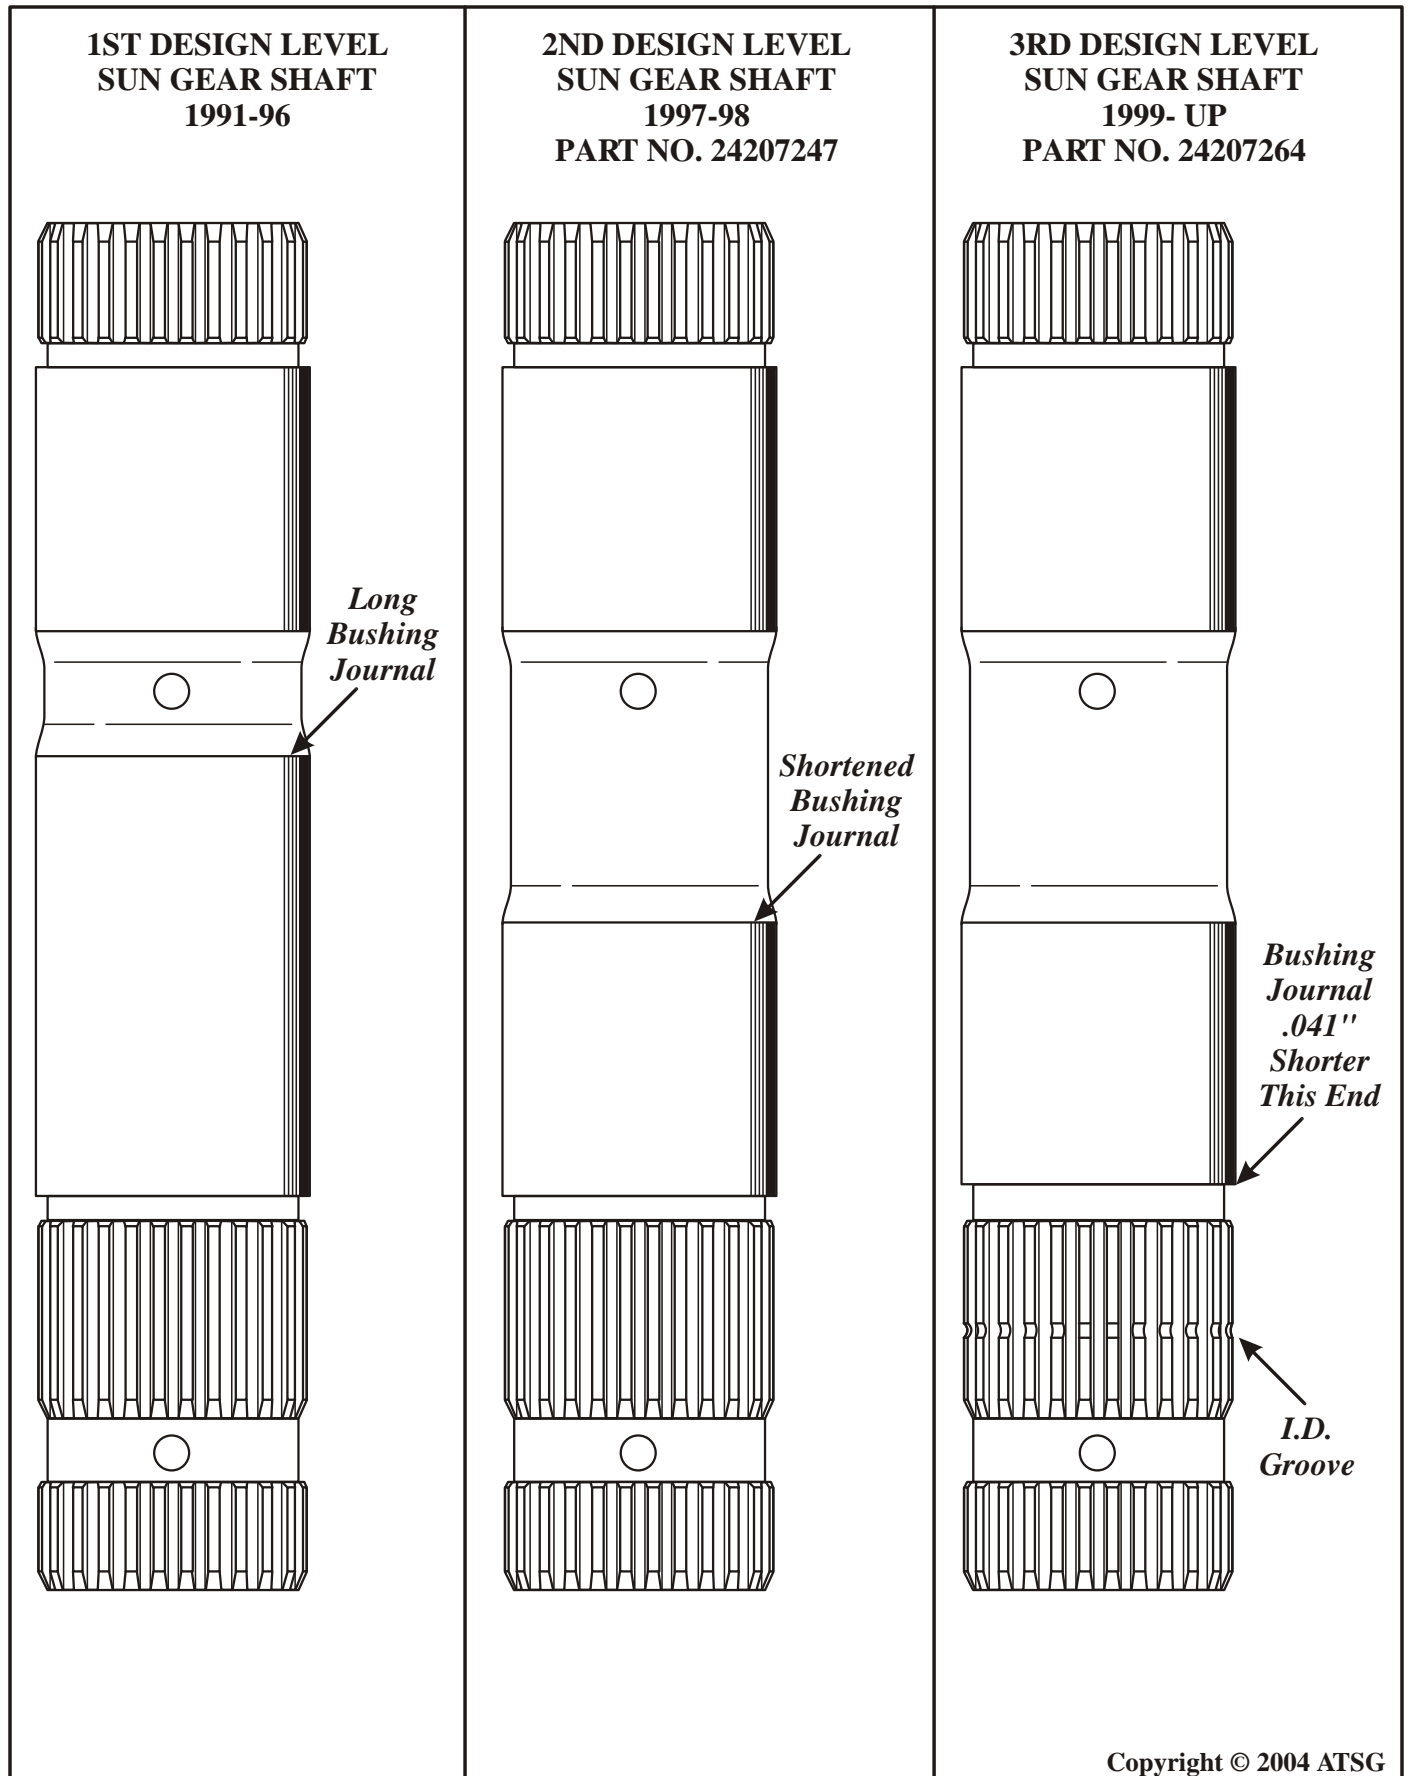
Figure 4

- (4) SUN GEAR SHAFT - Required that .041" be removed from the bottom of the rear bushing journal, to accommodate the re-centering of the sun gear in the revised planetary pinion gears, as shown in Figure 4. Notice that revised sun gear shaft can be identified with a groove cut into the shaft splines, as shown in Figure 4.

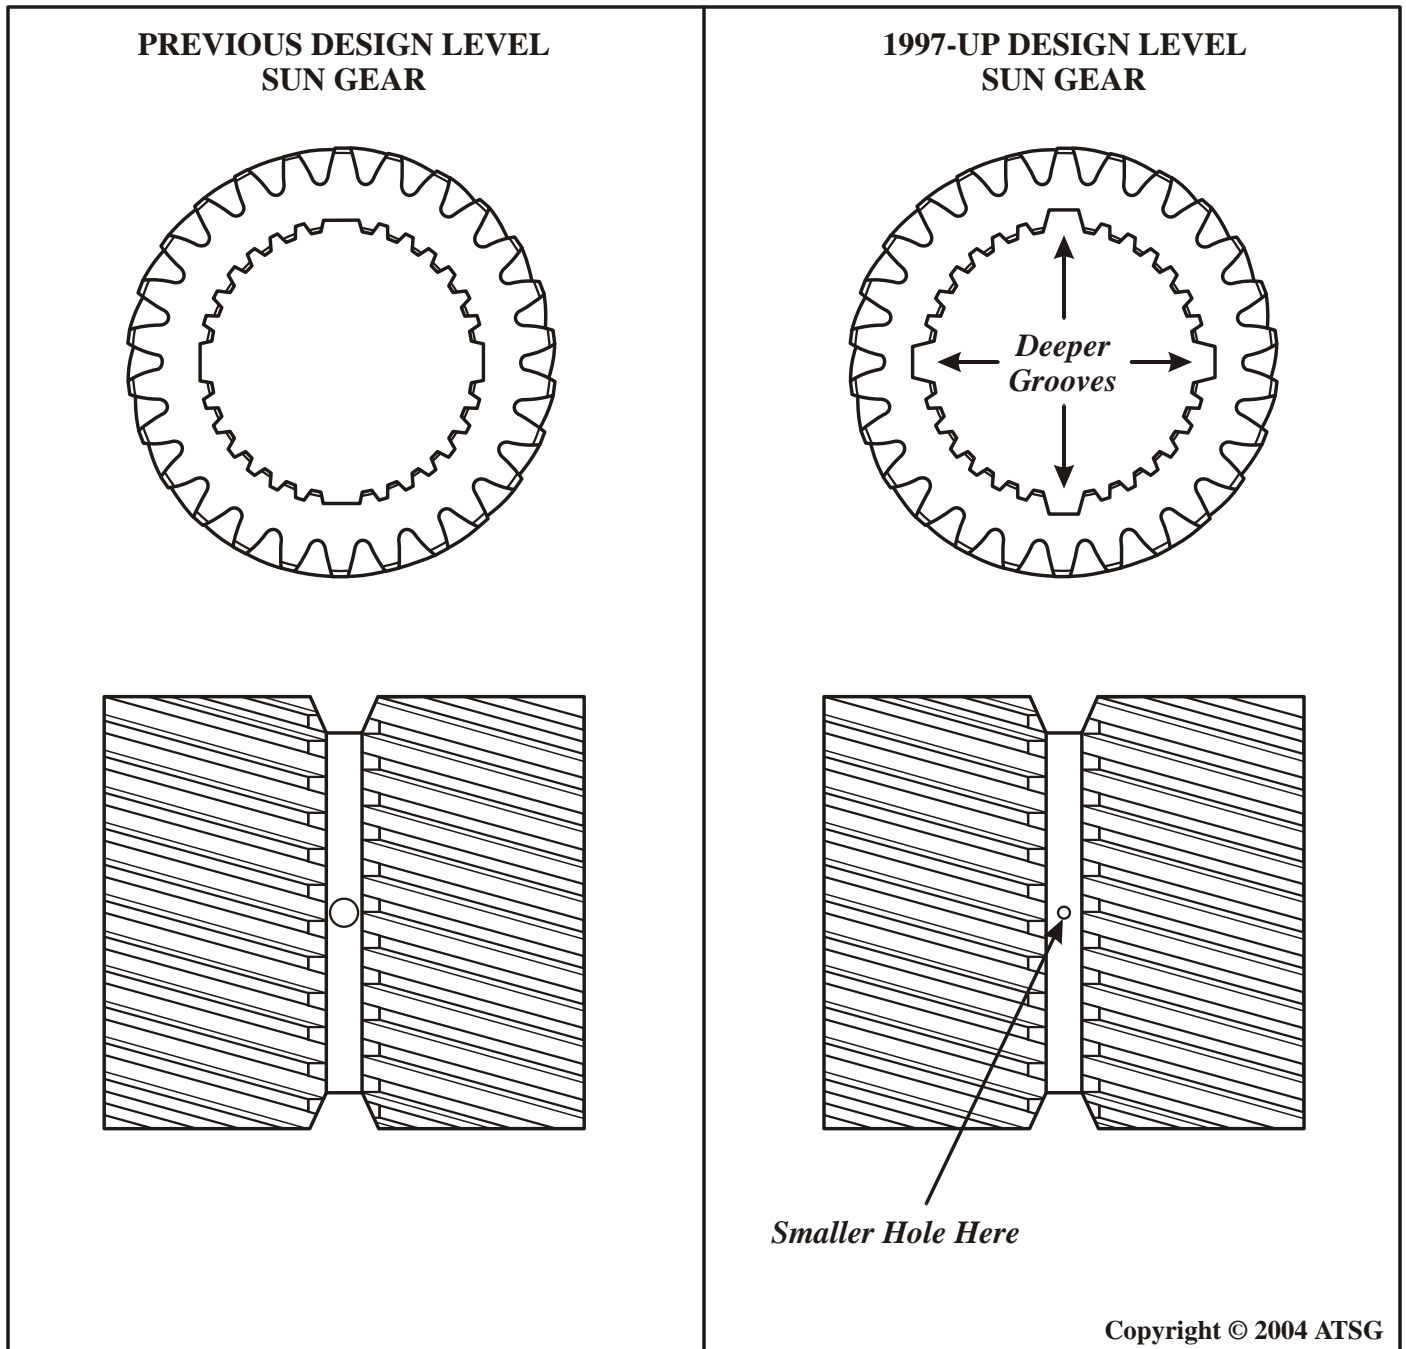
Figure 5

The Sun Gear, Main Shaft, Rear Internal Ring Gear and all Thrust Bearings remained the same, as shown in Figures 5, 6, and 7.

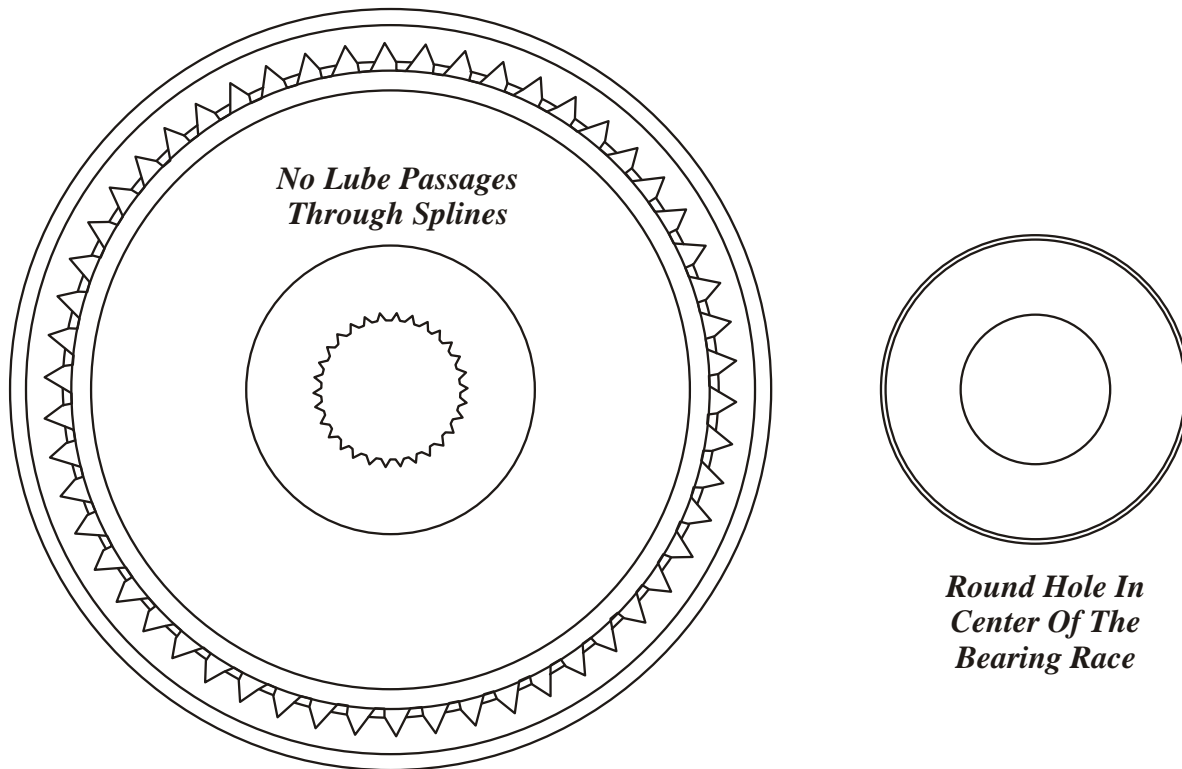
PREVIOUS DESIGN LEVEL REAR RING GEAR AND BEARING RACE

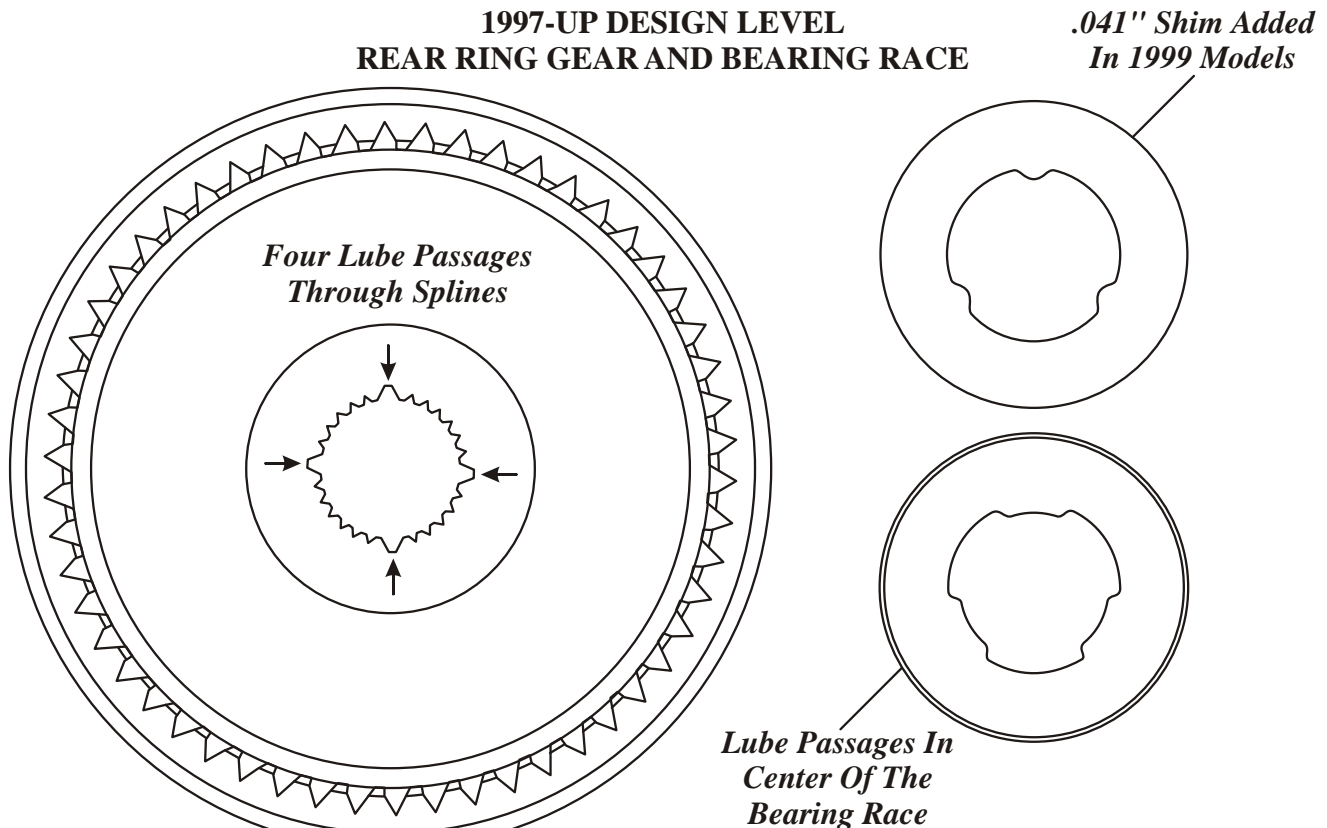
Figure 7

1997-UP DESIGN LEVEL REAR RING GEAR AND BEARING RACE

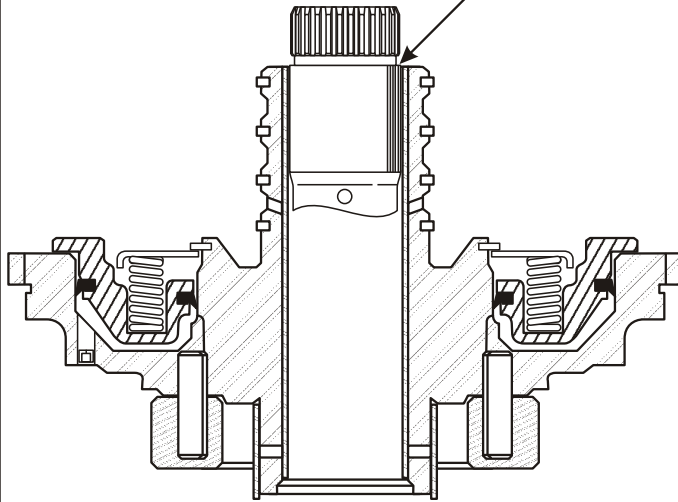
SPECIAL NOTE: Some mis-assembly examples are illustrated in Figure 8 with some dimensional checks to prevent this from happening to you.

1999 SUN GEAR SHAFT
WITH 1997-98 CENTER SUPPORT
AND NO .041" SHIM

*Shaft Journal
Approximately
Flush With Support*

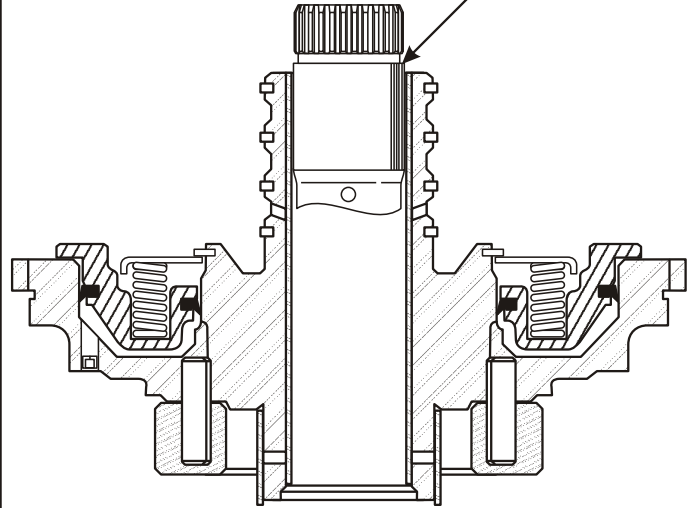
1997-98 SUN GEAR SHAFT
WITH 1999 CENTER SUPPORT
AND WITH .041" SHIM

*Shaft Journal
Approximately
.090" Above Support*

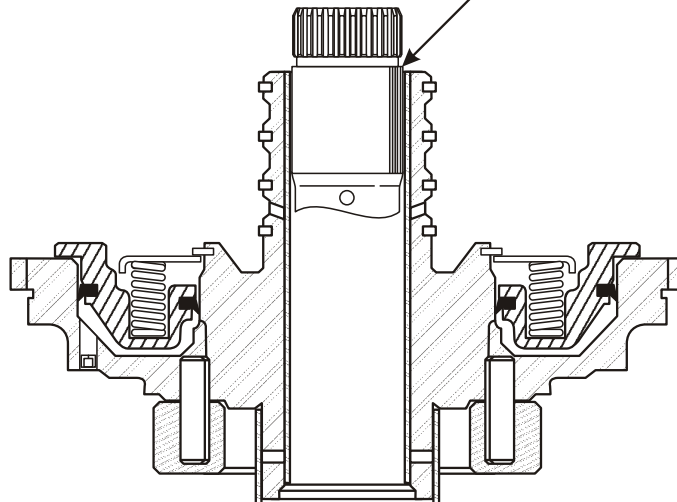
Figure 8

"CORRECT ASSEMBLY"
WITH PROPER
SUN GEAR SHAFT
AND CENTER SUPPORT

*Shaft Journal
Approximately
.050" Above Support*
