Technical Service Information

BMW - A4S (THM 4L30-E) **DIAGNOSTIC TROUBLE CODE 40** **(Pressure Control Solenoid Circuit)**

Adapted from BMW's Service Bulletin 24 06 94

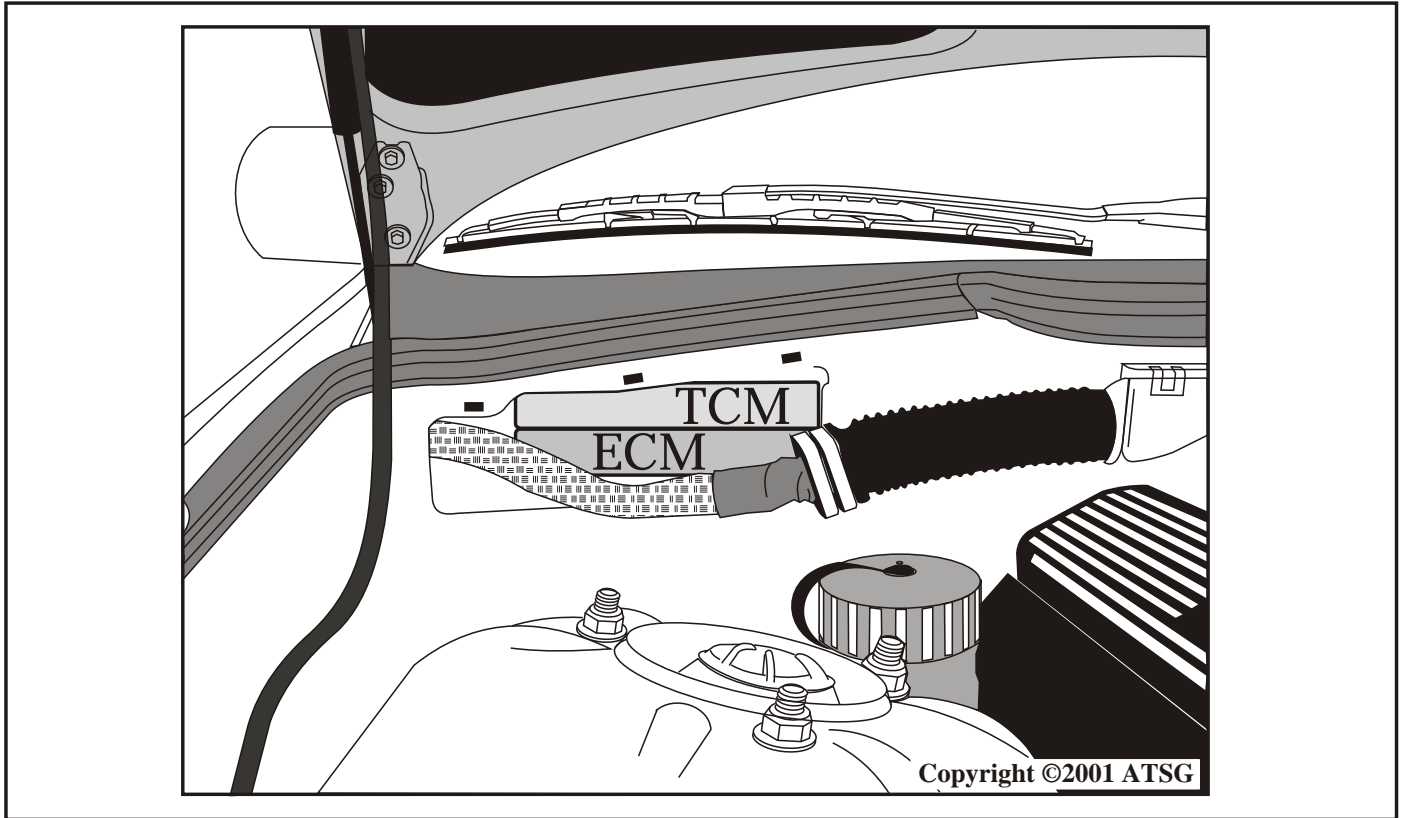
Figure 1

- a. 1992 to 1995 318i & 325i vehicles, the unit can be found in the passenger side engine compartment behind a cover plate as seen in Figure 1.
- b. 1991 to 1993 525i vehicles, the unit is behind the passenger side kick panel.
- c. 1994 to 1995 525i vehicles, it is the middle unit located in an electrical box in the engine compartment front of passenger side firewall.

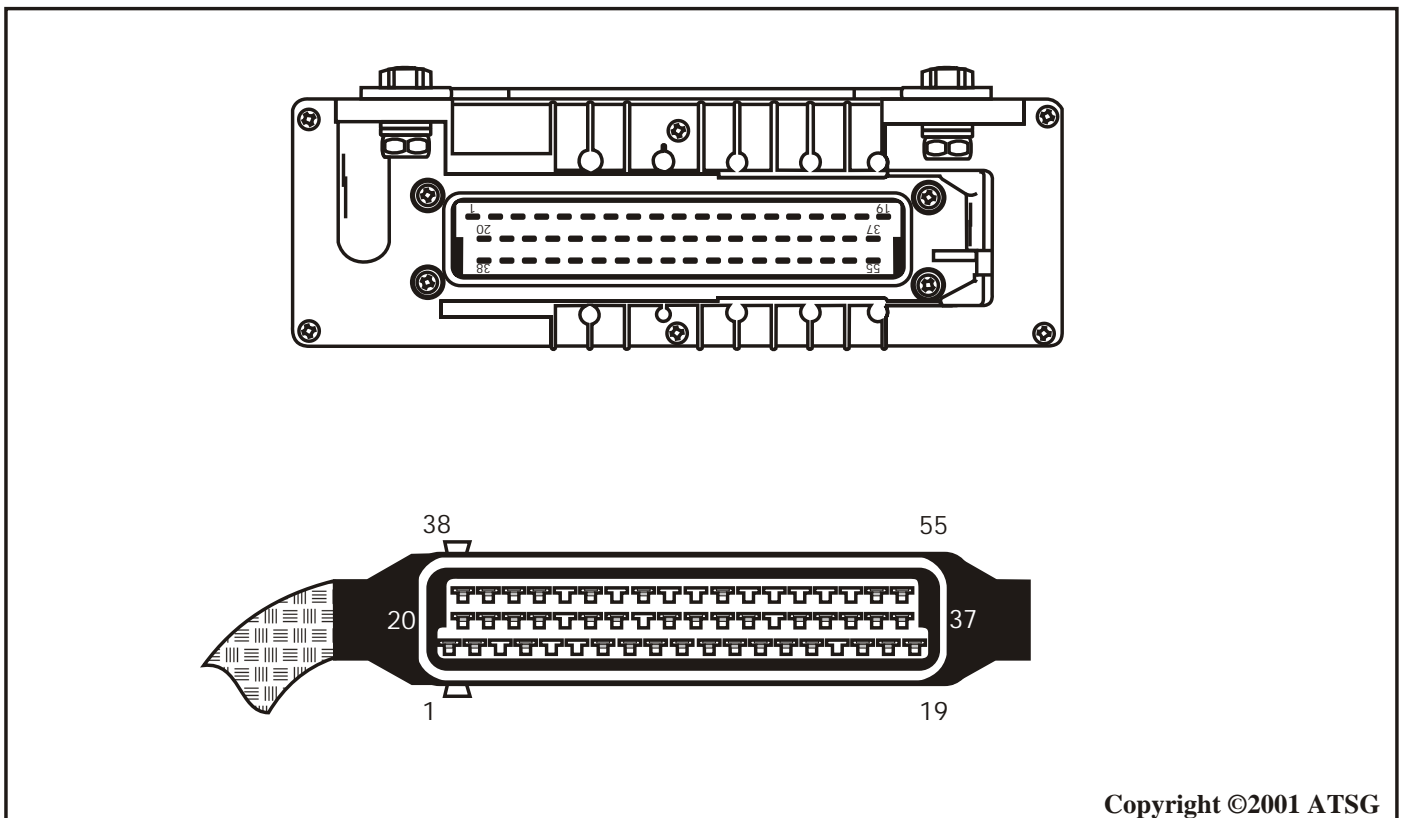
Figure 2

Once the TCM is located, unplug the 55 pin connector and identify pin locations using Figure 2. With the ignition OFF and a DVOM set to ohms, check the ground circuit for continuity from terminal 19 in the vehicle harness connector to ground. If continuity is not observed, provide a permanent ground for wire 19. To ensure that a good ground exists, plug the harness back into the TCM. Start up the vehicle and turn on as many electrical loads as possible. Switching your DVOM to DC volts, place the negative lead to ground and probe wire 19 with the positive lead. Less than 0.3 volts should be observed. Repair ground wire as necessary. Once the ground wire check is acceptable and code 40 persists, perform the following excessive voltage check procedure.

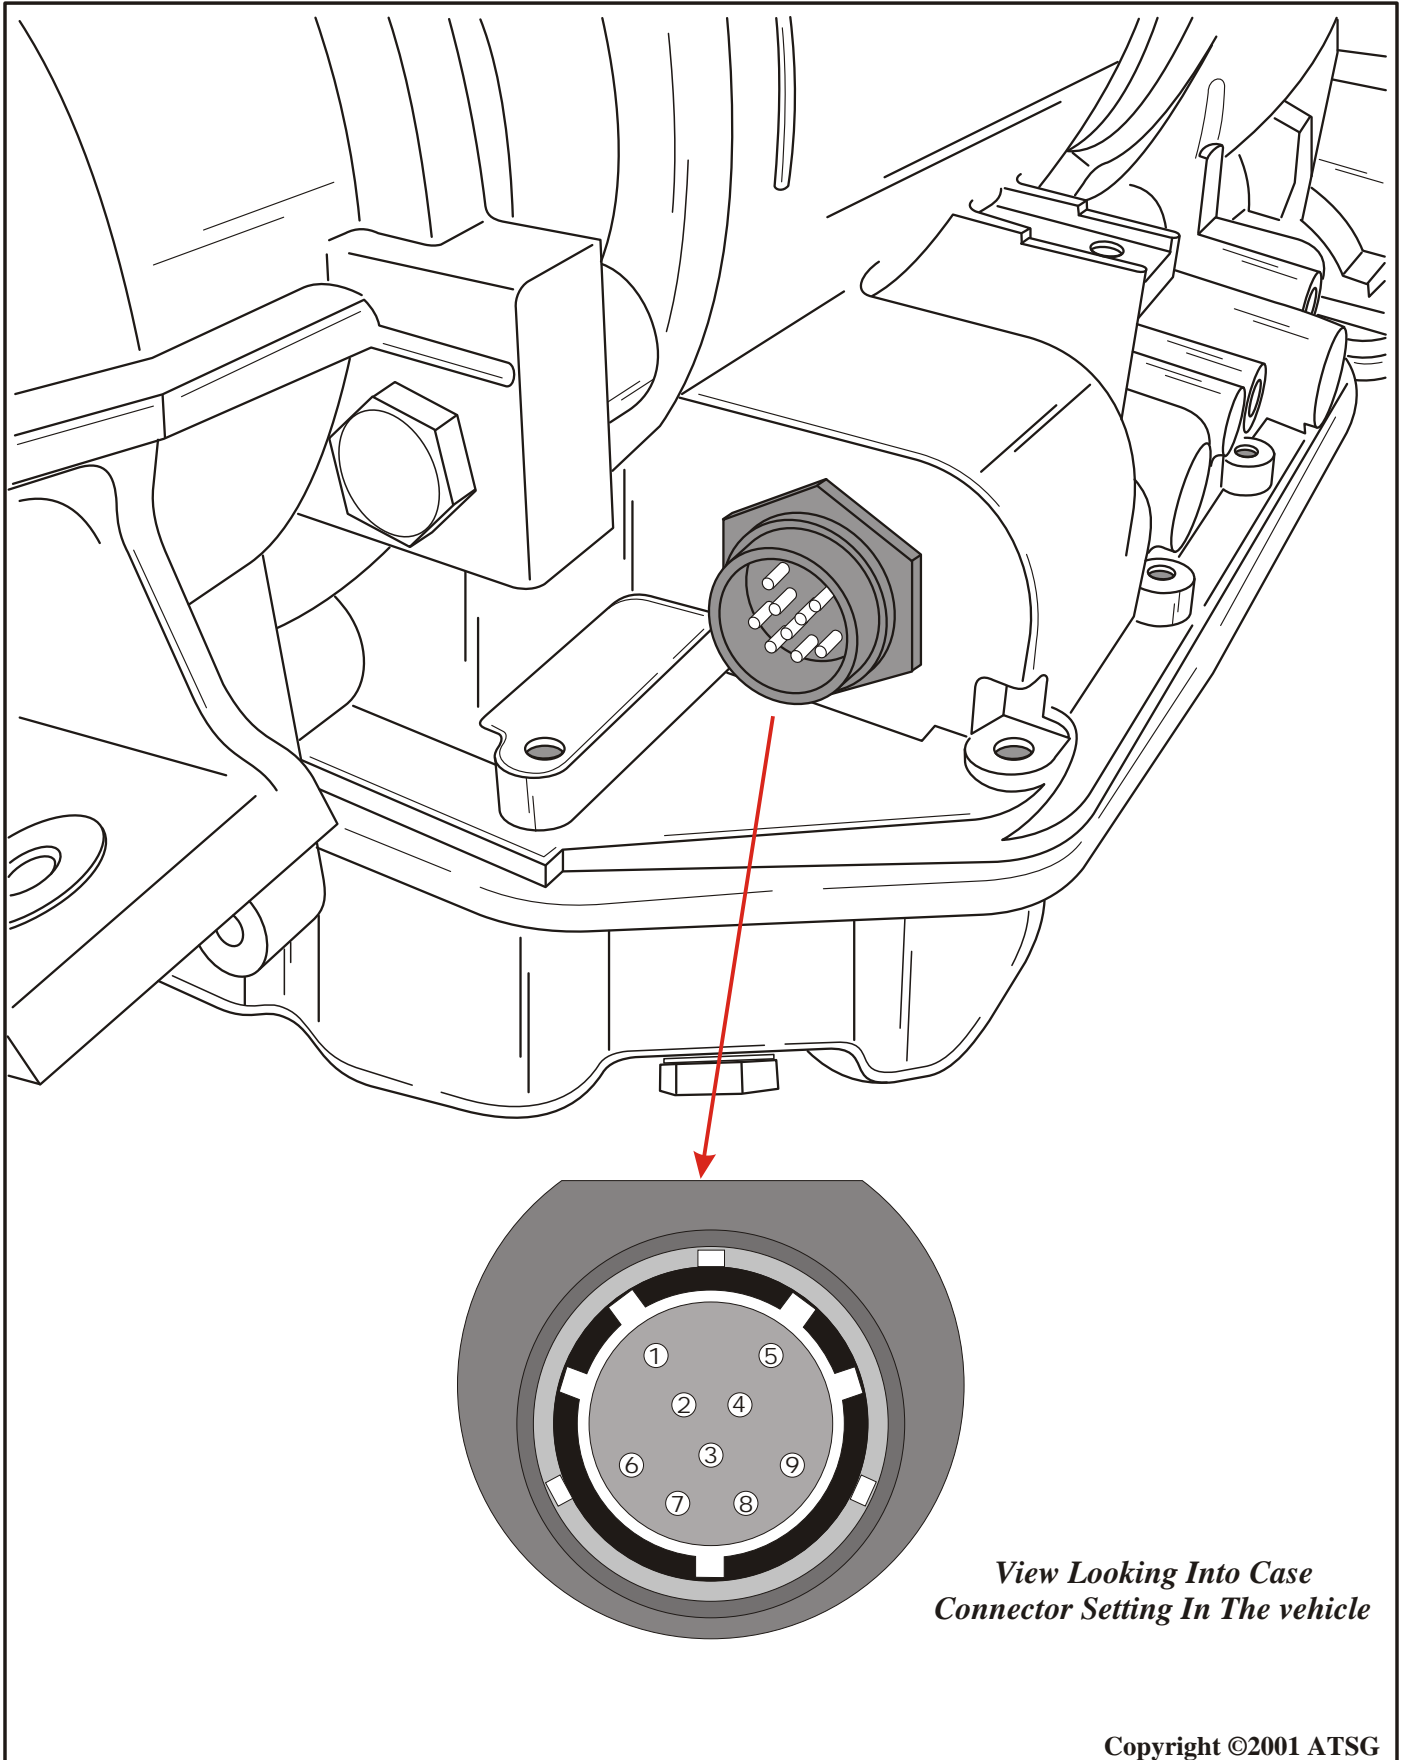
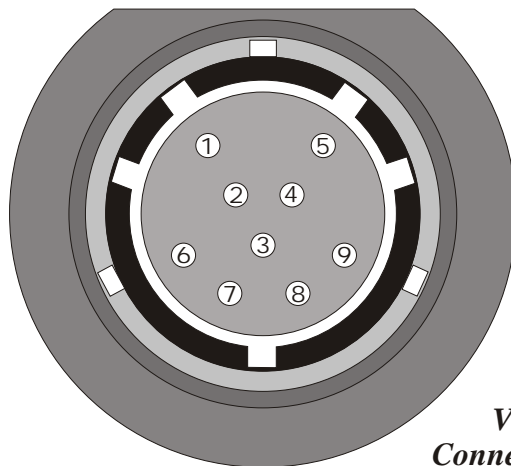
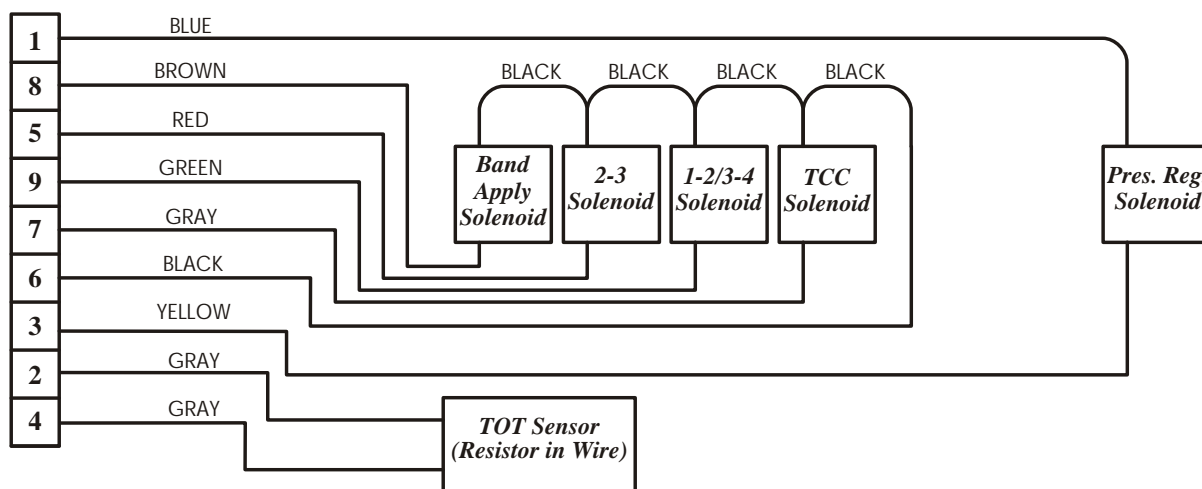
Figure 3

Turn ignition to the OFF position. Using a DVOM set to ohms, check the pressure control solenoid circuit between terminals 40 and 41 at the TCM. Solenoid resistance should be 2 to 6 ohms. If solenoid resistance is out of range, unplug the transmission case connector (See Figure 3), and recheck the pressure control solenoid resistance between terminals 1 and 3 (See Figure 4). If the resistance is still out of range, an inspection of the internal harness and solenoid will need to be performed and repaired. If the resistance is within range from the case connector but does not check correctly at the TCM, wires 40 and 41 at the TCM to the transmission will need to be individually inspected and repaired. If code 40 persists after all previous checks and necessary repairs have been made, continue on to step 3.

<i>Solenoid</i>	<i>Case Connector Pin Numbers - +</i>	<i>Resistance In Ohms</i>
Band Apply	6 and 8	9.5 - 10.5
2-3 Sol.	6 and 5	17.5 - 18.5
1-2/3-4 Sol.	6 and 9	17.5 - 18.5
TCC	6 and 7	17.5 - 18.5
Press. Sol.	1 and 3	3.7 - 4.7
TOT	2 and 4	20K @ 70°F
