Technical Service Information

VOLKSWAGEN/AUDI ZF5HP19FL/FLA NEUTRALS ON TAKEOFF

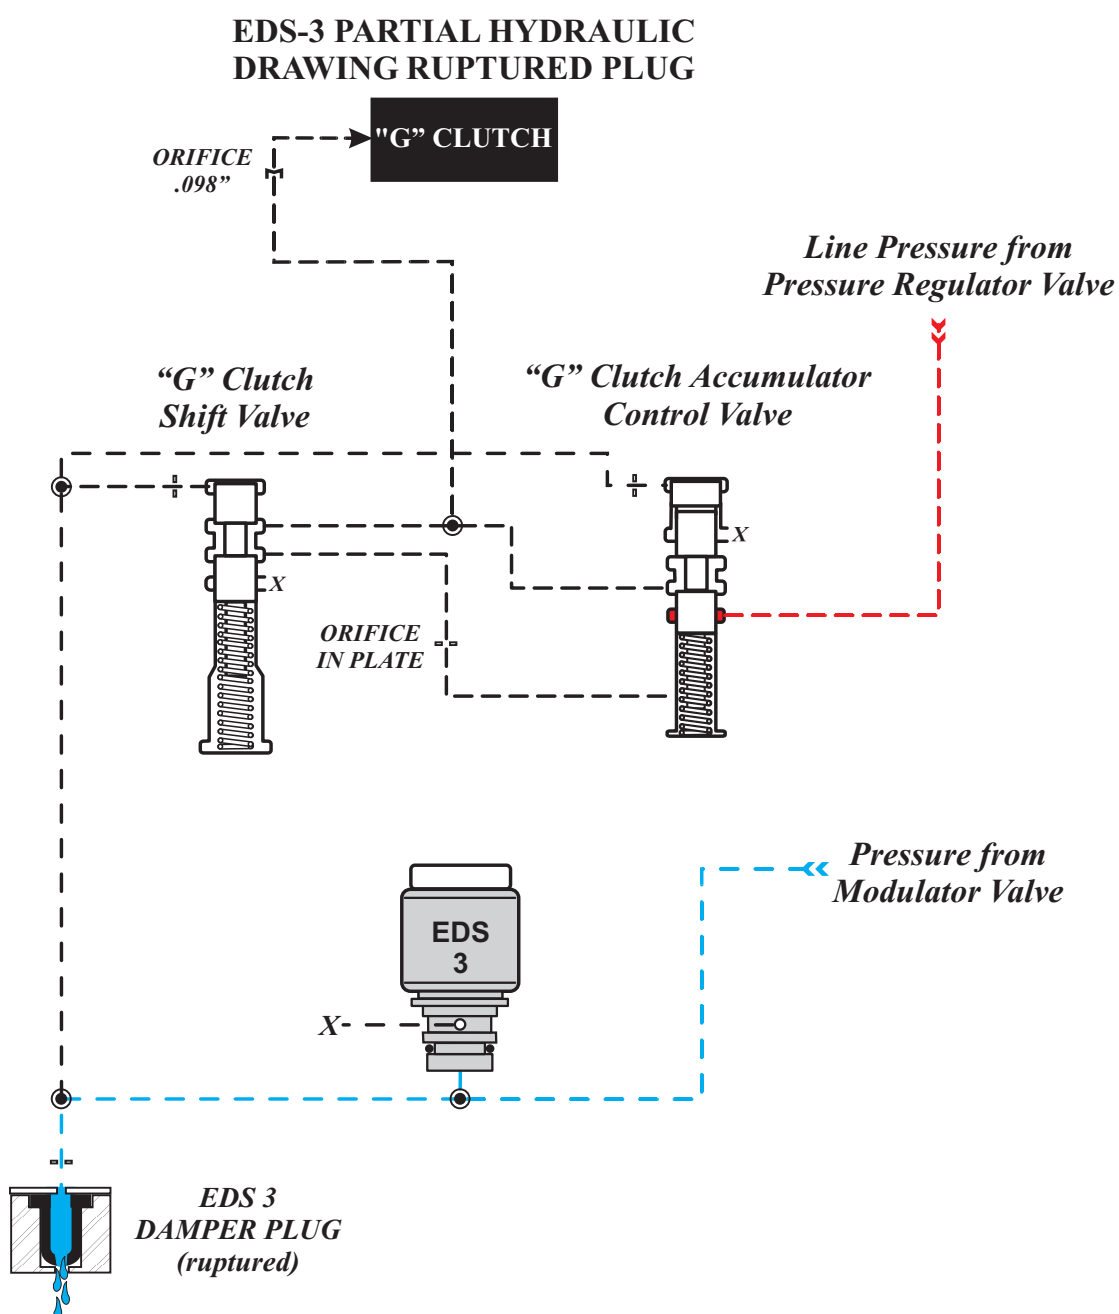
CAUSE: One cause may be a ruptured rubber damper plug in the channel plate section of the valve body. The root cause of the burned clutch may not be apparent during initial inspection, especially if the time is not taken to disassemble the valve body. In the channel plate section of the valve body are located three rubber damper plugs. These damper plugs act as accumulators for the pulse-width-modulated solenoids EDS 2, EDS 3, and EDS 4. The damper plugs must be removed from the valve body and carefully inspected. The reason they must be looked at carefully is because of their tendency to “rupture” or “burst”. If you experience a similar neutralizing effect during heavy acceleration, EDS 3 damper assembly will be the accumulator plug you want to look at closely. EDS 3 solenoid is pulsed “ON” in reverse, neutral, 1st, and 2nd gear. Refer to Figure 1. This drawing illustrates that modulator pressure is fed to solenoid EDS 3. With the solenoid “ON”, modulator pressure flows to the EDS 3 damper plug and then strokes the “G” clutch shift valve and “G” clutch accumulator control valve allowing line pressure to apply the “G” clutch. During heavy acceleration conditions, increased modulator pressure can cause a “rupture” or “burst” hole to occur in the plug and exhaust through the channel plate. When this occurs there will not be sufficient pressure to stroke the “G” clutch shift valve or accumulator control valve which will lead to a partial apply of the “G” clutch and the neutralizing condition.

EDS 3 is used to control the engagement of the "G" clutch. This hydraulic circuit drawing shows oil flow with a ruptured EDS 3 Damper.

NOTE: *With a ruptured EDS 3 Damper Plug, EDS 3 oil pressure exhausts through the hole in the bottom of the damper plug thereby not accumulating and passing to both Shift Valve "G" and Accumulator Control Valve "G".*

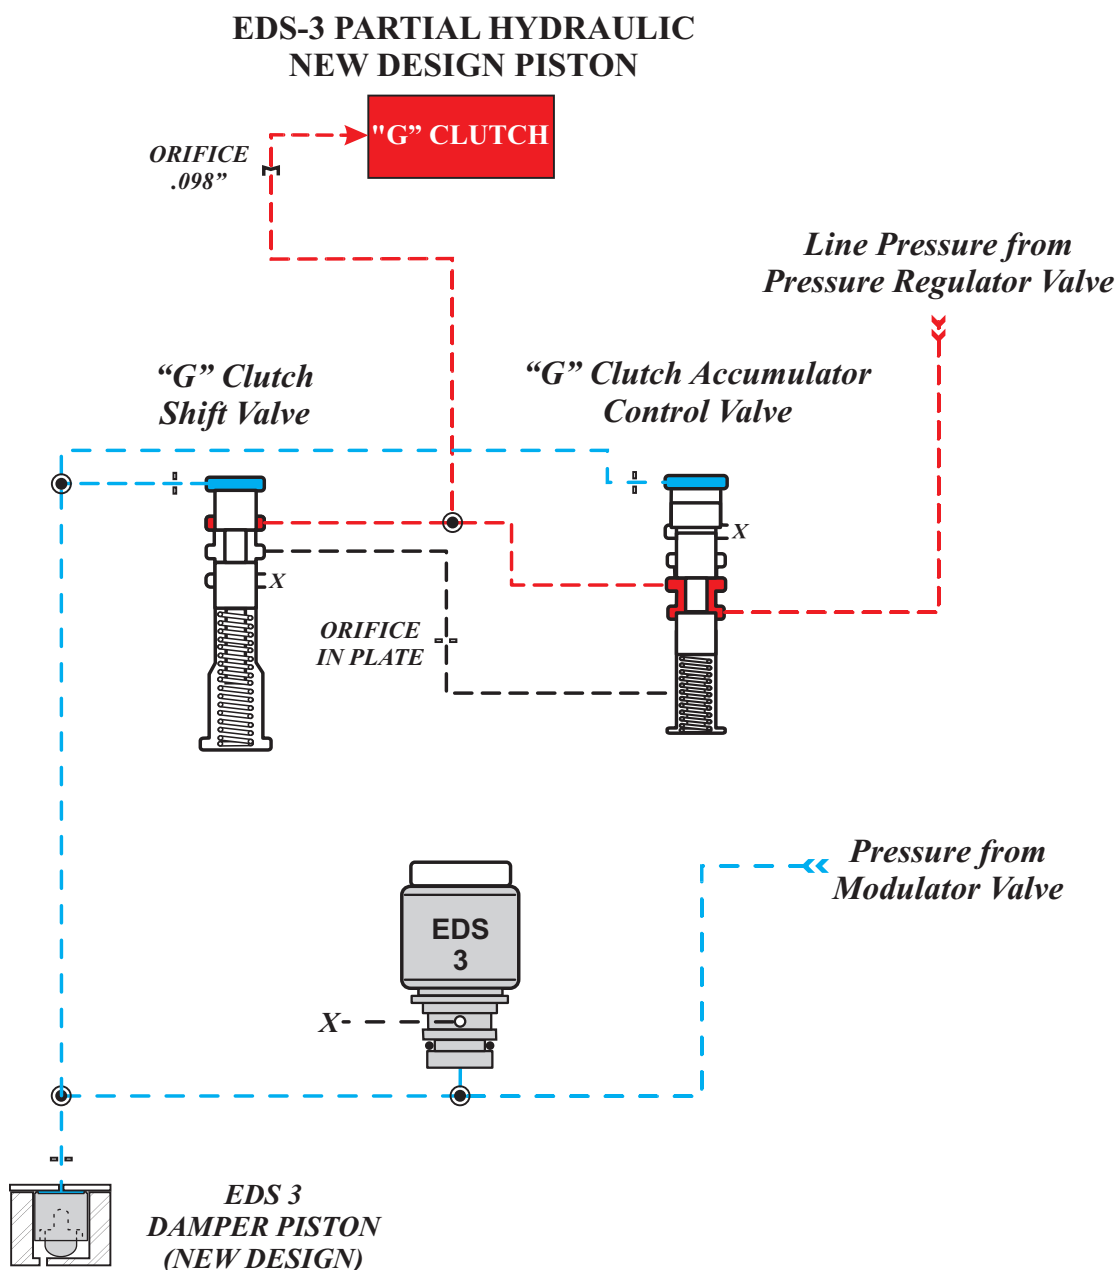
This hydraulic circuit drawing shows oil flow with New Design EDS 3 Damper Piston.

NOTE: With a new design damper piston installed in the valve body, oil pressure only contacts the face of the plug. Since the hole is eliminated in the new plug, it reduces the possibility of the plug rupturing, and normal oil accumulation is achieved.

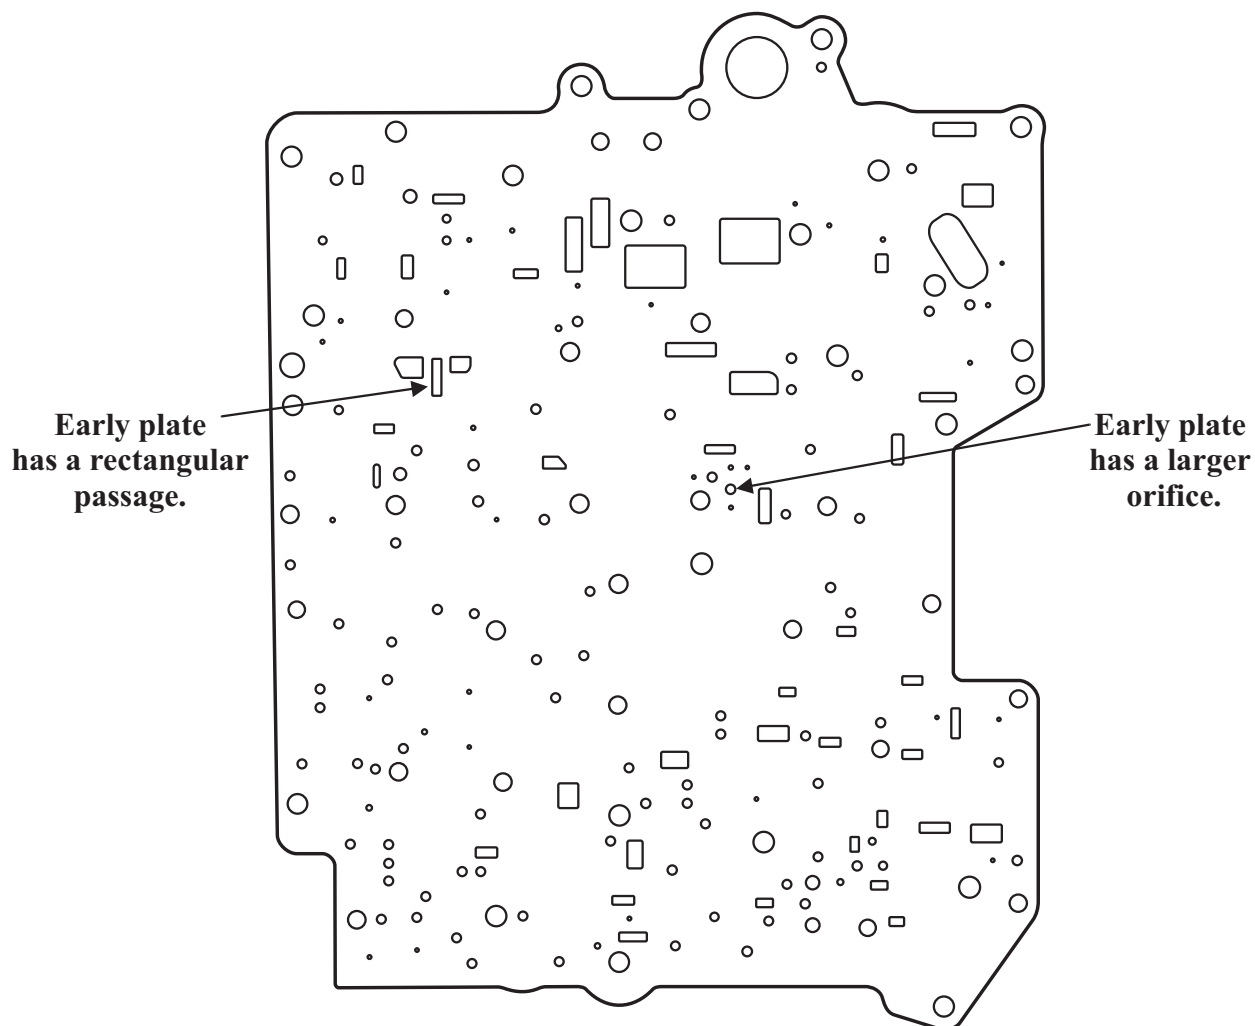
EARLY STYLE SEPARATOR PLATE

**NOTE:
SEPARATOR PLATE
DIFFERENCES**

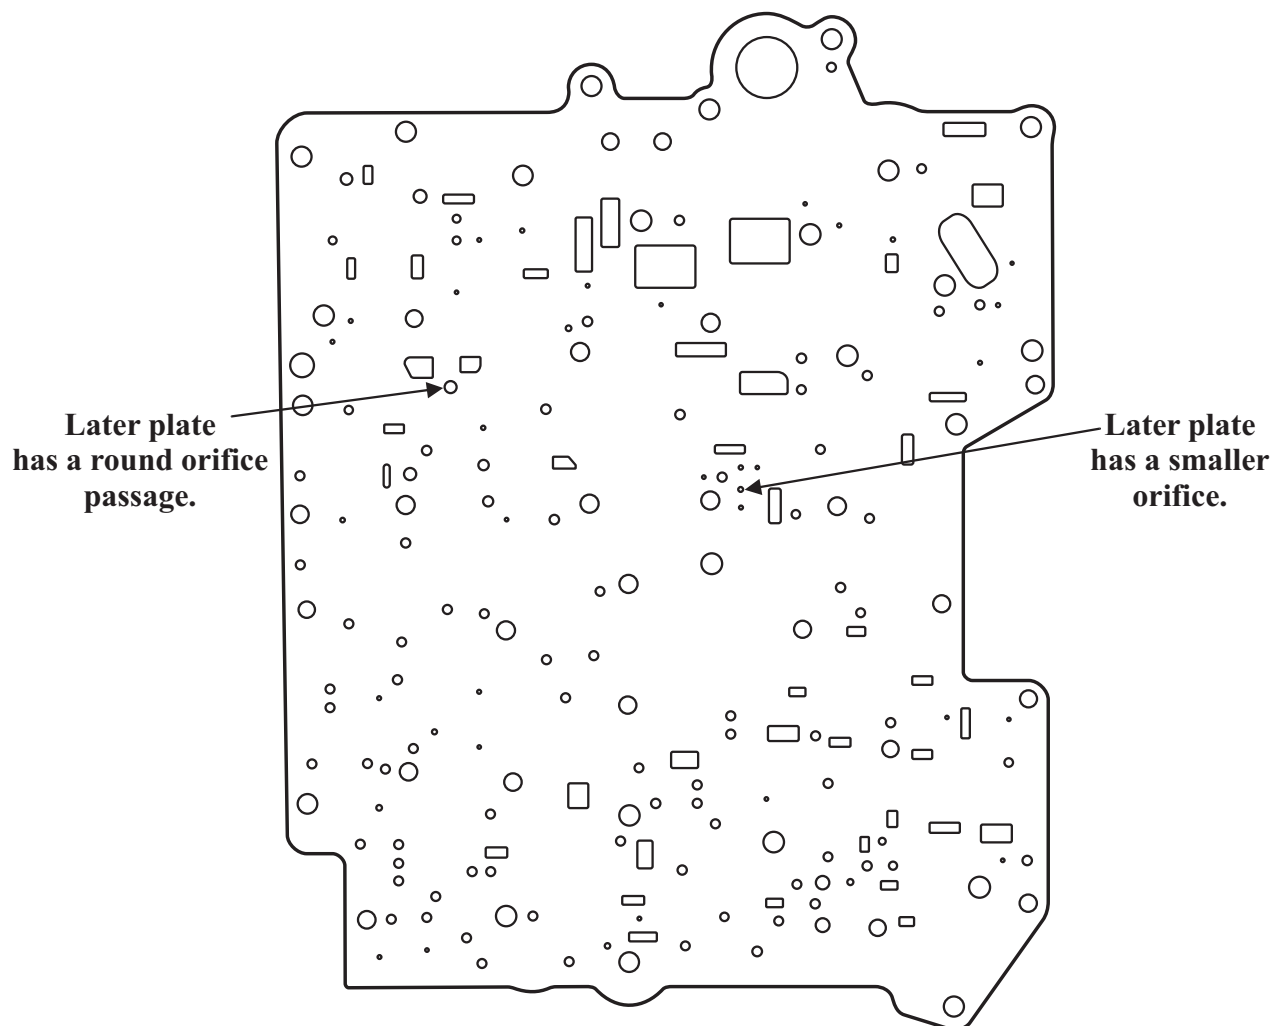
LATER STYLE SEPARATOR PLATE

**NOTE:
SEPARATOR PLATE
DIFFERENCES**
