THM 3T40 (125C) NO REVERSE AND/OR PREMATURE LOW/REVERSE CLUTCH FAILURE

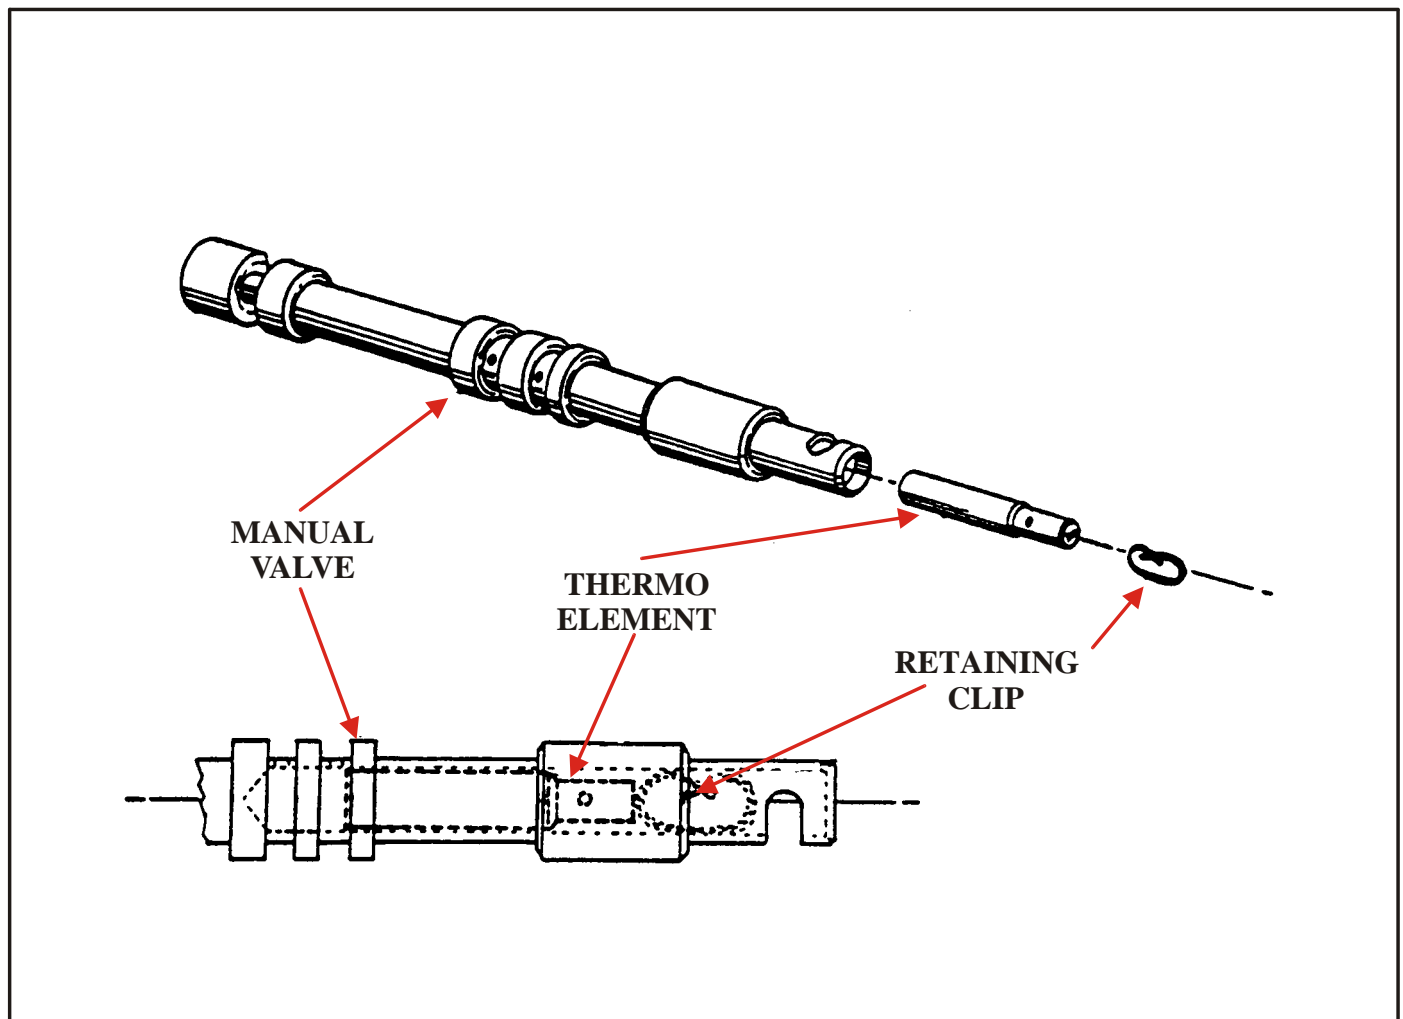
Figure 1

COMPLAINT: A no reverse condition and/or low/reverse clutches badly burnt at a very low mileage.

CAUSE: The cause may be the Low/Reverse fluid not completely exhausting, so that the Low/Reverse clutch remains partially applied while moving in all forward gears. All reverse fluid must exhaust through the thermo element, located in the manual valve, on a reverse to drive garage shift.

CORRECTION: Remove and discard the thermo element and the retaining clip, located inside the manual valve, on all vehicles so equipped (See Figure 1). This should be done as standard procedure during ALL rebuilds.
