Technical Service Information

MAZDA G4A-EL STACKED SHIFTS

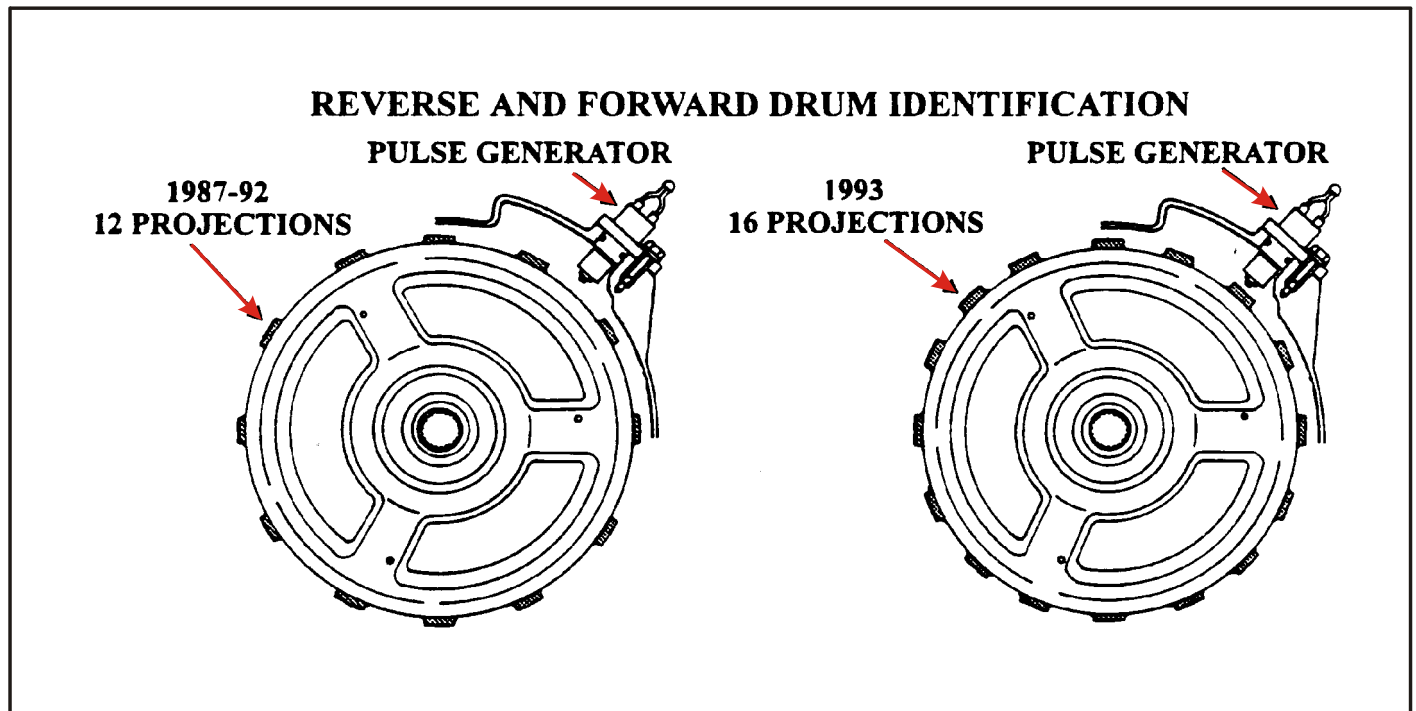
Figure 1

COMPLAINT: Vehicles equipped with G4A-EL transmissions may exhibit early or "Stacked Shift's" with Converter Clutch apply by 20 mph., *after overhaul*, without storing any trouble codes.

CAUSE: The cause may be, a mismatched 1993 Reverse and Forward drum was installed into a 1987-92 vehicle. **REASON:** 1987-92 Reverse and Forward drums have 12 "Projections." 1993 Reverse and Forward drums have 16 "Projections." These "Projections" are picked up by the "Pulse Generator" converting drum or turbine speed into an A.C. current or frequency that is sent to the ECAT computer. When a 16 "Projection" drum is installed into a 1987-1992 vehicle, drum or turbine speed will automatically be faster and may change shift strategy. (See Figure 1).

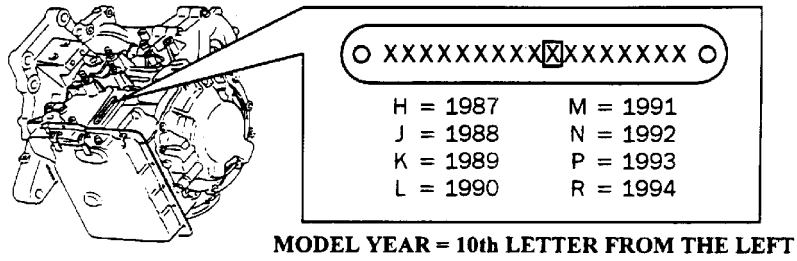
MODEL YEAR IDENTIFICATION

CORRECTION: Refer to Figure 2 to identify model year and install the proper drum for your application.
