NISSAN RE4R01A / RE4F02A SOFT OR FLARED UPSHIFTS

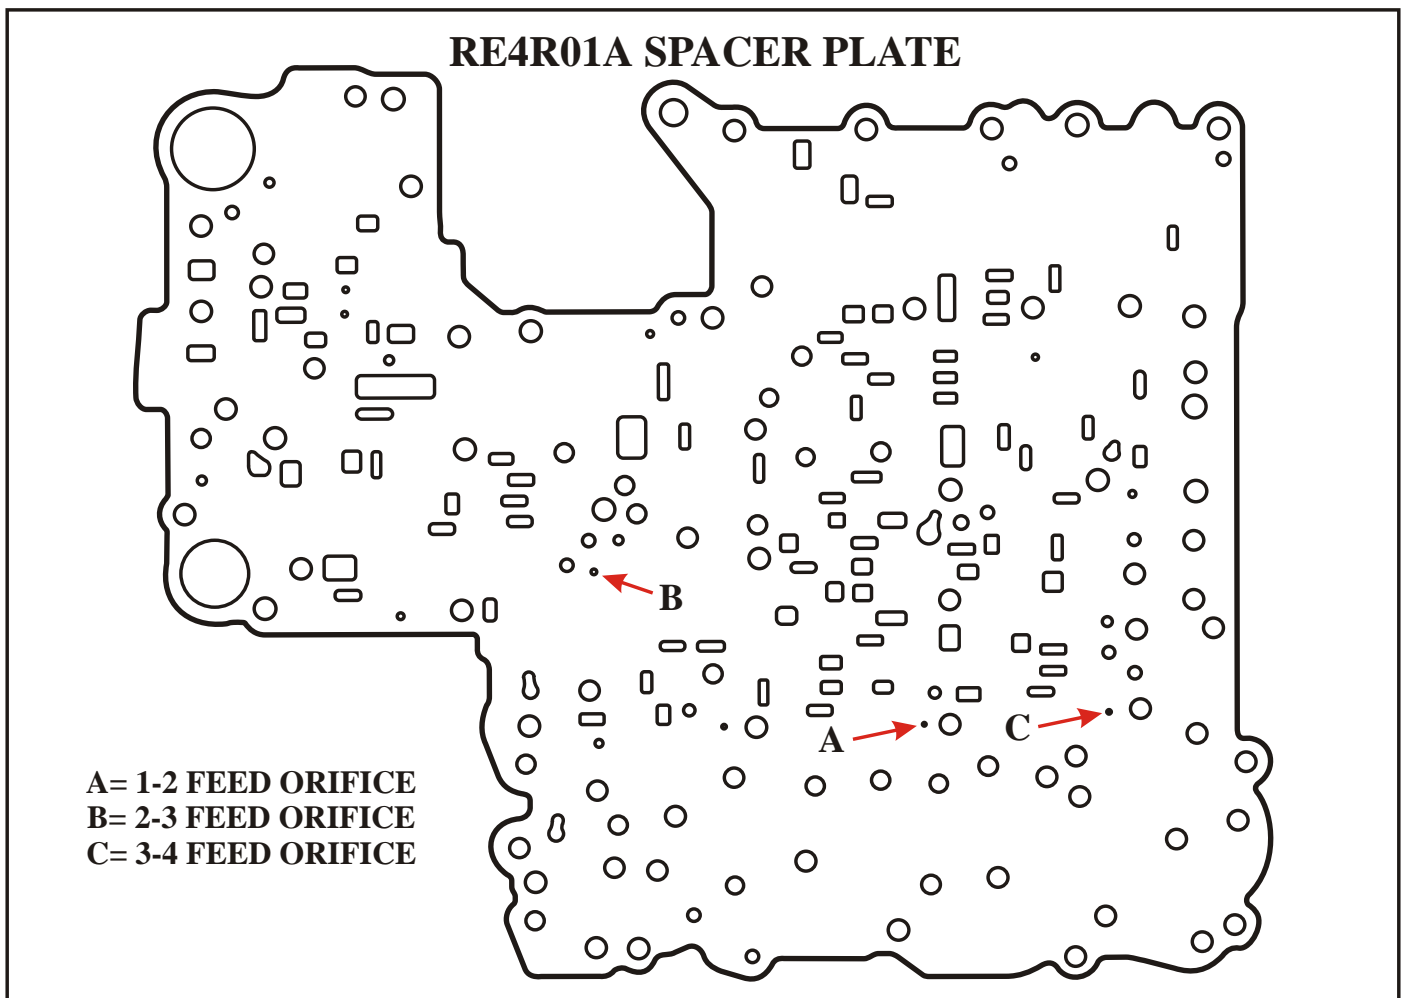
COMPLAINT: After overhaul, vehicles equipped with RE4R01A or RE4F02A transmissions, may exhibit soft or flared upshifts.

CAUSE: The cause may be, insufficient feed oil to the clutch or band servo related to the upshift taking place.

CORRECTION: Refer to Figure 1 for RE4R01A feed orifice locations. Refer to Figure 2 for RE4F02A feed orifice locations. To firm the upshift in question, enlarge the orifice marked in the spacer plate .020“--.030” larger.

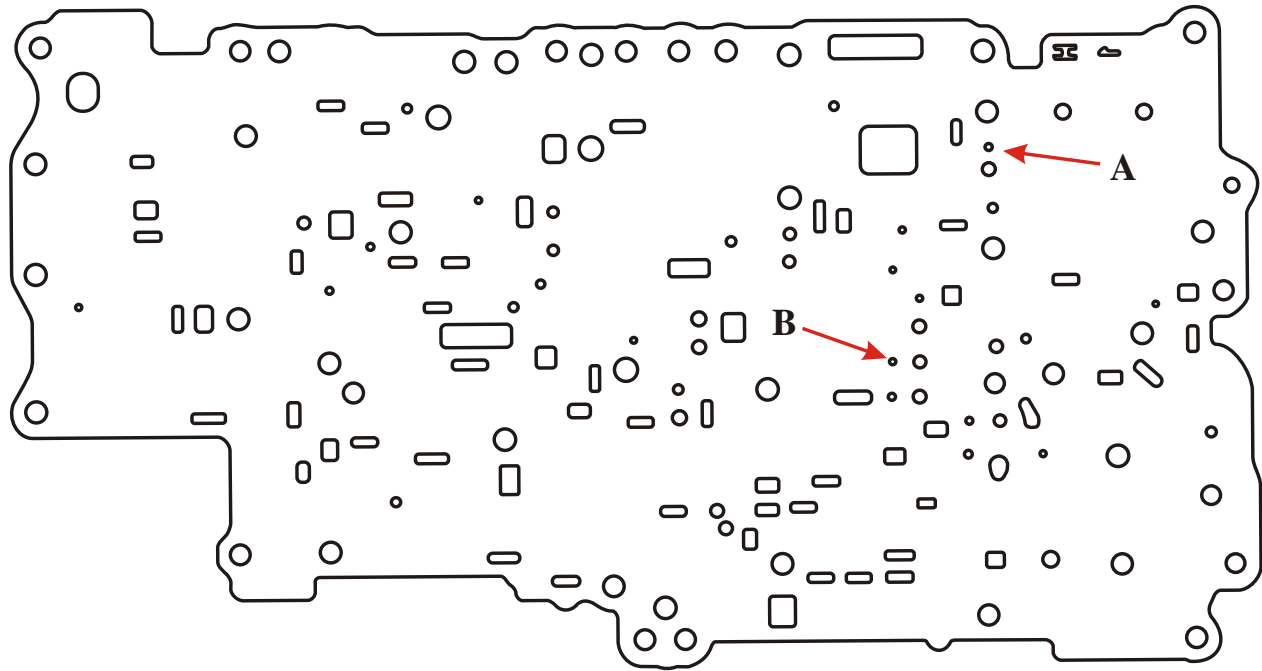
Figure 2

A= 1-2 AND 3-4 FEED ORIFICE
B= 2-3 FEED ORIFICE
