# Technical Service Information

## NISSAN 4N71B HARSH 4-3 COAST DOWNSHIFT

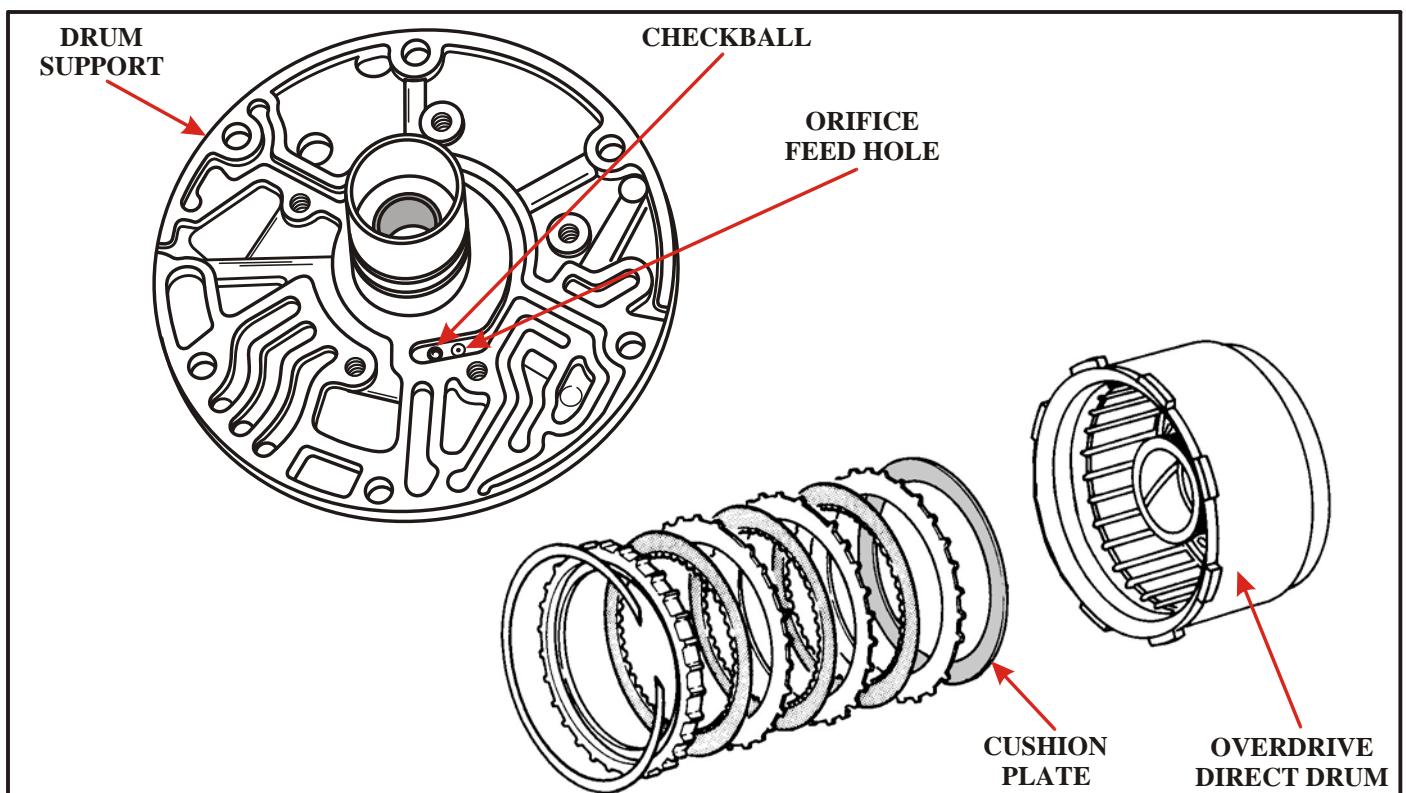
Figure 1

**CAUSE:** The cause may be, a mis-matched overdrive direct clutch drum assembly and the overdrive drum support. The cushion plate arrangement in the overdrive direct drum and the size of the overdrive direct clutch feed hole located in the drum support. Some drum supports also require a checkball depending on cushion plate arrangement. Refer to Figure 1.
