"The Seminar to See for 2003" Technical Seminar

INDEX *Ford, Chrysler & Imports*

AUTOMATIC TRANSMISSION SERVICE GROUP

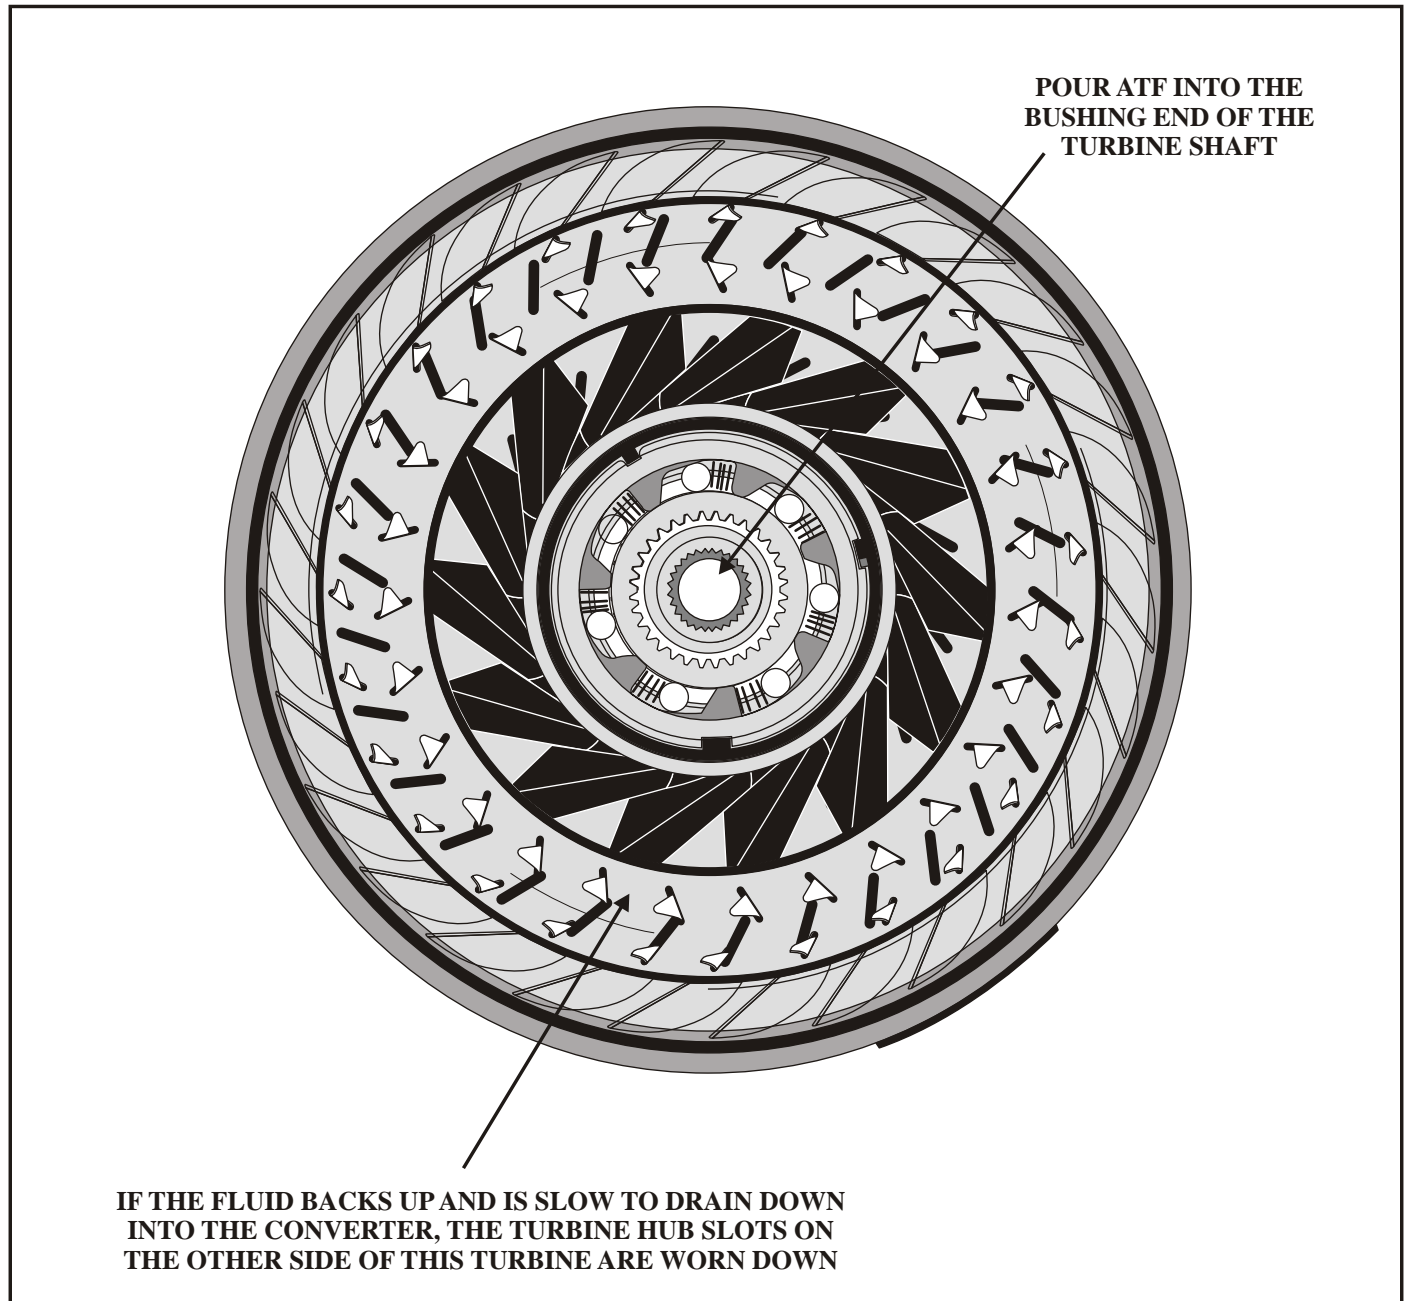
Figure 1

COMPLAINT: The vehicle came into shop with a 628 or P1744 TCC slip code stored. The Turbine Speed Sensor tests good. There are a number of valve body concerns that could cause this as well, but the reason in this case is not valve body or internal transmission related. This can also occur if a seemingly "clean" converter is reused.

CAUSE: The torque converter is the problem. Internal wear of the torque converter is the reason for TCC slippage and the codes that are stored. The turbine hub slots have worn down, restricting the flow of transmission fluid to the apply side of the converter clutch, See Figure 1. This causes converter slippage even when all other related components are good.

FORD/MAZDA CD4E
TORQUE CONVERTER CLUTCH SLIPPAGE

CORRECTION: To test the converter for this problem, insert a turbine shaft into the converter. Pour ATF into the shaft at the bushing end.
If the turbine hub is not worn, the fluid drain into the converter almost as fast as you can pour it in.
If the turbine hub is worn, the fluid will back up the turbine shaft and take some time to finally drain down into the converter.

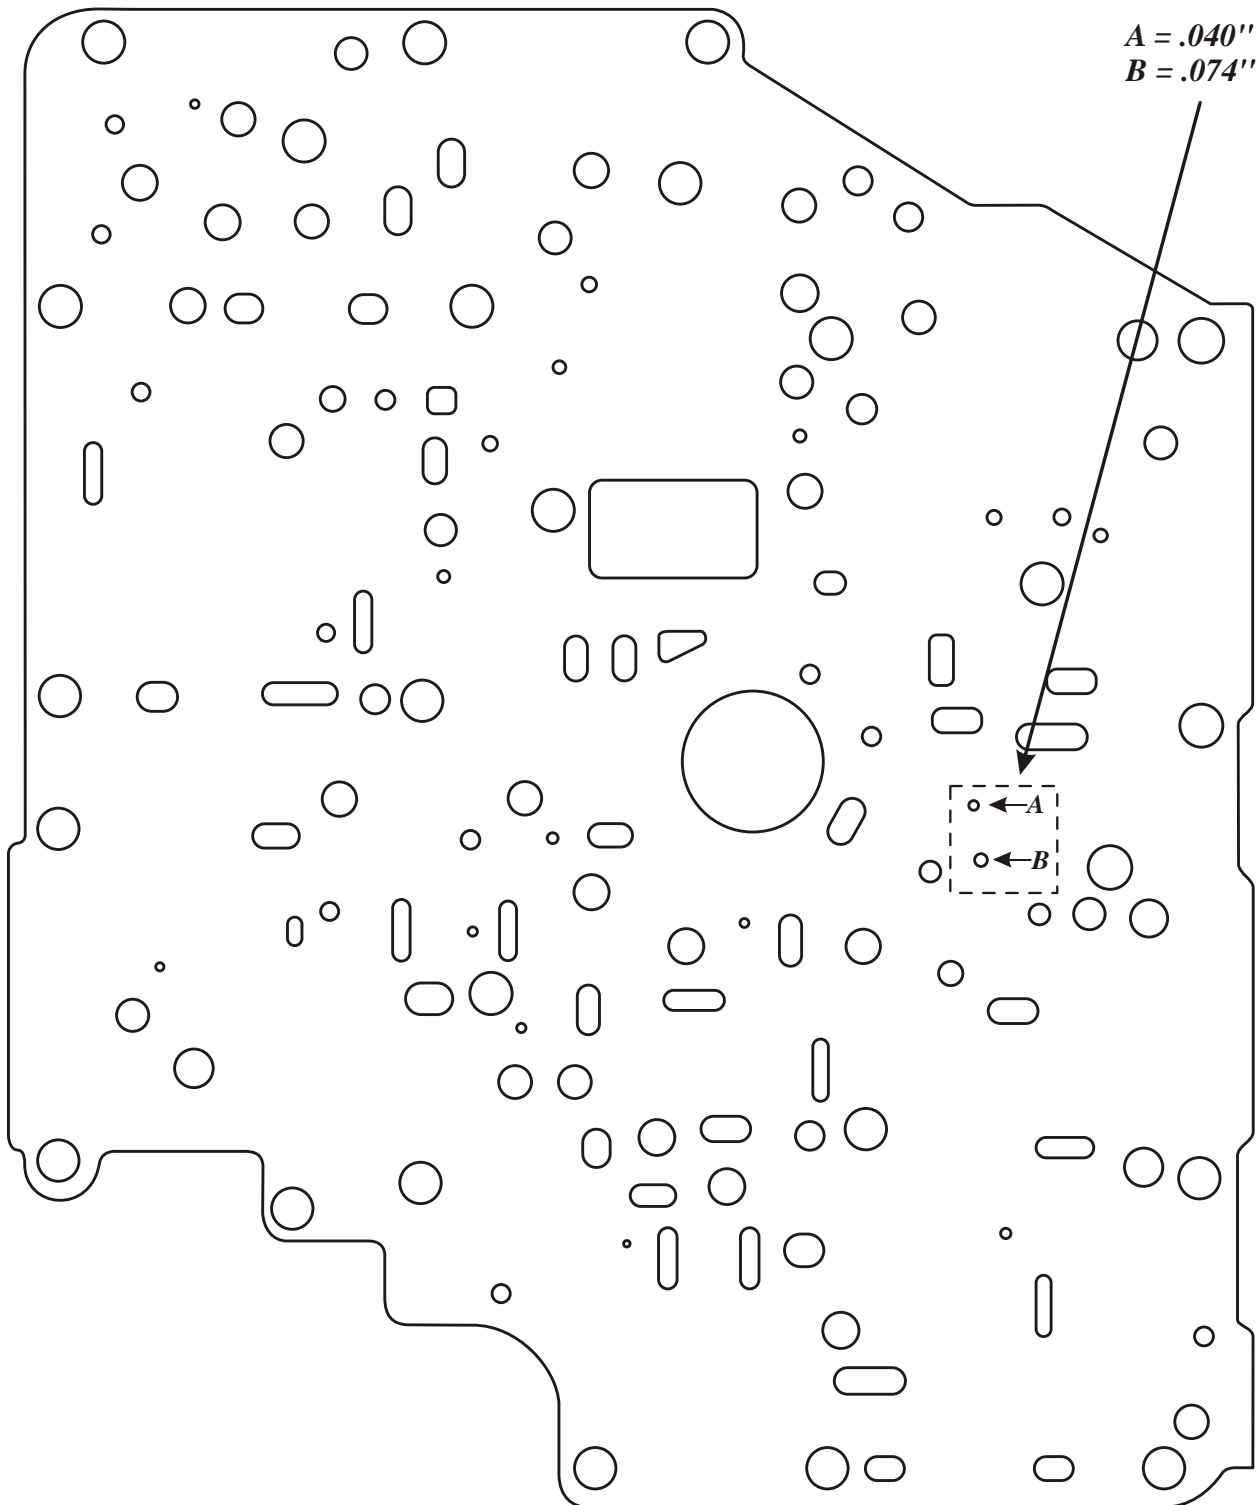
Figure 1

CAUSE: The cause may be, a valve body spacer plate designed for the Taurus, Sable, Continental passenger car family, has been installed on a Windstar Van, creating a harsh 1-2 upshift. If the Windstar Van valve body spacer plate, is installed on the Taurus, Sable, Continental family of vehicles, the result will be a soft or flared 1-2 upshift. ***Obviously these two spacer plates are different.*** Refer to Figures 1 and 2, using the two holes over the 1-2 capacity modulator valve area, for identification.

"WINDSTAR" SPACER PLATE IDENTIFICATION

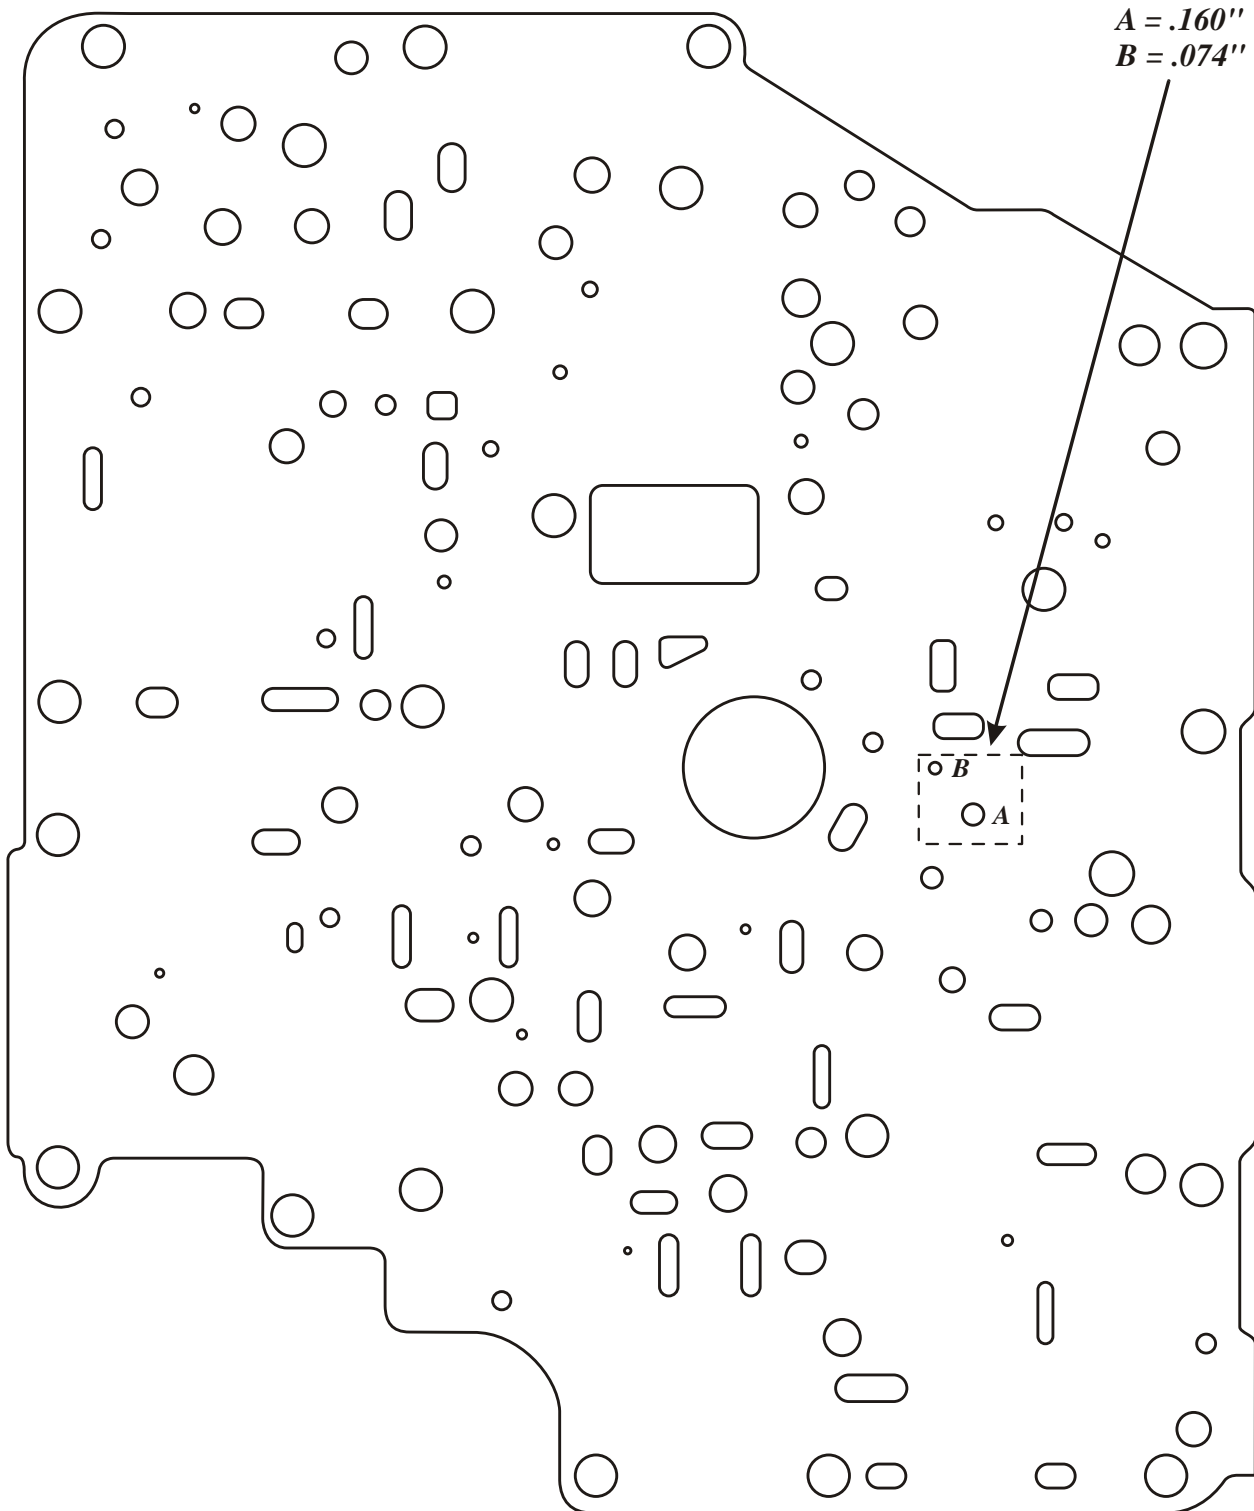
Figure 2

"TAURUS FAMILY" SPACER PLATE IDENTIFICATION

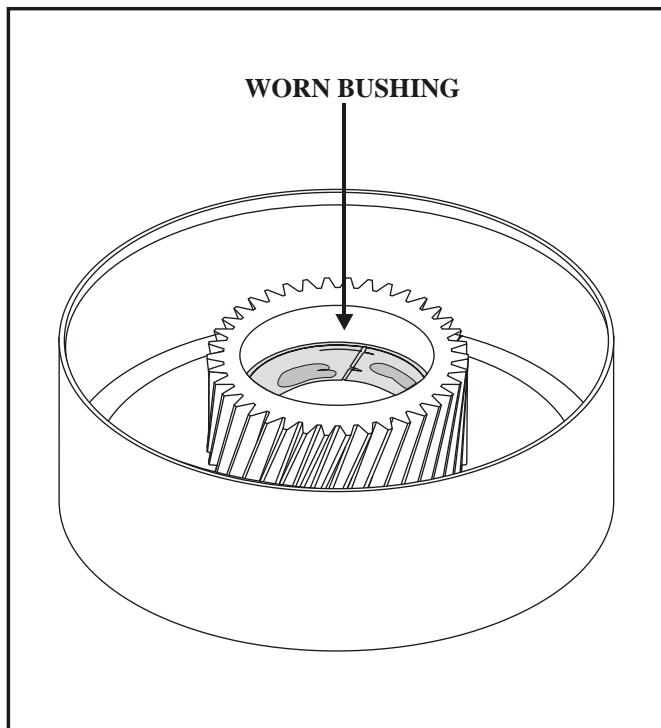
Figure 1

CAUSE: A worn Low/Intermediate Drum Bushing, as seen in figure 1, causes this complaint because the Low/Intermediate drum cocks off centerline when the 1-2 band releases or grabs the drum. This could be compared to a warped brake drum or rotor that causes a pulsation in the brake pedal.

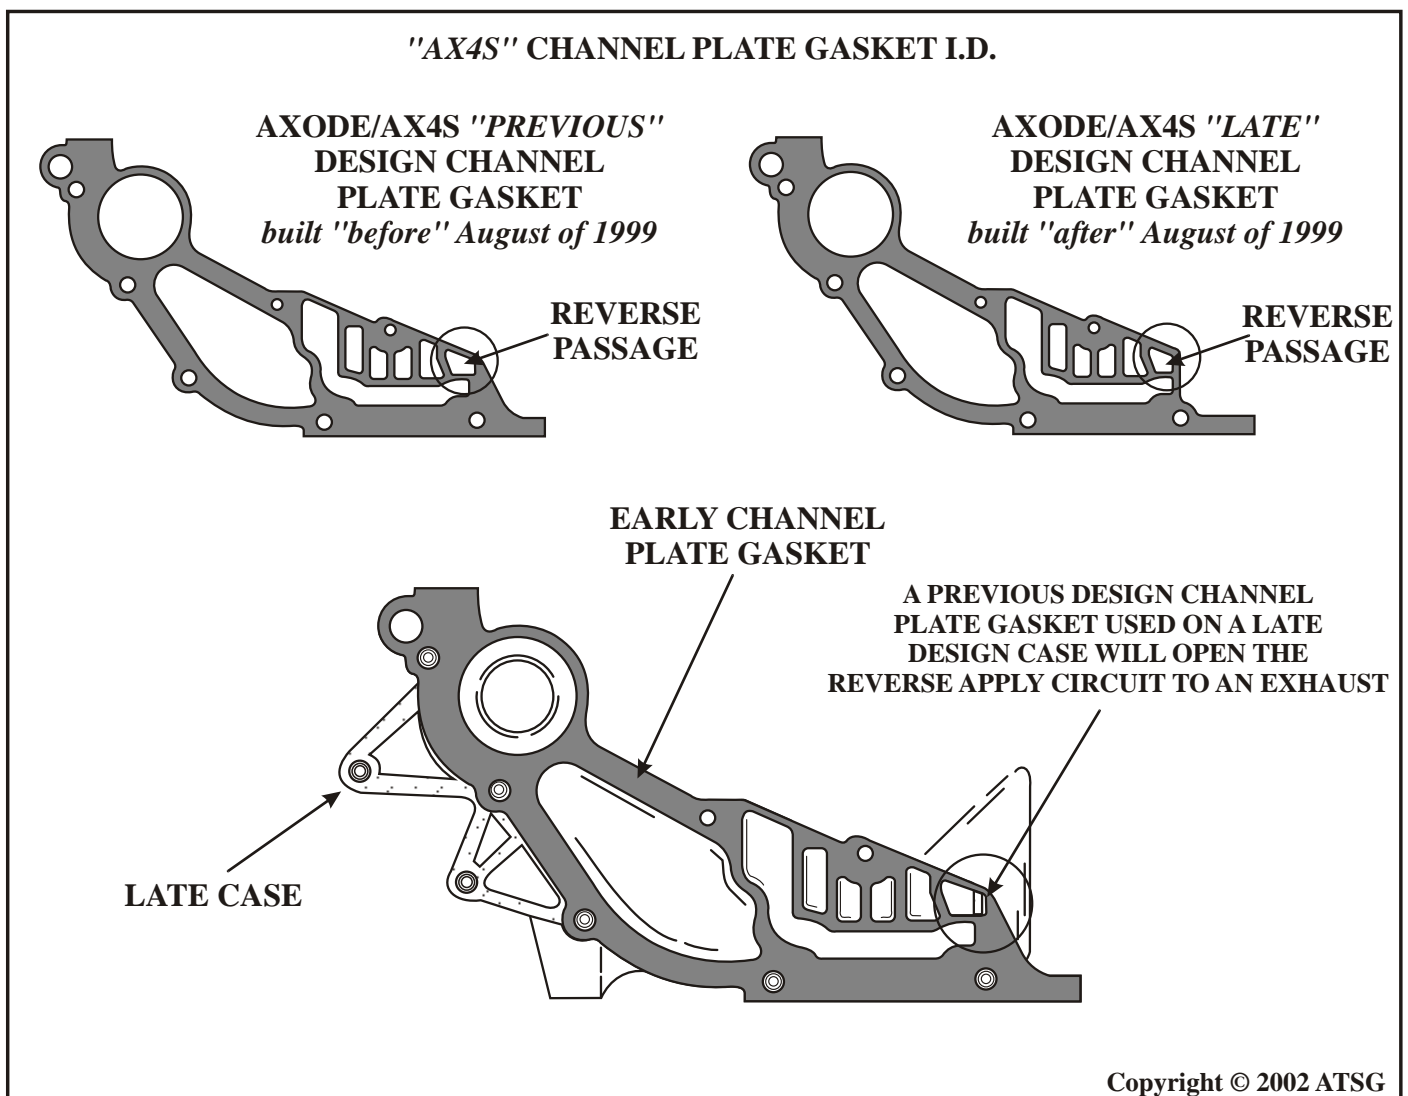
CAUSE: The cause may be, that the *Previous Design* Channel Plate Gasket, was used on a *Late Design* case as shown in Figure 1. When this happens, Reverse apply pressure will be exhausted back into the case because of the gasket hanging over the case casting.

CORRECTION: AX4S-Refer to Figure 1 to identify the correct Channel Plate Gasket for the application of vehicle you are working on.
AX4N-Refer to Figure 2 to identify the correct Channel Plate Gasket for the application of vehicle you are working on.

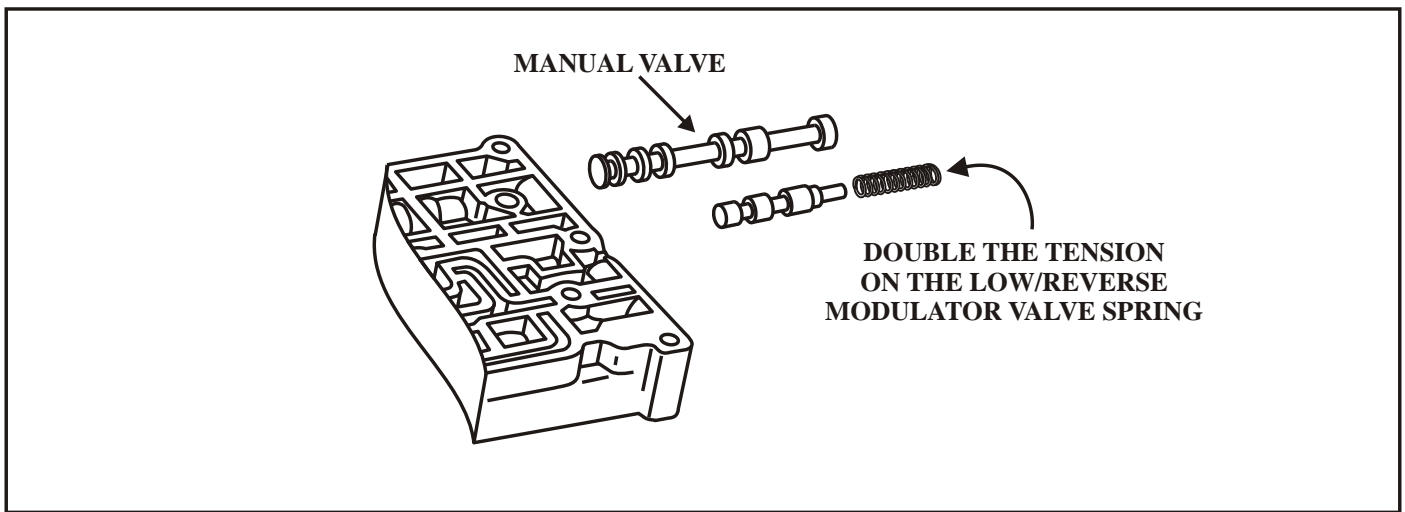
Figure 1

CAUSE: One reason could be a timing problem whereby the Direct Clutches are applying before the Low Reverse Clutch applies. With the Direct Clutches on first, the gear train begins to spin, when the Low/Reverse Clutch finally applies, reverse is engaged harshly as it stops the gear train from spinning. One possible reason for the late Low/Reverse Clutch apply is a weak spring on the Low/Reverse Modulator Valve, which is the valve next to the Manual Valve (See Figure 1).

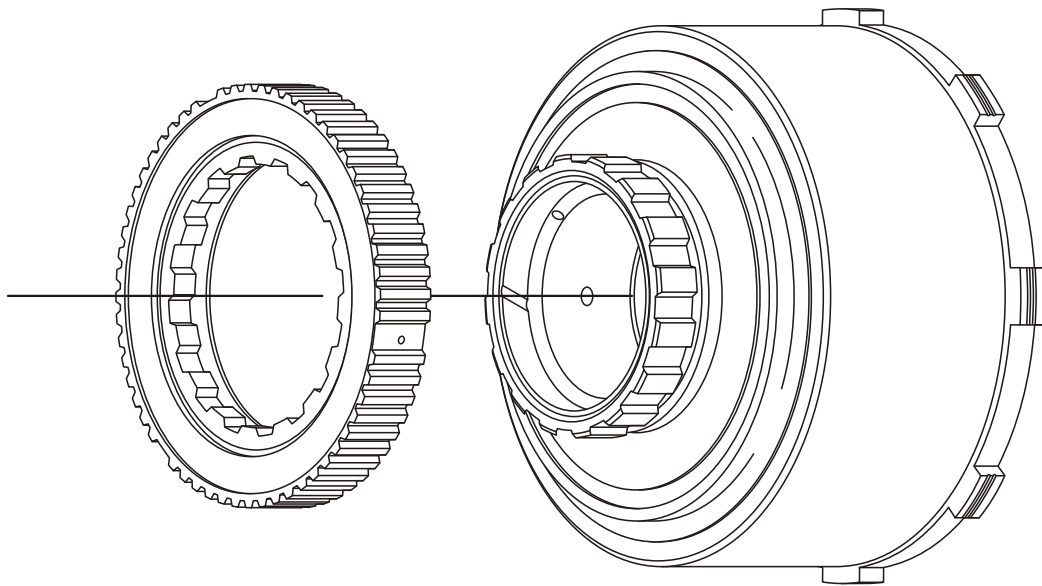
Figure 1

COMPLAINT: Some Ford Motor Company vehicles equipped with the 4R100 transmission may exhibit premature failure of the newly introduced Intermediate "Diode" Freewheel device that was installed in model year 2001 and illustrated in Figure 1.

CAUSE: The cause may be, more than expected load factors.

4R100 INTERMEDIATE "DIODE"

CORRECTION: The Intermediate "Diode" is ***no longer serviced*** by Ford Motor Company. The part number now supercedes to all of the previous design level parts, which include the direct clutch housing, intermediate sprag assembly, outer race to direct drum thrust washer, and the intermediate friction plates. All of the previous design level parts are illustrated in Figure 2, along with the OEM part numbers. The intermediate frictions must be replaced because the tooth count on the outer race between the diode and the sprag are different.

Special Note: ATSG recommends replacing the Intermediate "Diode" during service, even if it has not yet failed, to protect yourself from possible future failures.

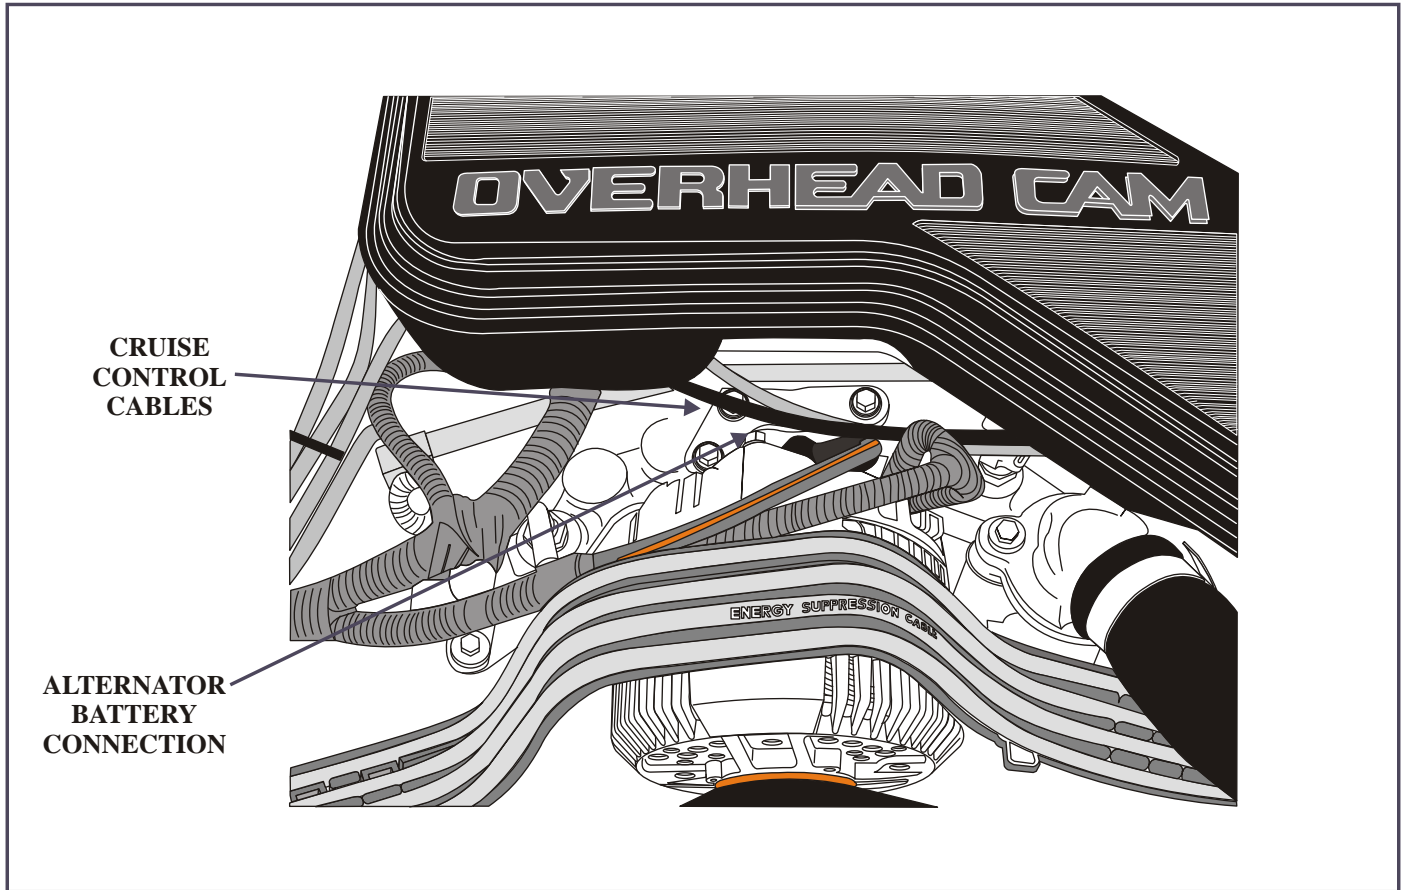
Figure 1

- COMPLAINT:** A Ford vehicle comes into the shop with a complaint of the digital speedometer indicating 20 MPH with the engine running in Park and miles are accumulating on the odometer. Applying the brakes causes the speedometer reading to drop to zero. When a scan tool was connected to the vehicles diagnostic connector, miles per hour on the scan tool read zero even though the speedometer read 20 MPH. The miles per hour reading on the speedometer will fluctuate with throttle opening.

- CAUSE:** One of the cruise control cables that are routed too close to the back of the alternator had rubbed through and was shorting out on the alternators battery connection. (Refer to Figure 1)
As a result of this shorting out, one or more diodes on the rectifier bridge inside the alternator was allowing a large amount of "AC Ripple" into the vehicles electrical system. The speedometer picked this "Ripple" up and indicated vehicle speed and mileage added to the odometer but the PCM was not affected therefore the scan tool indicated NO vehicle speed.
"AC Ripple" can best be described as an AC voltage signal "piggybacking" on a level of DC voltage which causes interference with other electrical systems in the vehicle.

FORD 4R70W
ERRATIC SPEEDOMETER OPERATION

- CORRECTION:** In most cases the alternator and the cruise control cable will need to be replaced. Make certain the cruise control cable and the back of the alternator have adequate clearance between them.

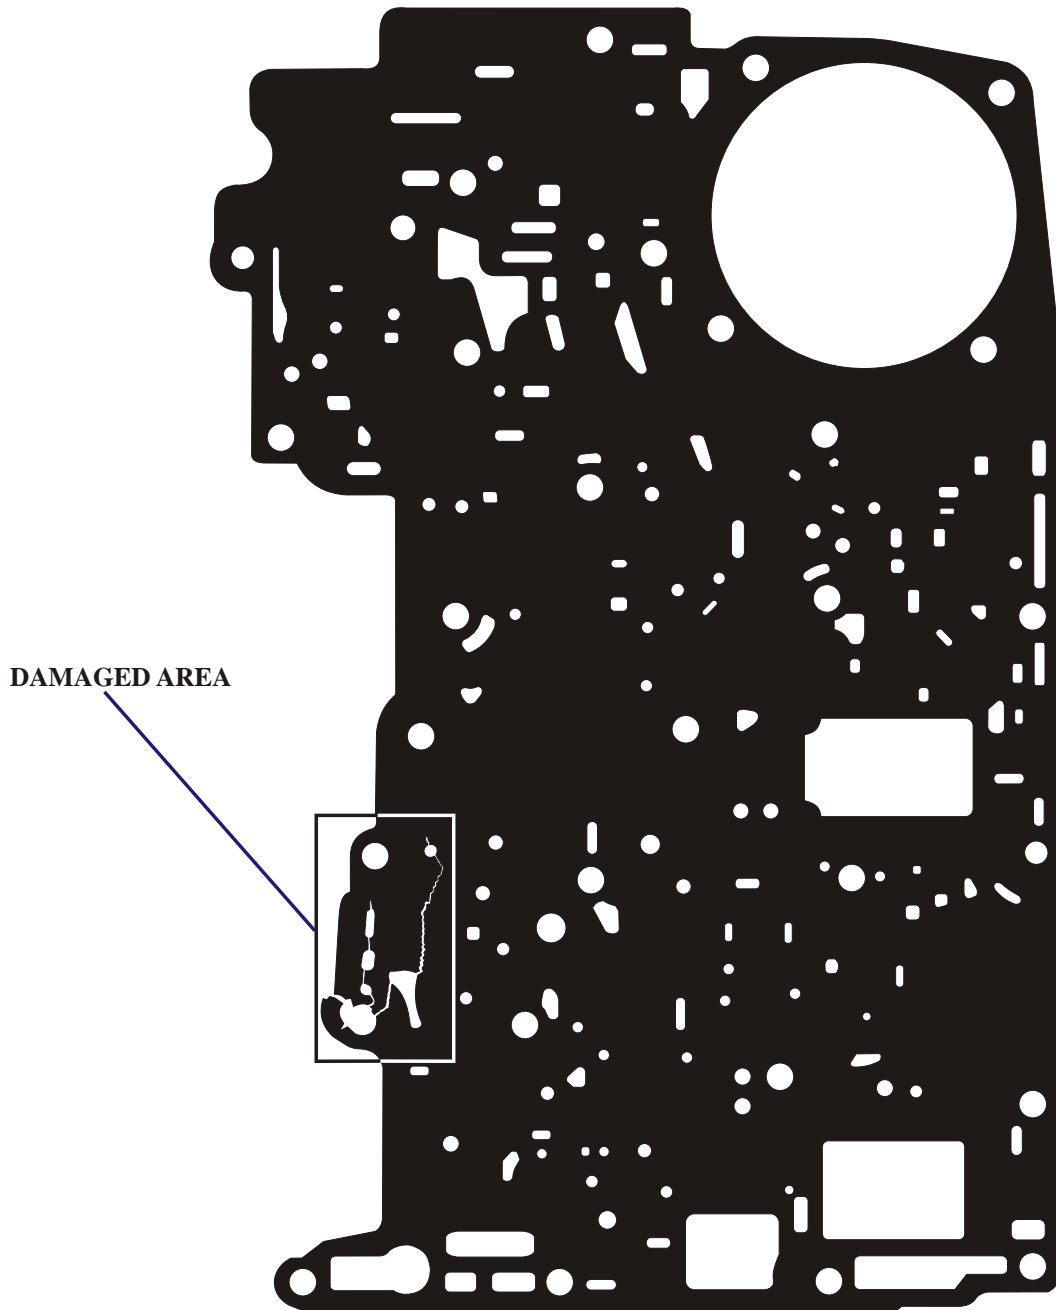
Figure 1

CAUSE: The upper valve body gasket has blown out along the edge right above shift solenoid #2 as shown in figure 1. The gasket area that is damaged is located directly over the line pressure and Shift Solenoid #2 oil passages as illustrated in figure 2. The gasket appears to have been over-tightened. Apparently, this condition leads to the storage of the above codes, which results in a *Failure Mode Effects Management (FMEM)* condition which will blow the already weakened gasket out resulting in the above complaints.

FORD 4R44E/55E
VALVE BODY GASKET BLOW OUT

CORRECTION: It has been ATSG's experiences that this gasket problem seems to only occur on 1999 and later models, and that the only repair necessary is to replace the valve body gaskets and torque the valve body to factory specifications which is 71-97 in lbs (8-11 N-m).

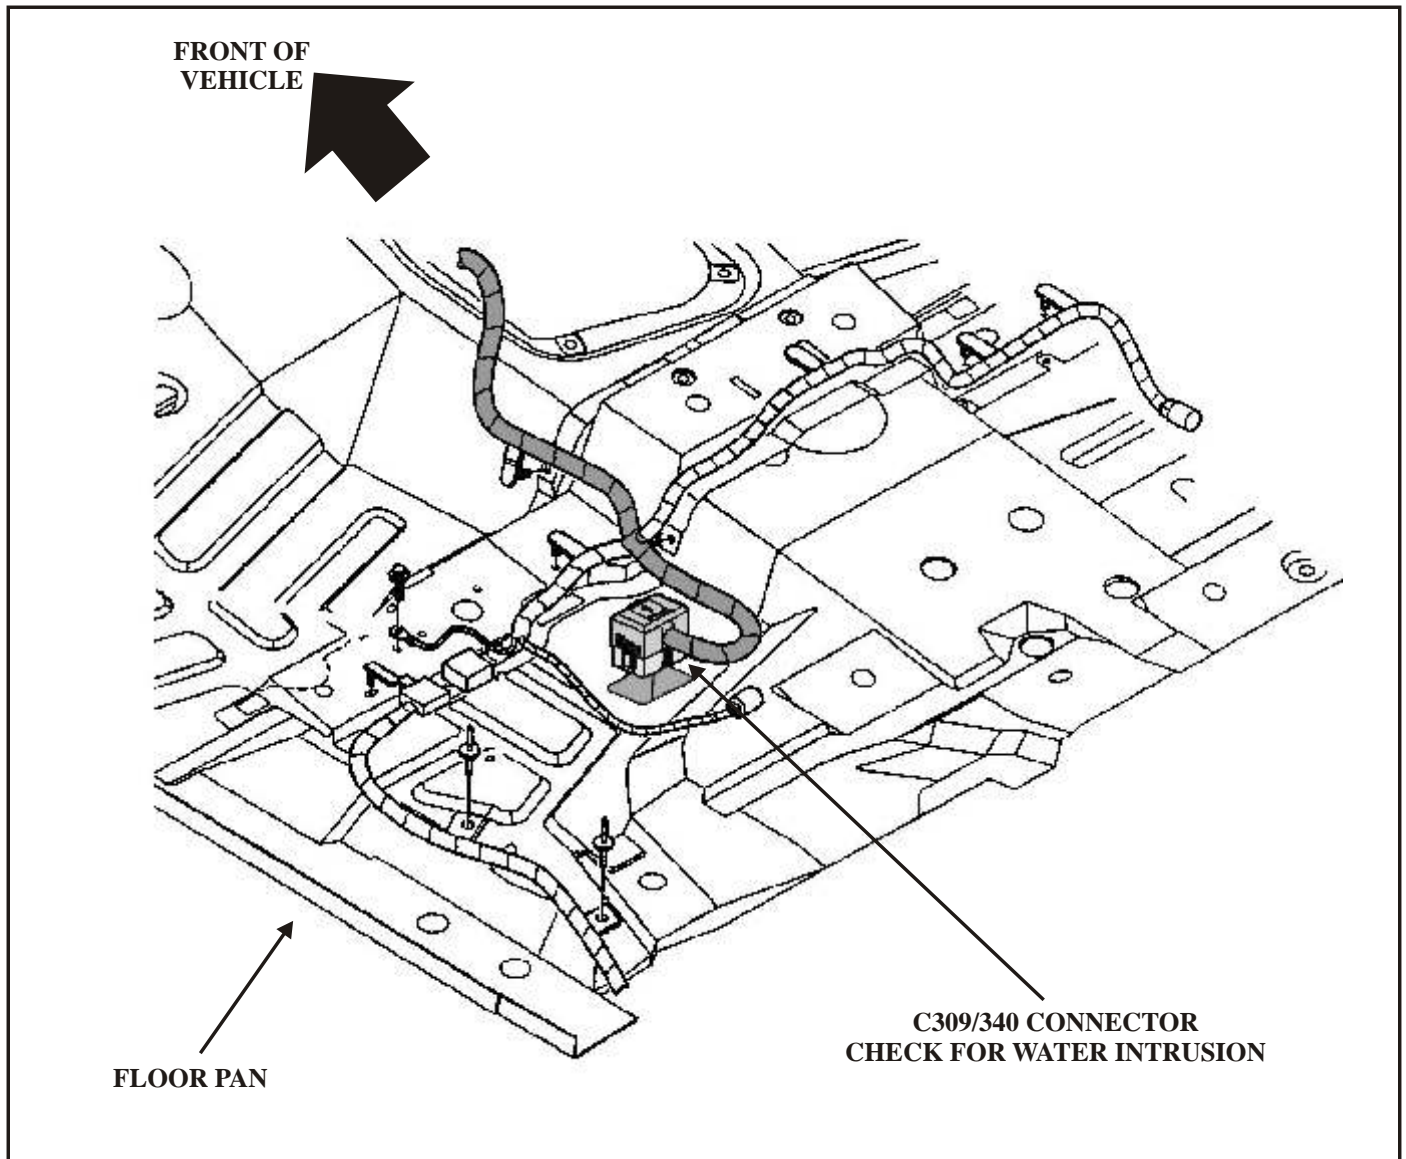
Figure 1

- COMPLAINT:** Some 2000-2001 Ford Ranger Trucks built before January 2, 2001 may exhibit delayed or harsh upshifts accompanied by an erratic or inoperative speedometer with DTC P0500, P0501 or P0503 VSS codes stored.
In addition to the above complaints, the ABS warning lamp will be illuminated along with associated ABS system codes. The vehicle may also exhibit a rough idle condition with driveability codes P0176 and P1721 stored.

- CAUSE:** A deteriorated weather pack seal at the C309 connector (2000 models) or the C340 connector (2001 models), located under the drivers seat, illustrated in figure 1, has allowed water intrusion into the connector resulting in corrosion of the various circuits contained in these connectors causing the above complaints.

**2000-01 FORD RANGER
HARSH/DELAYED SHIFTS**

- CORRECTION:** Disconnect the above mentioned connector and verify that water intrusion has occurred. Next, determine the extent of the damage the connector terminals have sustained. If the connector terminals are in good condition, dry the connectors out, and apply a liberal amount of dielectric grease to the connectors. Acquire from Ford parts department, a new Rubber Connector Boot and Plastic Connector Cap and install them.
If terminal damage has occurred, the terminal ends will have to be replaced which are also available from Ford parts department and will require an extensive soldering operation in order to insure a proper connection.
Figure 2 shows the 2000 Ranger C309 connector and its terminal and circuit identification, while figure 3 illustrates the 2001 Ranger C340 connector information.

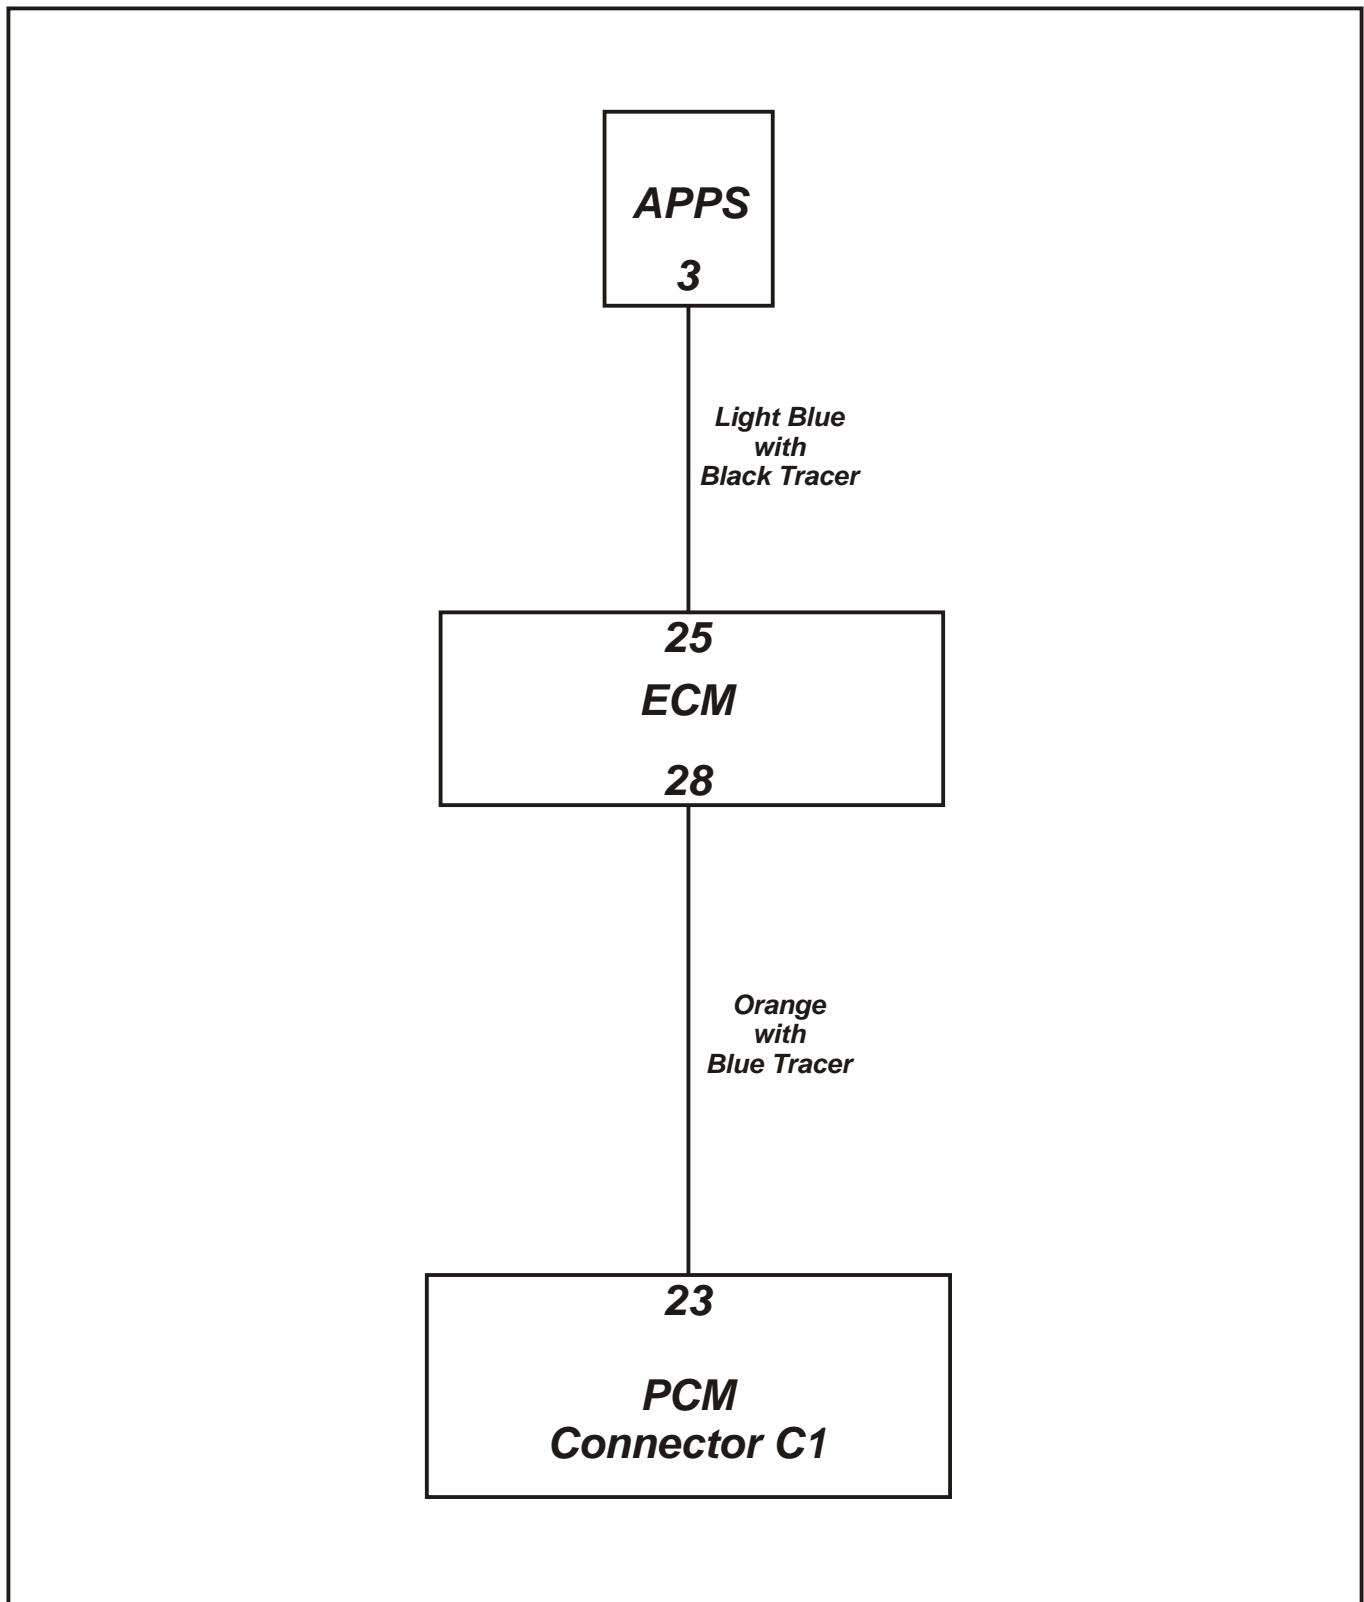
Figure 1

CAUSE: There are many possibilities such as a malfunctioning brake switch or brake support bracket. Temperature sensors, alternators, throttle position sensors, vehicle speed sensors to name a few. Chrysler has even issued a reprogramming procedure (Bulletin #18-02-99) for 1996 and later vehicles which compensates for alternator or TPS noise correcting this complaint. Reports of TCC shuttle has also occurred while driving with a scanner is attached to the data link connector. Unplug the scanner and the problem goes away. One other possibility that may go overlooked is a defective ECM with 1998 and later vehicles. These vehicles are equipped with an Accelerator Pedal Position Sensors (APPS) rather than a TPS. The APPS sends a typical TPS signal to the ECM and the ECM sends that signal to the PCM. Should the ECM malfunction, the incorrect signal is received by the PCM causing the shuttle shift complaint (See Figure 1).

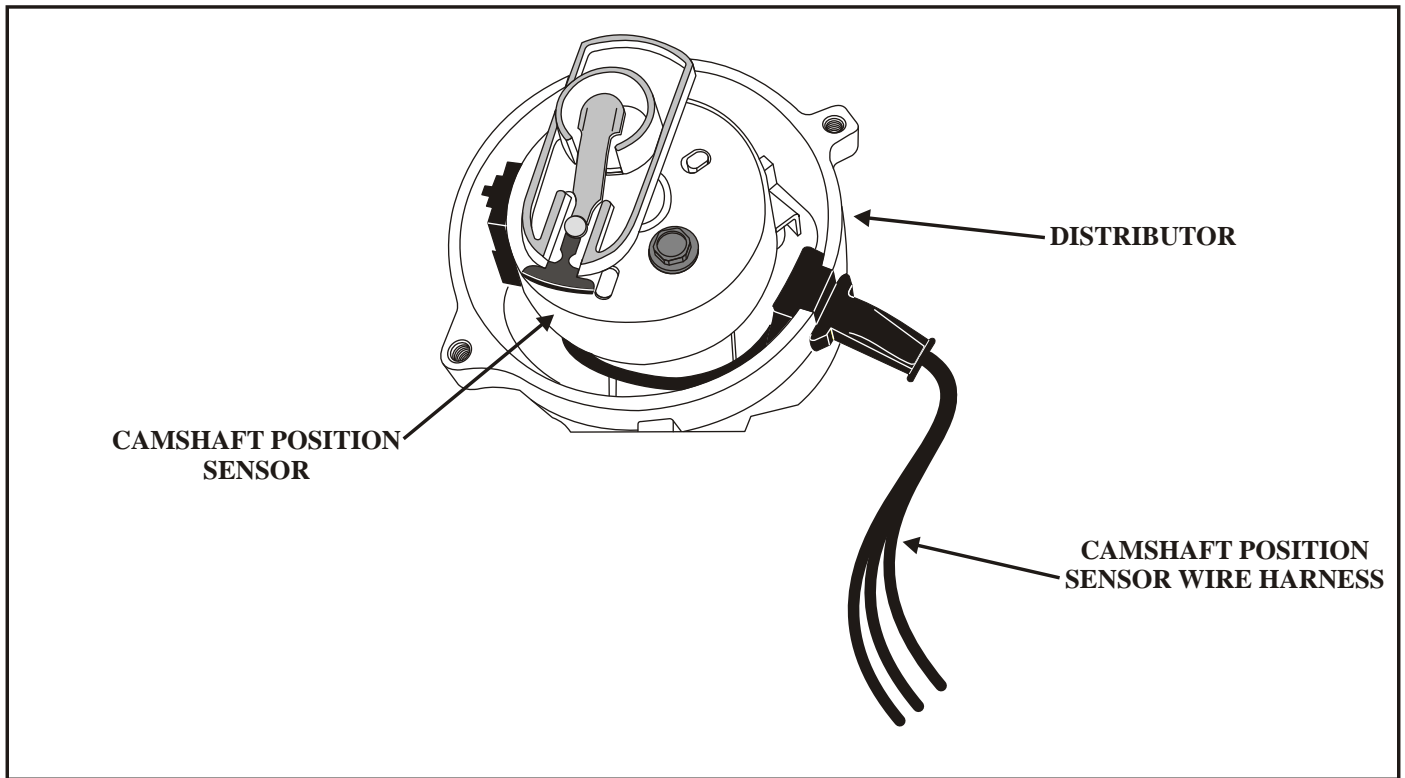
Figure 1

CAUSE: The cause is a faulty Camshaft Position (CMP) Sensor which is not bad enough to store a code, but produces the "double bump" shift feel and the engine miss. The CMP Sensor is a Hall Effect Sensor that is located inside the distributor as illustrated in figure 1.

1991-99 JEEP WITH GAS ENGINES DOUBLE BUMP SHIFT

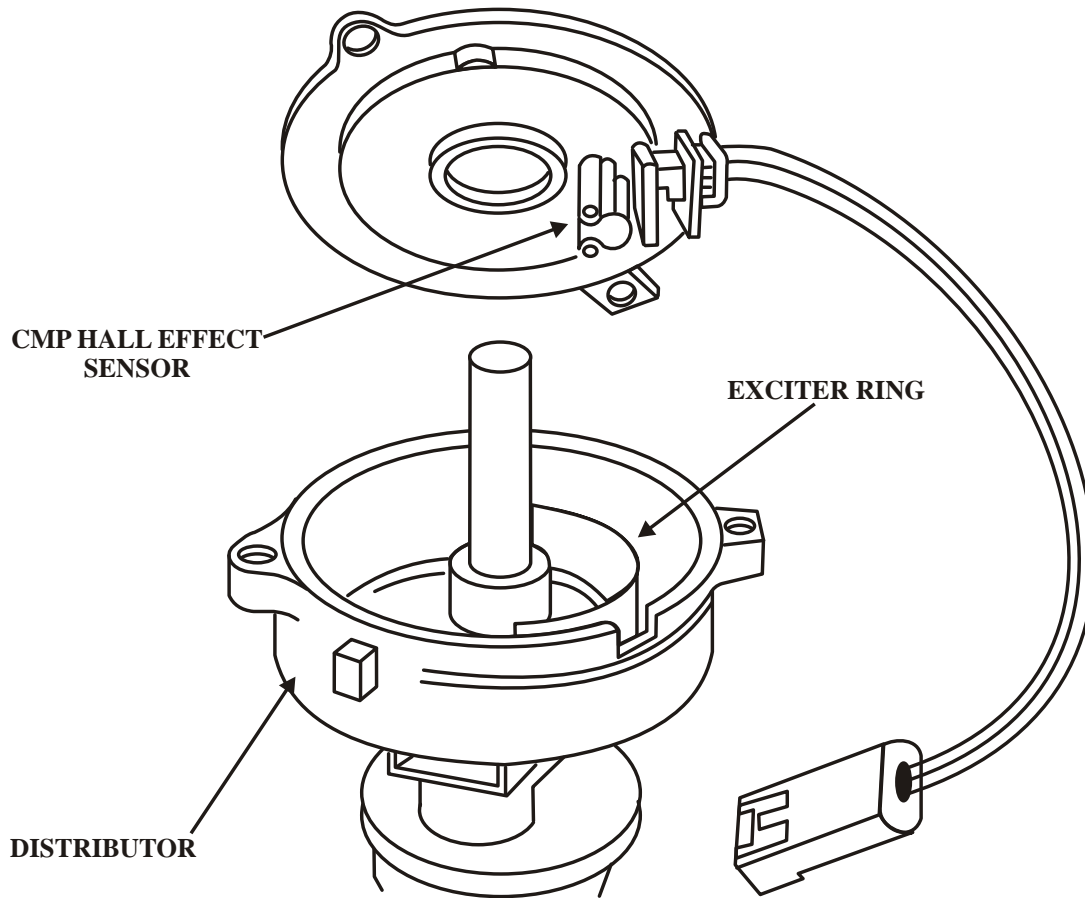
Figure 5

The illustration of the distributor in figure 5 shows that the CMP Sensor exciter ring only goes half way around the distributor base, which creates the high toggle signal per 360° of crankshaft rotation, and a low toggle signal for the next 360° of crankshaft rotation as illustrated in the oscilloscope waveform patterns in figures 3 and 4.

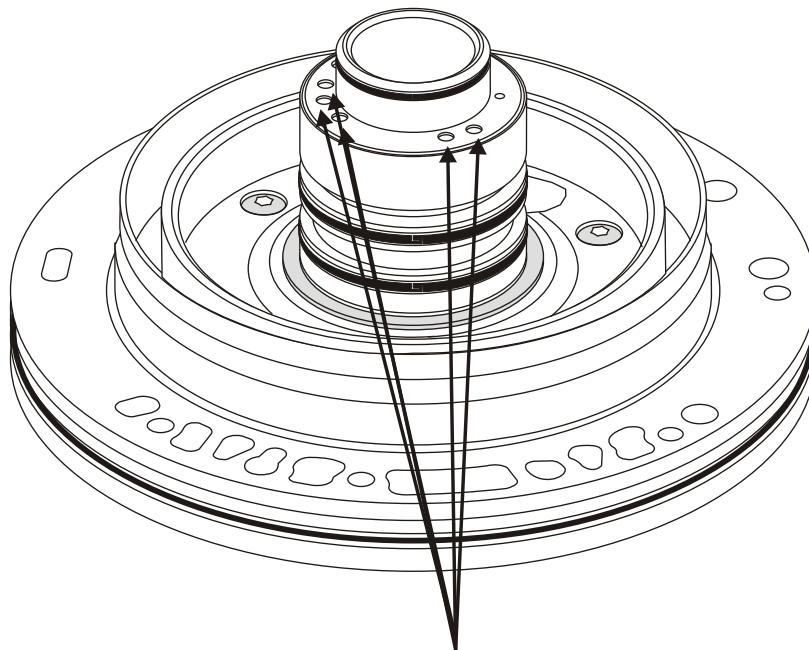
Figure 3

**MAKE CERTAIN THE SIX STAKED IN
CUP PLUGS ARE PRESENT AND NOT
LEAKING**
