Technical Service Information

THM 4L80-E 1-2 SLIDE BUMP

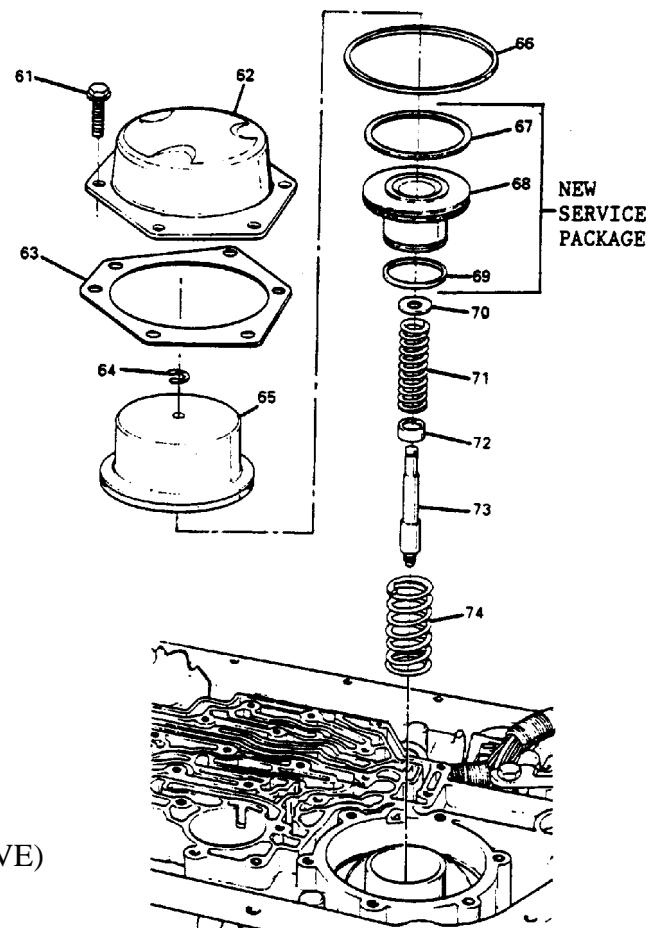
- COMPLAINT:** Some THM 4L80-E transmissions may exhibit a 1-2 slide and/or harsh double bump feel.
- CAUSE:** The cause may be, fluid leaking past the 1-2 accumulator piston seals. The 1-2 accumulator piston is located inside of the reverse servo piston (See Figure 1).
- CORRECTION:** Install a new design 1-2 accumulator piston and ring assembly to eliminate this condition. The new service package is available under OEM part number 8680929. Refer to Figure 1 for assembly.
