Technical Service Information

VOLVO AW55-50SN NEUTRAL BANG ON TAKE-OFF

07-25
Page 1 of 1

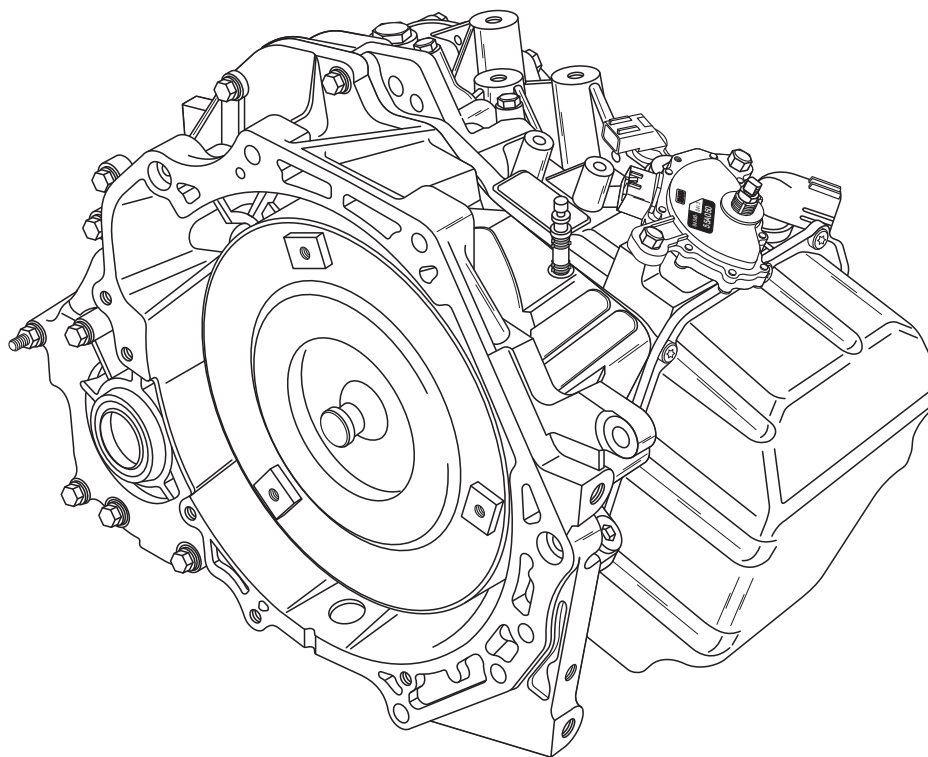
Figure 1

COMPLAINT: Some Volvo models equipped with the AW 55-50 SN transaxle, as shown in Figure 1, may exhibit a neutral bang on take-off before or after overhaul.

CAUSE: The cause may be, that when the accelerator pedal is depressed rapidly, the customer may feel a re-engagement of the C1 clutch on take-off because of a Transmission Control Module software issue.

CORRECTION: To correct this complaint, the TCM will have to be reflashed by a Volvo dealer, which will deactivate or de-sensitize this feature. TCM 012B Neutral Control Flash.

TCM UPGRADE NUMBER (Volvo).....30677036
