Technical Service Information

THM 4L80-E LOSS OF REVERSE WHEN HOT

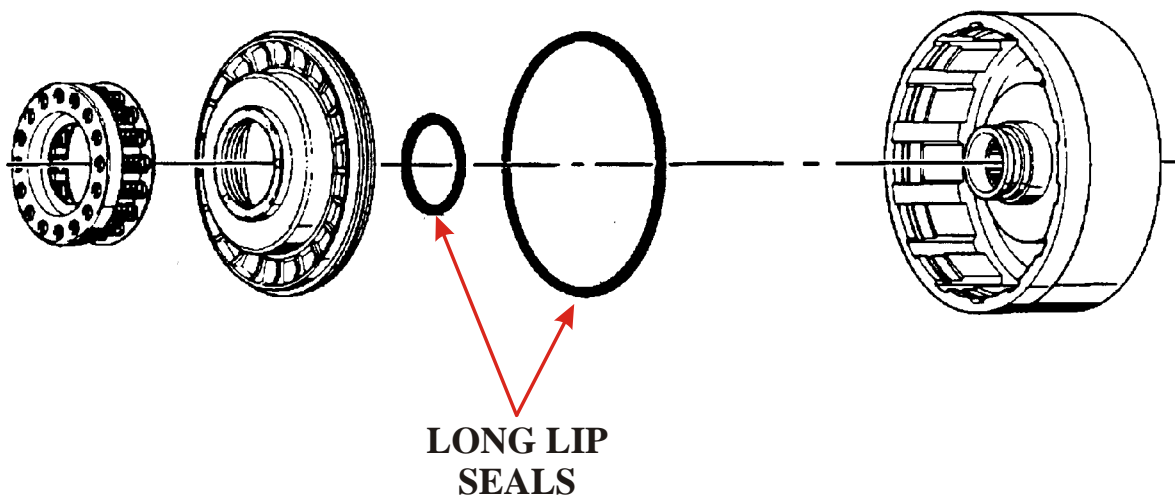
Figure 1

COMPLAINT: Vehicle has a good reverse until the transmission reaches full operating temperature, primarily after sustained highway speeds, and then displays no reverse.

CAUSE: The cause has been traced to the use of short lip seals on the direct clutch piston, causing the direct clutch not to apply when reverse is selected.

CORRECTION: Install LONG lip seals on the direct clutch piston when reconditioning the transmission, as shown in Figure 1. Also be sure to replace the solid Teflon sealing rings on the center support with white rings with Red speckles (See Figure 2). Always replace the center support feed bolt with a NEW one every time it is removed, and ensure that the center support is Fully drawn up against the case surface (See Figure 3).

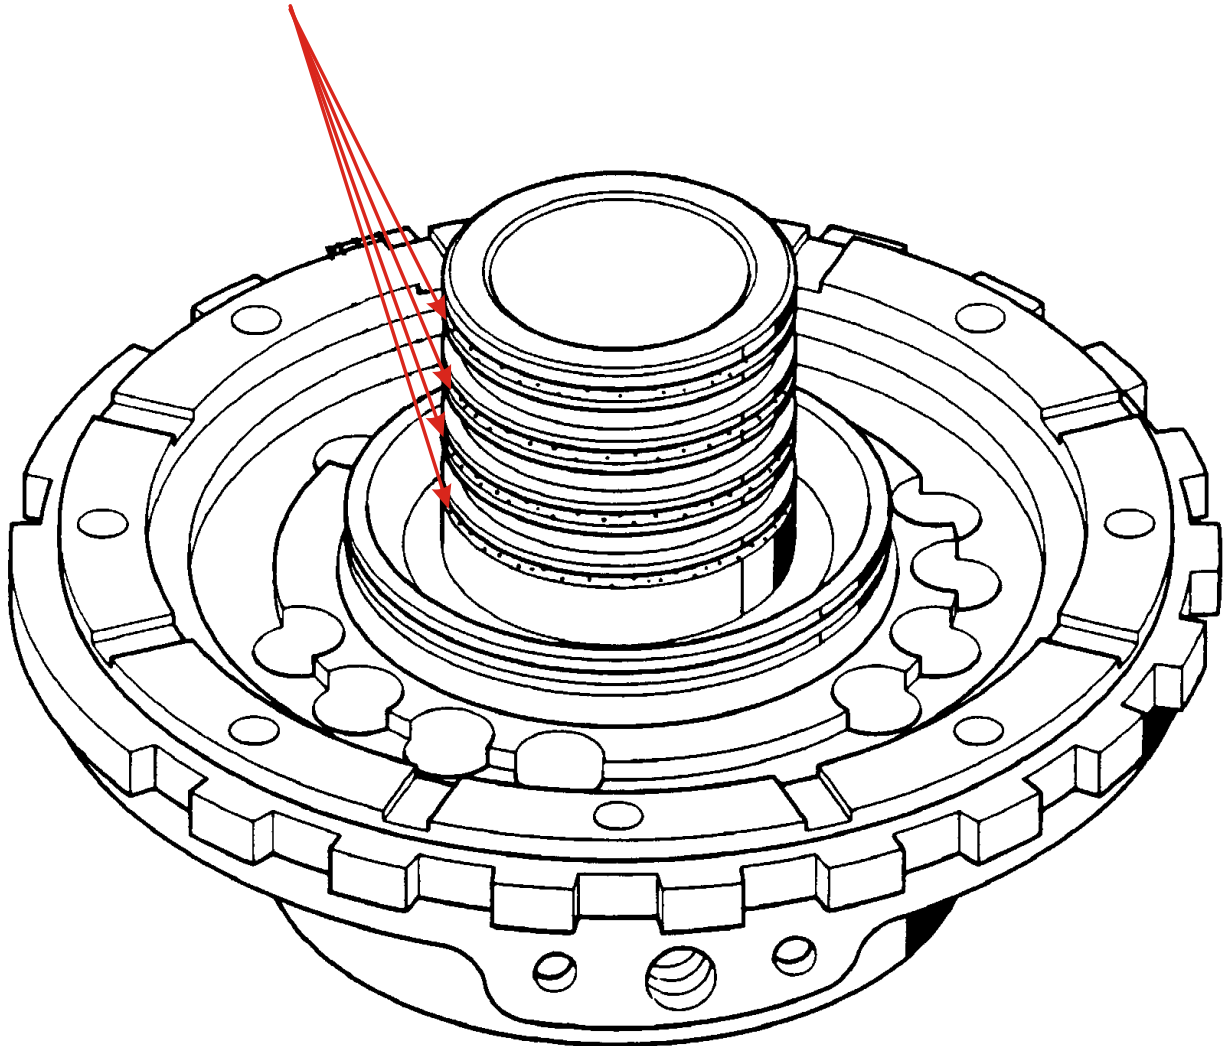
Figure 2

**CENTER SUPPORT SEALING RINGS MUST
BE WHITE WITH RED SPECKLES**

**THE WHITE WITH RED SPECKLES RINGS
HAVE A HIGHER GLASS CONTENT TO
REDUCE SHRINKAGE**
