Technical Service Information

THM 4L80-E HIGH LINE PRESSURE IN REVERSE

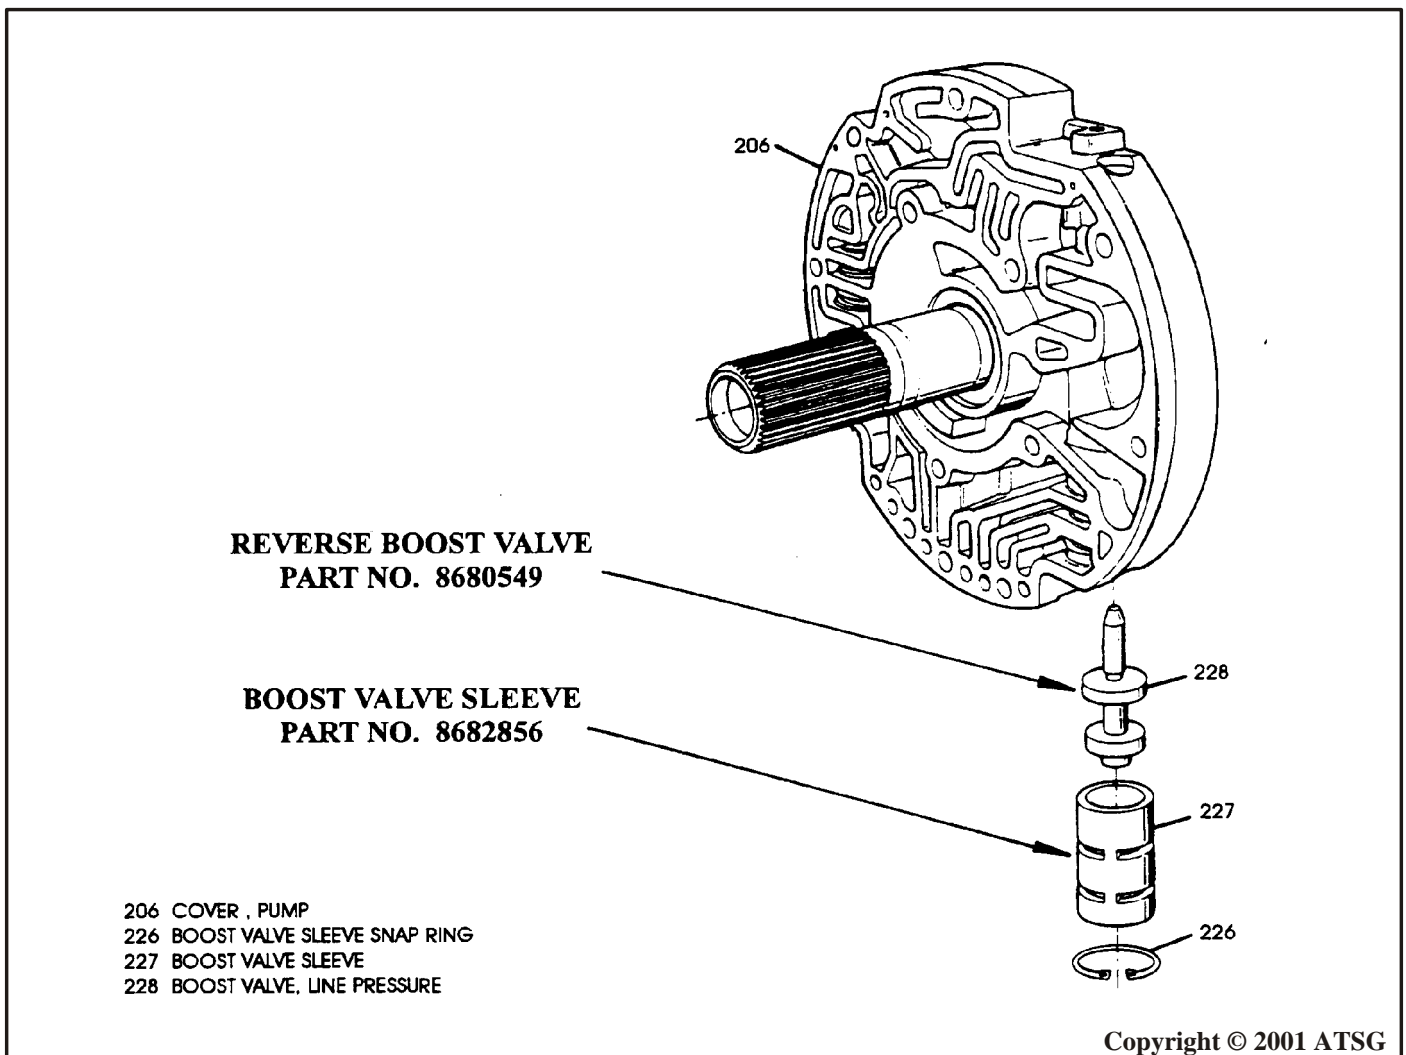
COMPLAINT: Before and/or after rebuild, the vehicle has a very high line pressure reading when the selector lever is in the Reverse position, and may repeatedly break direct clutch piston and/or reverse band assembly.

CAUSE: The cause may be, a worn boost valve sleeve and/or boost valve in the pimp assembly.

CORRECTION: Replace the Boost Valve and/or Boost Valve Sleeve, as necessary (See Figure 1). Parts are currently available from G.M. Service Parts, and part numbers are listed below.

Boost Valve Sleeve	8682856
Boost Valve, Line Pressure	8680549
