NISSAN RE4FO4A OR VILLAGER 4F20E SLIPPING OR NO 2ND GEAR

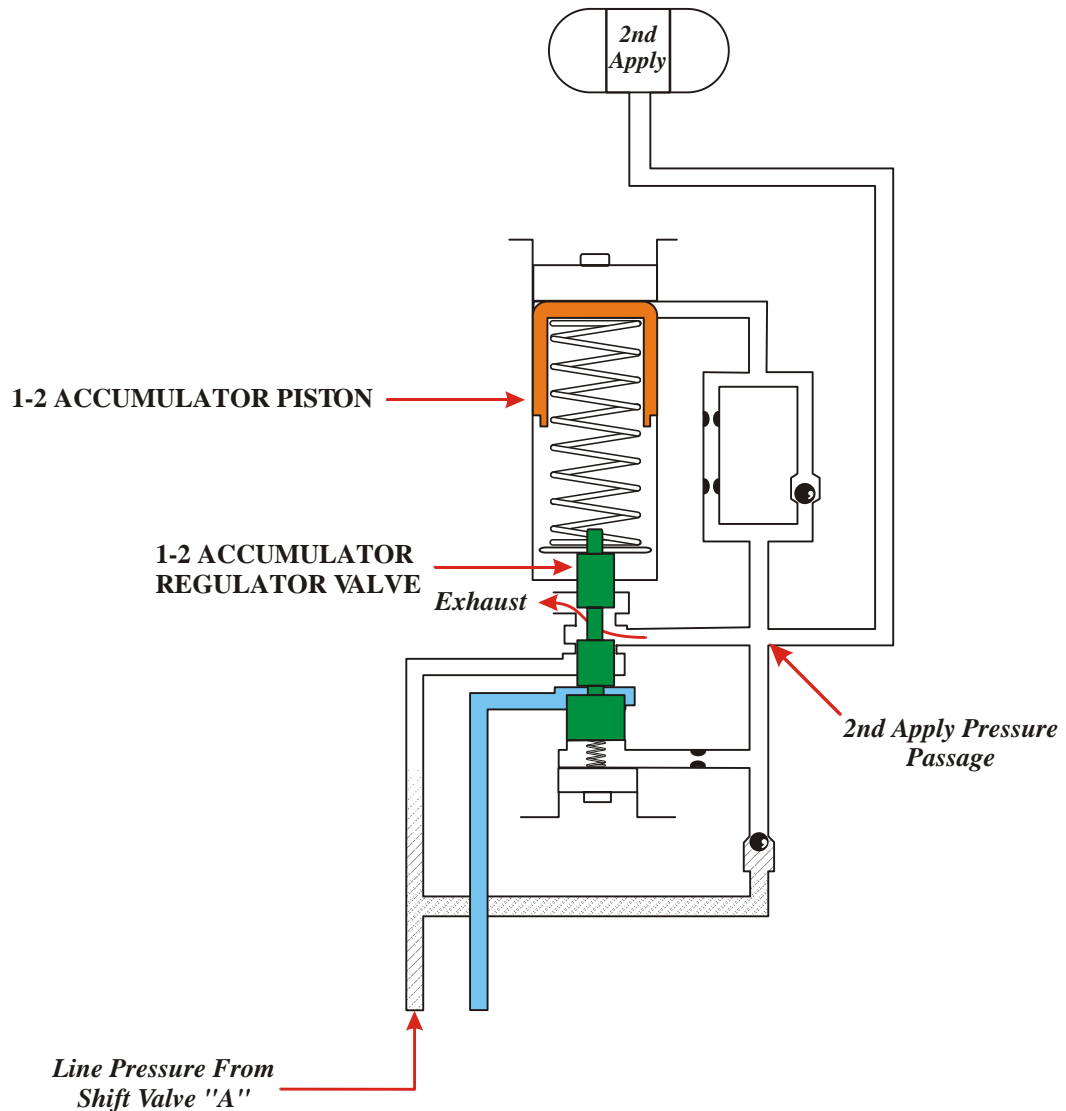
- COMPLAINT:** Before and/or after rebuild, the vehicle exhibits a condition of no upshift into second gear, or a slipping condition into 2nd gear.
- CAUSE NO. 1:** One cause may be insufficient spring tension on the 1-2 accumulator piston, or a stuck 1-2 accumulator regulator valve allowing 2nd apply oil to be restricted. Refer to Figure 1, for a description of the 1-2 hydraulic circuit with a stuck valve, or insufficient spring tension on the 1-2 accumulator piston. Refer to Figure 2, for a description of the 1-2 hydraulic circuit with sufficient spring tension on the 1-2 accumulator piston.

"NO" SECOND GEAR APPLY

If the 1-2 accumulator regulator valve is stuck as shown here, line pressure cannot pass through the valve and apply the servo. In addition, If the spring for the accumulator piston is too weak, 2nd apply pressure may allow the accumulator regulator valve to stroke toward the piston, and block oil coming from shift valve "A" allowing all apply oil to exhaust through the valve as shown by the arrow.

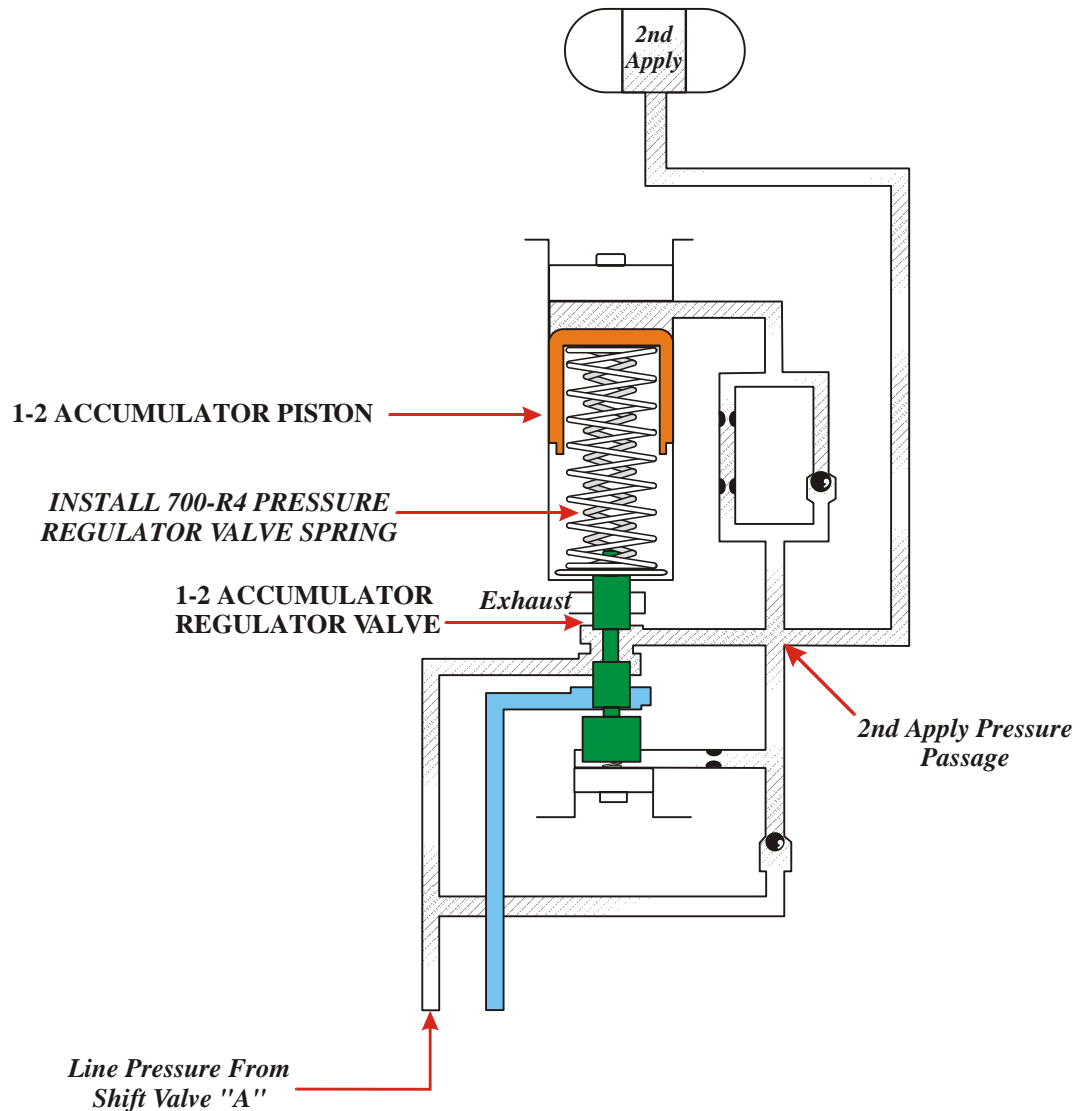
Figure 2

"GOOD" SECOND GEAR APPLY

With a 700-R4 pressure regulator valve spring installed inside the original 1-2 accumulator spring, the 1-2 accumulator regulator valve remains in the proper position (exhaust closed) and allows line pressure to flow to the 2nd apply side of the servo.

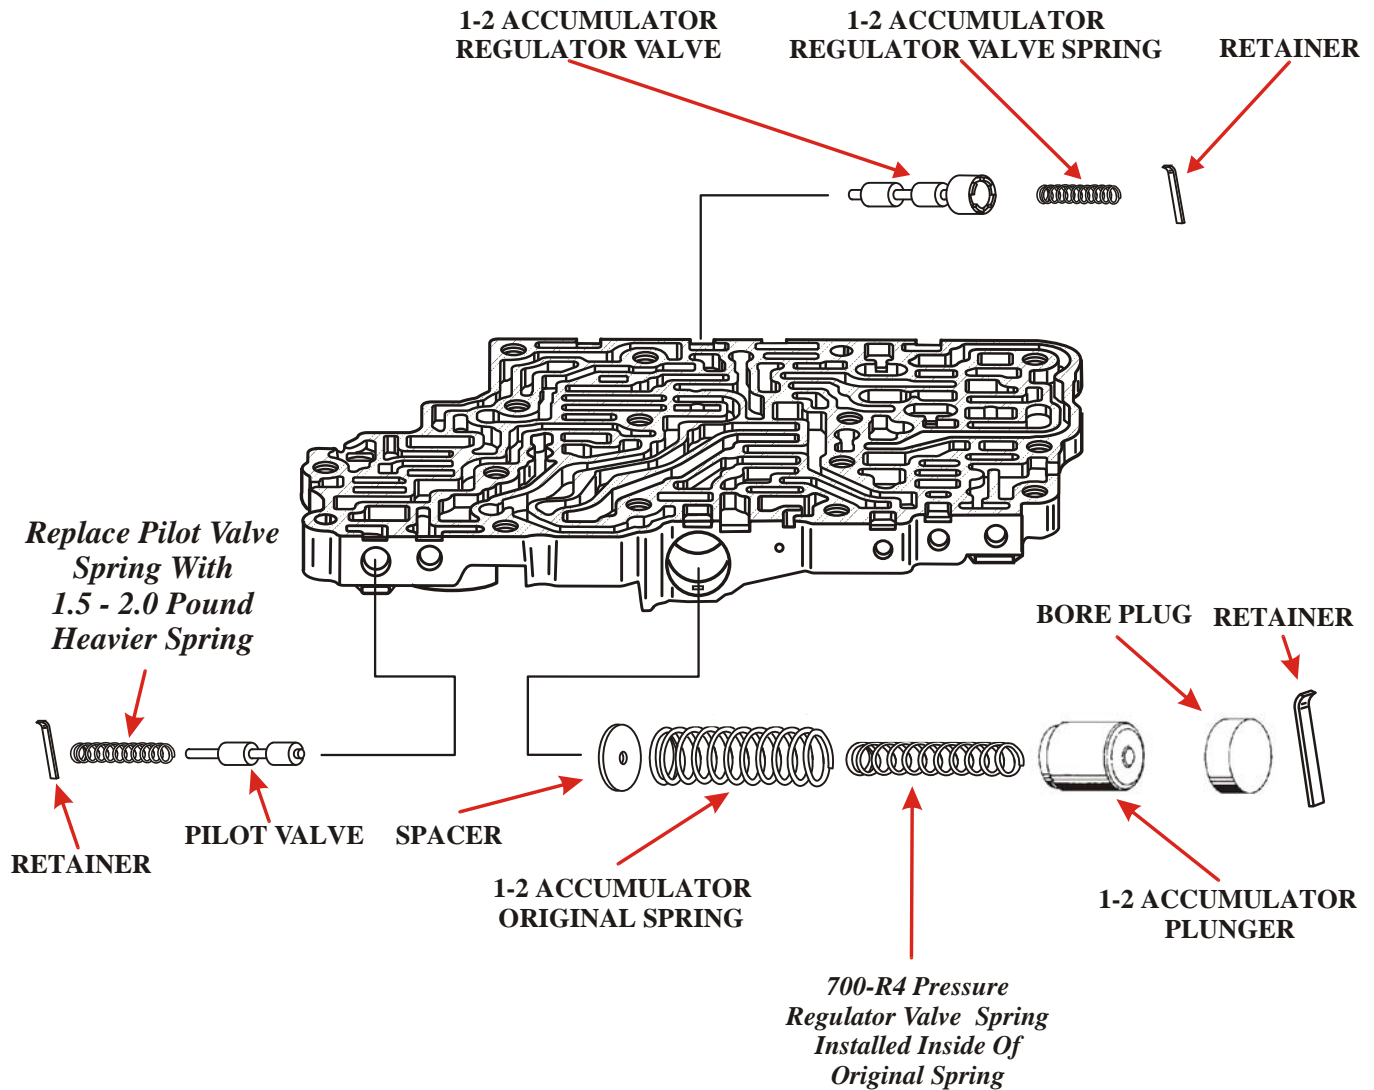
Figure 3

RECOMMENDED MODIFICATIONS

- CORRECTION NO. 1:** Add a pressure regulator valve spring from a 700-R4 inside of the original 1-2 accumulator spring as shown in Figure 3. Install a 1.5 - 2.0 pound heavier spring in the Pilot Valve line-up, as shown in Figure 3. Also install two 125C front planetary shims on the Pressure Regulator Valve, to increase line pressure, as shown in Figure 4. This will greatly increase transmission durability and reliability.

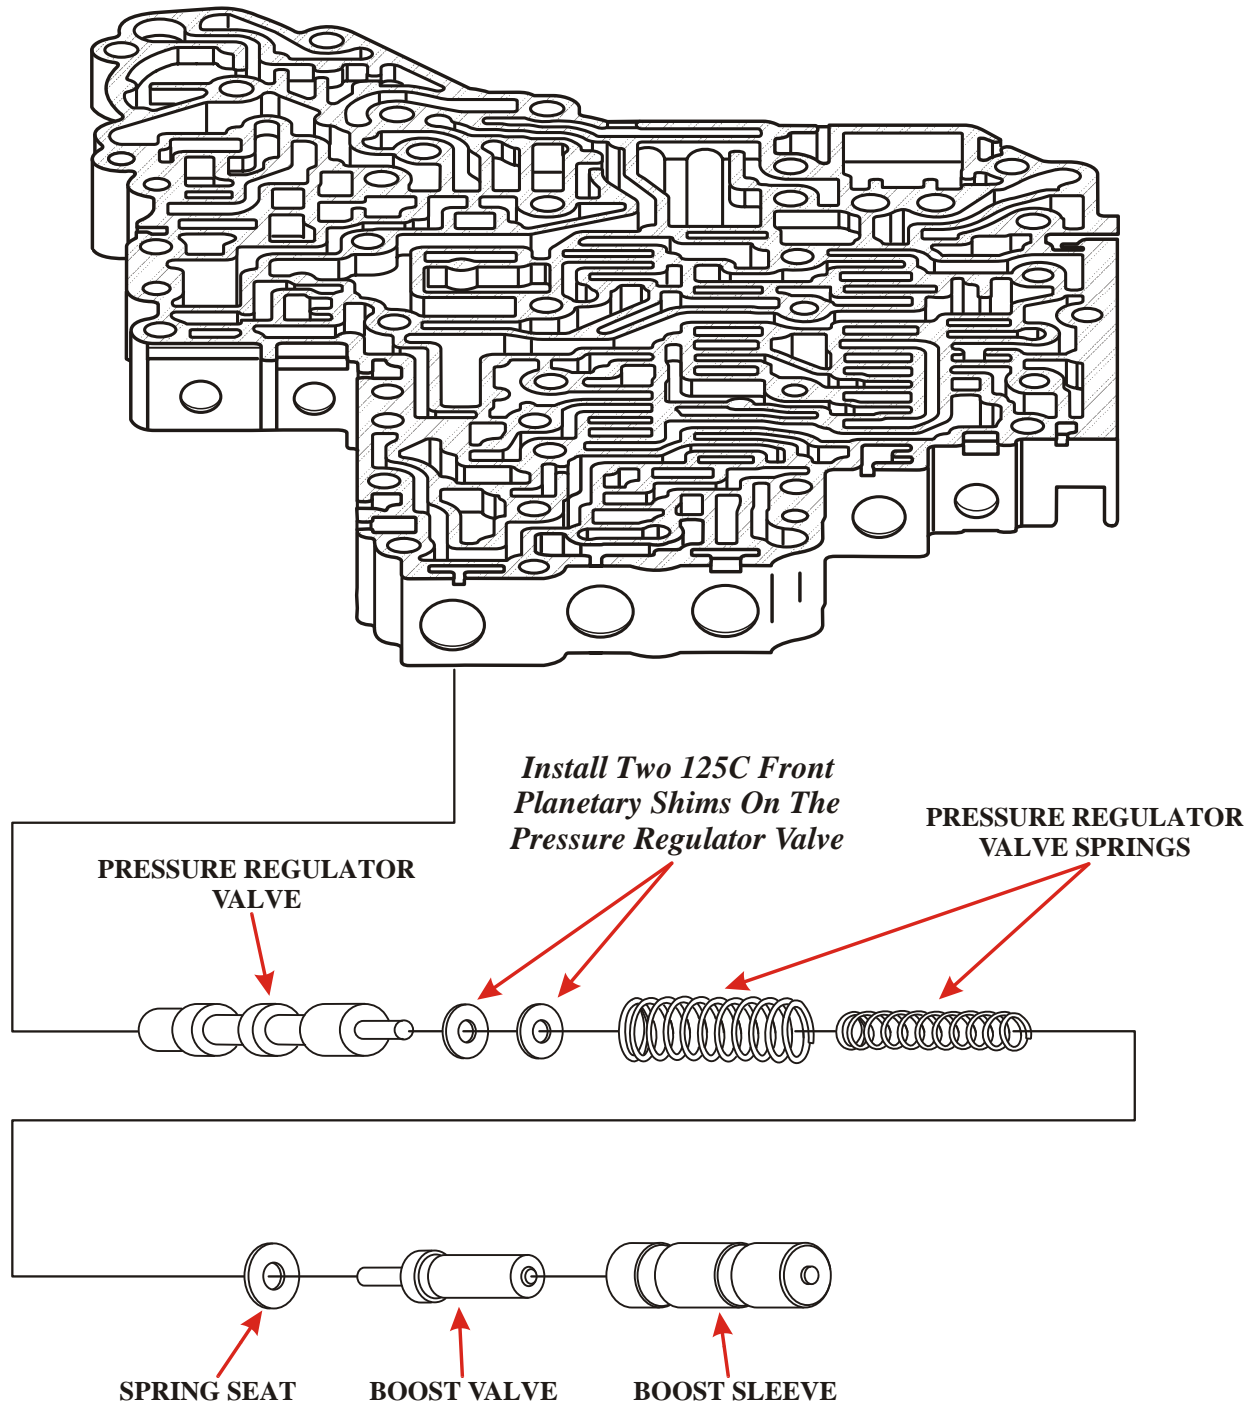
Figure 4

RECOMMENDED MODIFICATIONS

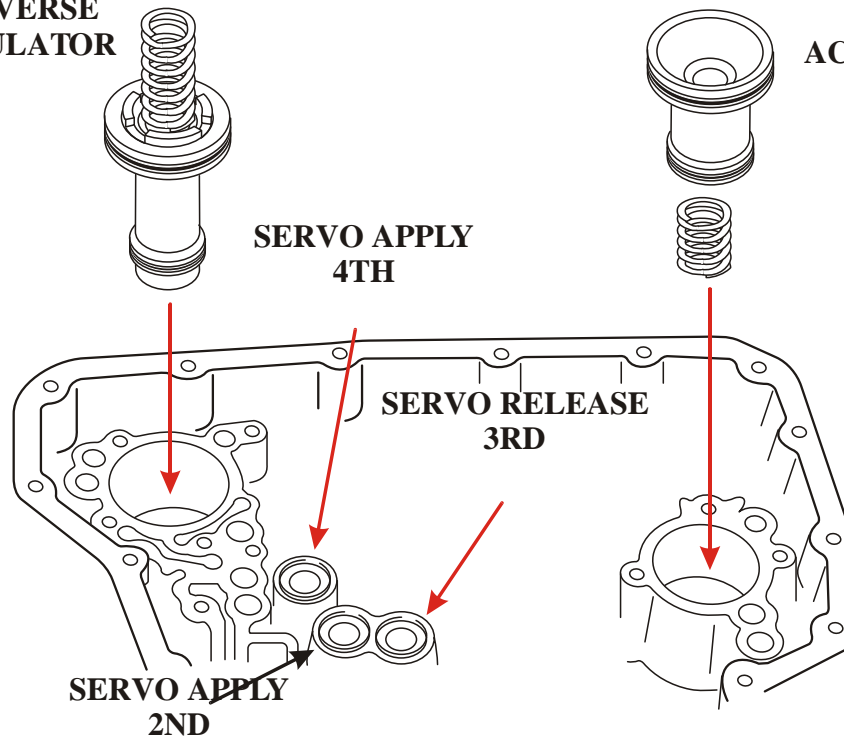
- CAUSE NO. 2:** Another cause may be the 2/4 servo return spring switched with the N/D accumulator spring. If the N/D accumulator spring is installed in the location for the 2/4 servo return spring, the N/D accumulator spring will coil bind before the 2/4 servo gets a chance to fully apply the band resulting in a no second gear condition. Refer to Figure 5 for spring specifications and proper placement of the 2-4 servo return spring and the N-D accumulator spring.

ACCUMULATOR SPRING IDENTIFICATION AND PROPER LOCATIONS

**THE N/D ACCUMULATOR
SPRING IS APPROX. 1.7" TO 1.9"**

**THE 3RD/REVERSE ACCUMULATOR
SPRING IS APPROX. 2.0" TO 2.2"**

**THE 2ND/4TH SERVO
SPRING IS APPROX. 1.2" TO 1.5"**

- CORRECTION NO. 2:** Refer to Figure 5 for spring specifications and place the 2-4 servo return spring and the N-D accumulator spring in their proper locations.
