"The Seminar to See for 2003" Technical Seminar

INDEX *Imports*

AUTOMATIC TRANSMISSION SERVICE GROUP

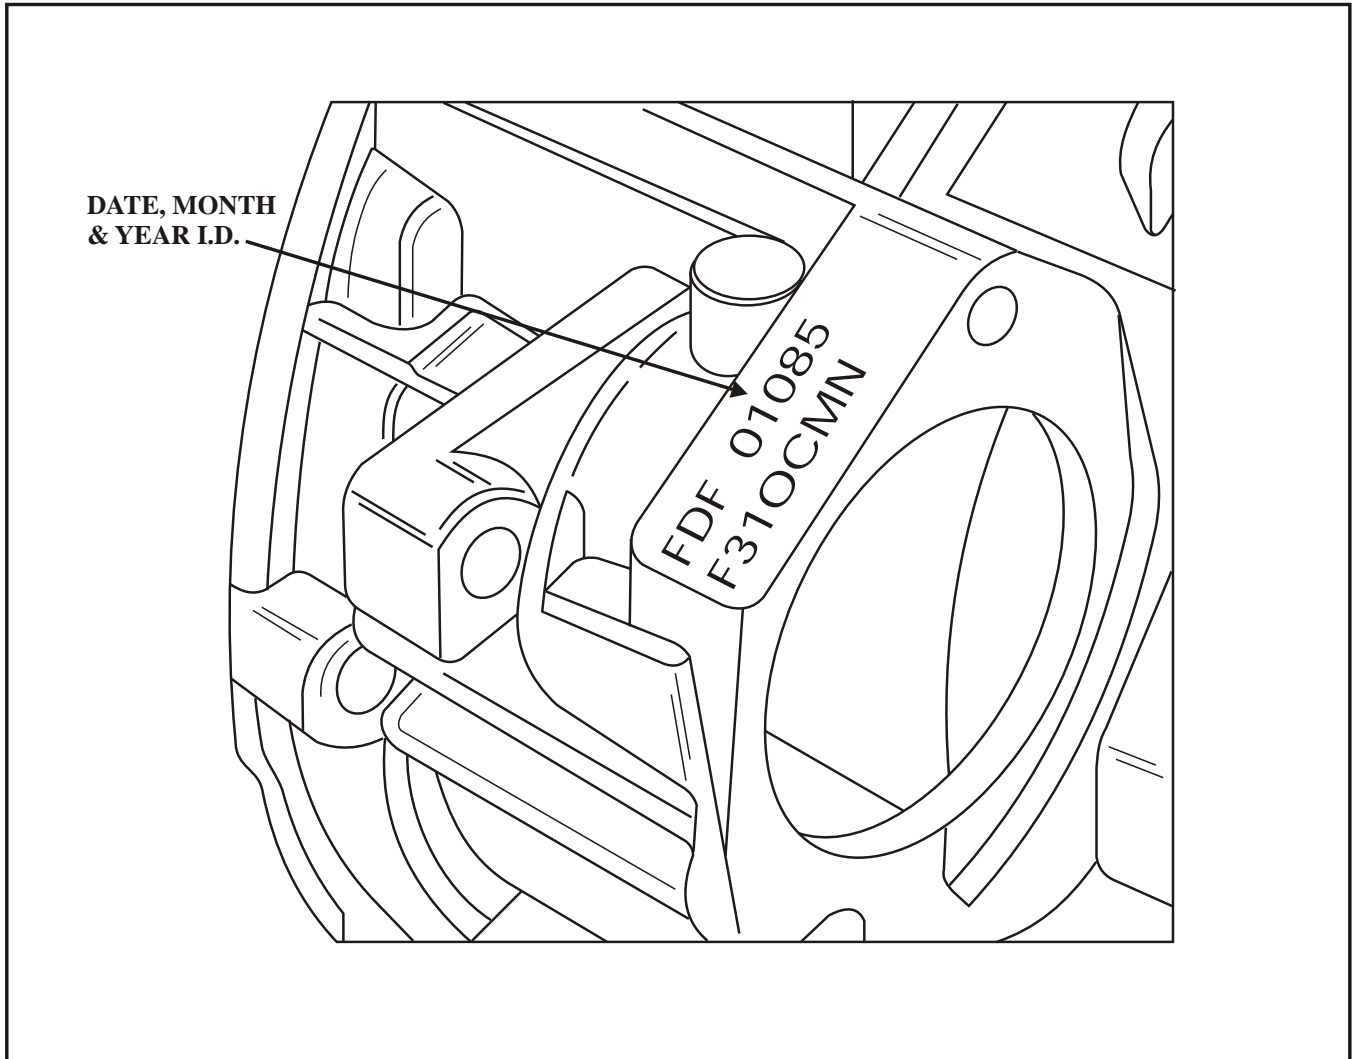
Figure 1

CAUSE: Some 1996 VW Jetta, Golf and Passat models equipped with the 01M transmission, and built between August 1, 1995 and December 19, 1995 have valve bodies that were assembled with **BROWN** bore plugs in three locations.
Check the transmission build date that is located on the transmission case indicated in the illustration in figure 1 in order to determine if your transmission falls into this complaint category.

CORRECTION: A service kit is available from Volkswagen that provides four new bore plugs that are **WHITE** in stead of the previous **BROWN** plugs. The kit also provides a new "Check Plug" washer and a replacement "Locking Collar" for the oil fill tube. The filter screen and pan gasket does NOT come in the kit, these items must be acquired separately. The plugs are secured by pushing them in so the lug aligns with the notch in the valve body, and then turning them clockwise ¼ turn.

Valve Body Bore Plug Repair Kit.....01M 398 998
Refer to Factory TSB.....3897-01
A Valve Body Bore Plug Service Kit will be available from Southeast Parts, check with your distributor for availability.

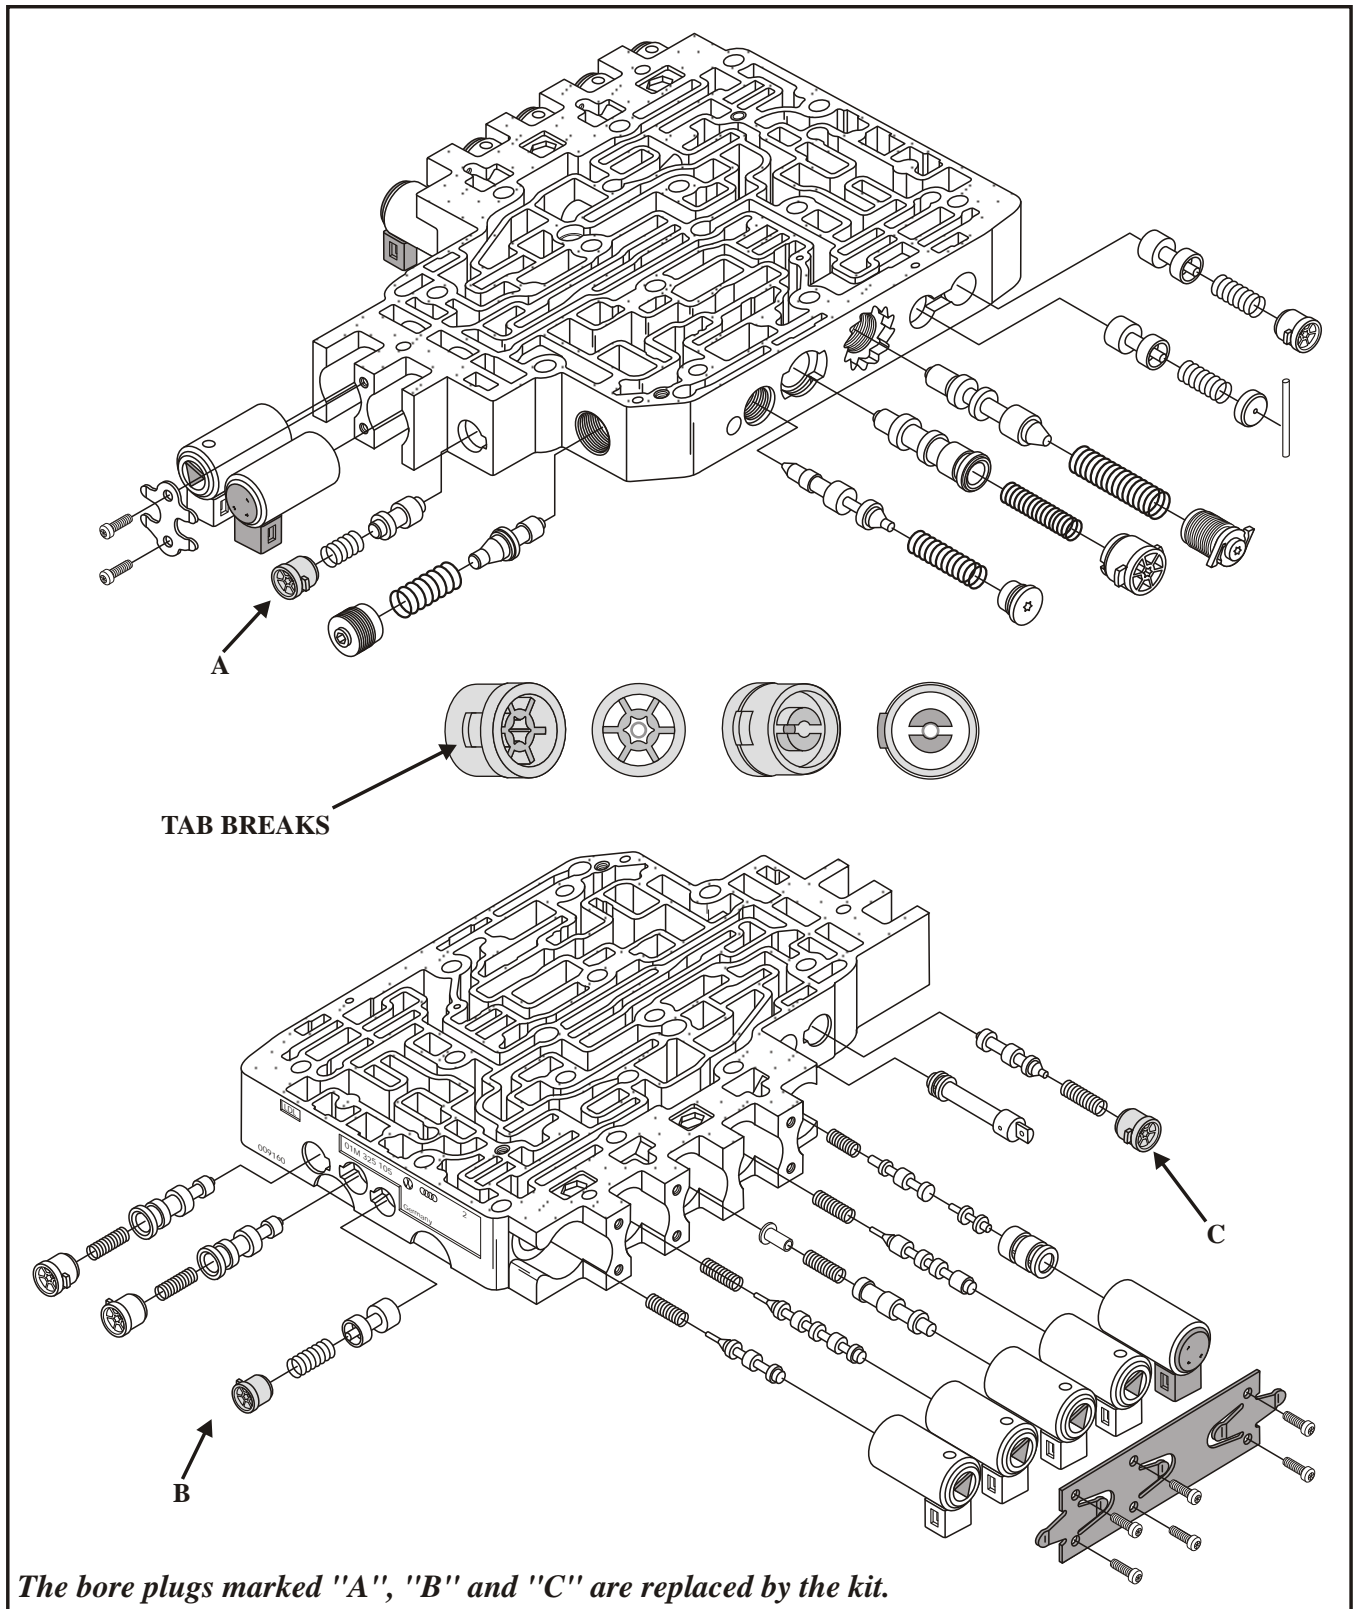
Figure 2

The retaining lugs on each of these valve body bore plugs indicated by "A", "B" and "C" in figure 2, have broken allowing the plugs to protrude or fall completely out of the valve body due to tension of the valve spring pushing against the bore plug. The complaint will depend on which plug has broken, the location of which, are shown in figure 3.

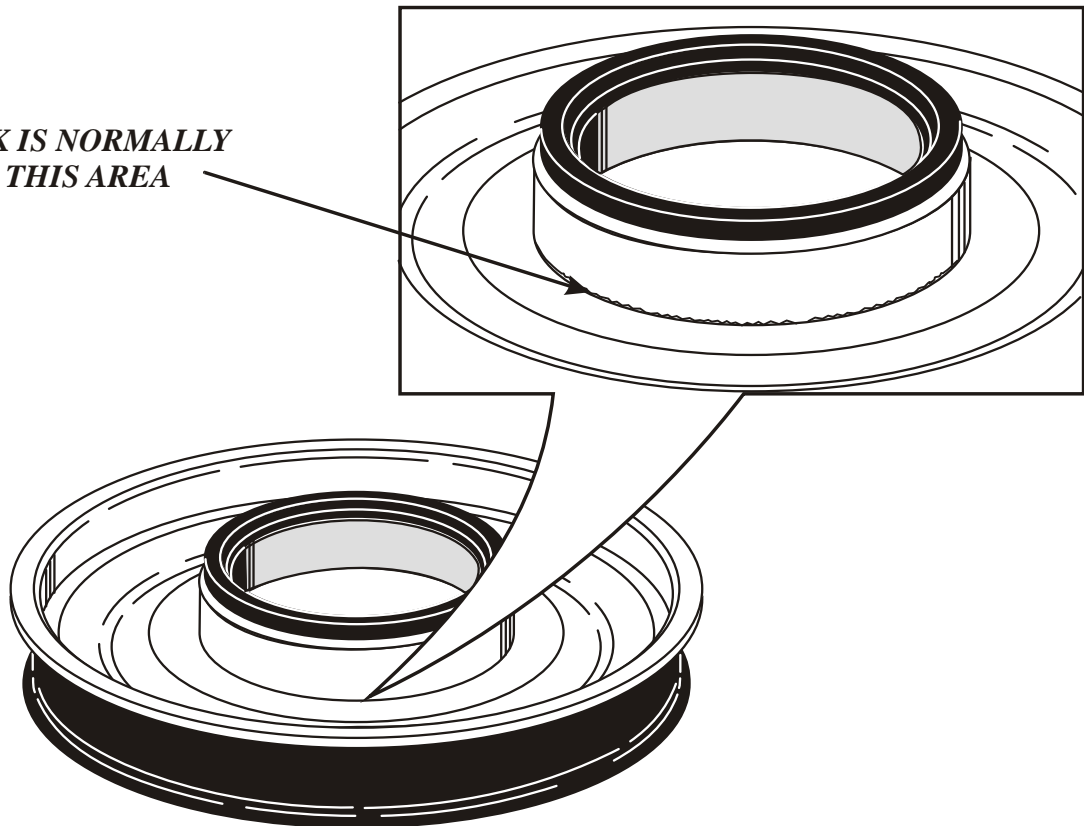
Figure 1

CAUSE: The cause may be, that the K1 (Forward) Piston is cracked, as shown in Figure 1, which can cause a loss of forward clutch pressure.

*CRACK IS NORMALLY
IN THIS AREA*

CORRECTION: Replace the K1 (Forward) Piston as part of every overhaul.

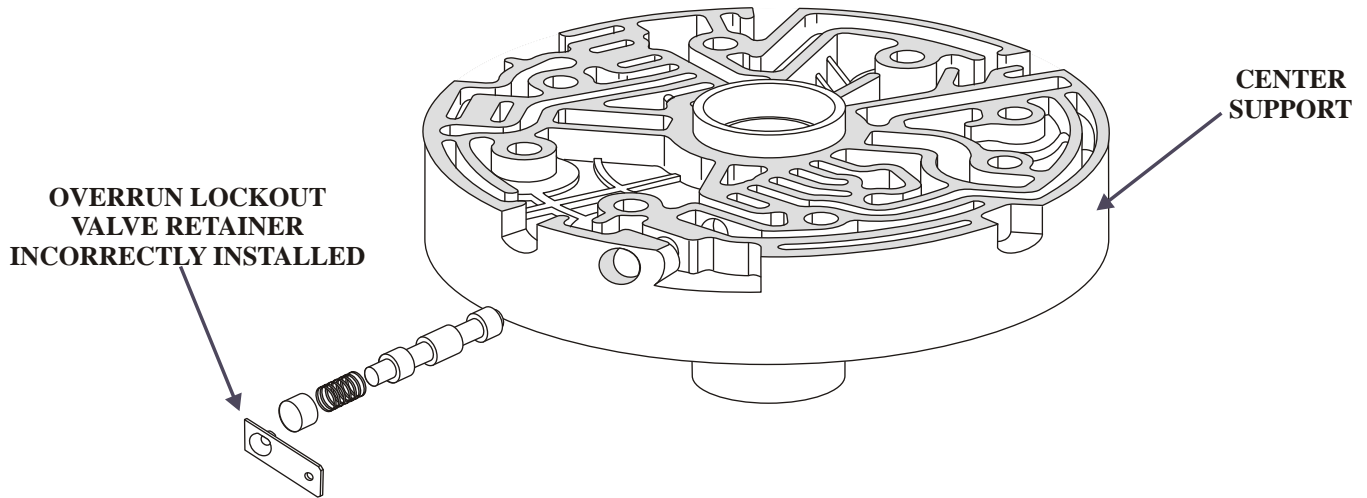
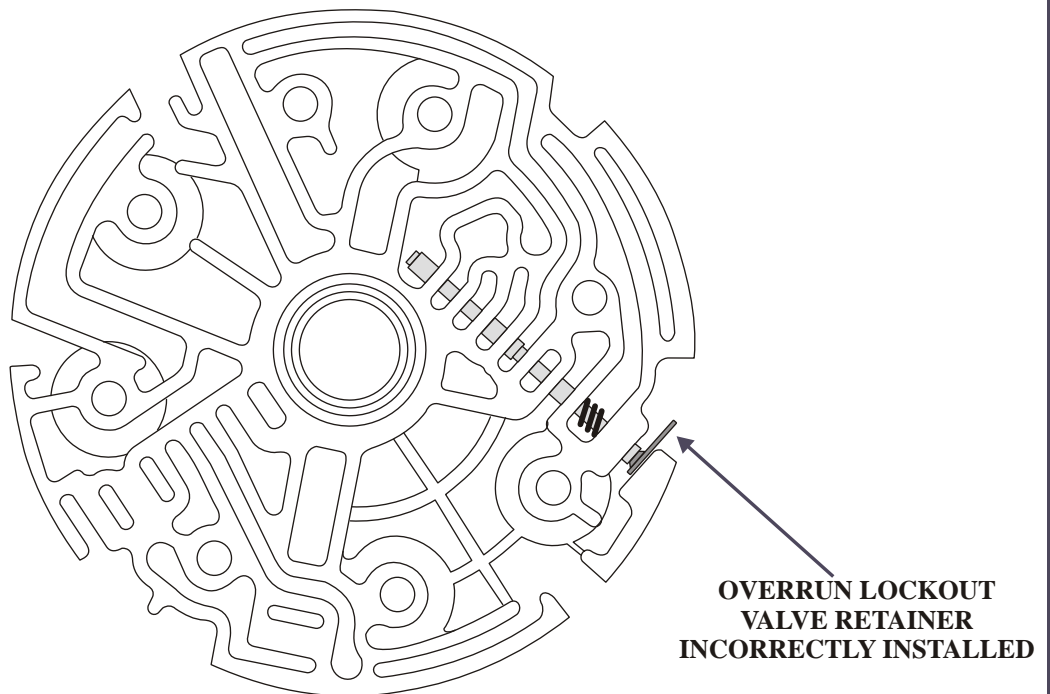
Figure 1

CAUSE: The Overrun Lockout Valve retainer was installed backwards, Refer to Figure 1, which prevents the valve from moving against the spring to allow fourth clutch feed oil from applying the fourth clutch.

INCORRECT

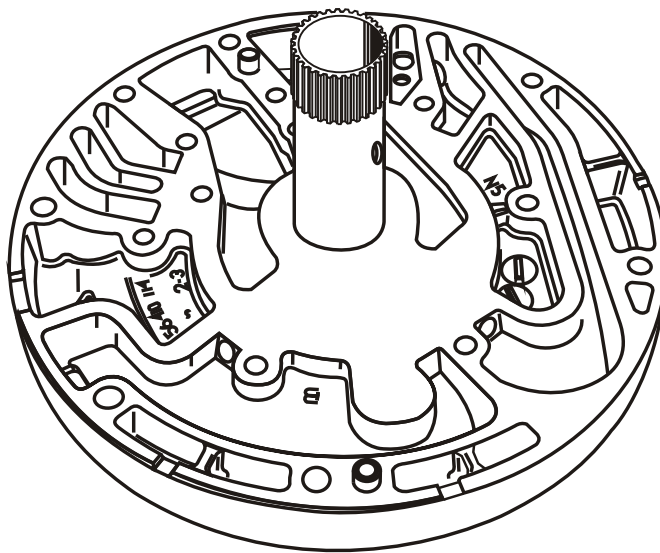
Figure 1

CAUSE: It is not uncommon to find that the stator support in the pump cover has turned. Depending on the severity of the turn will determine the type of complaint.

CORRECTION: If the stator support has turned inside the cover, the assembly will need to be replaced. The replacement support and cover is called by ZF Industries as "The Intermediate Plate" (See Figure 1). The part is 1056-210-119 and lists for \$ 524.45.

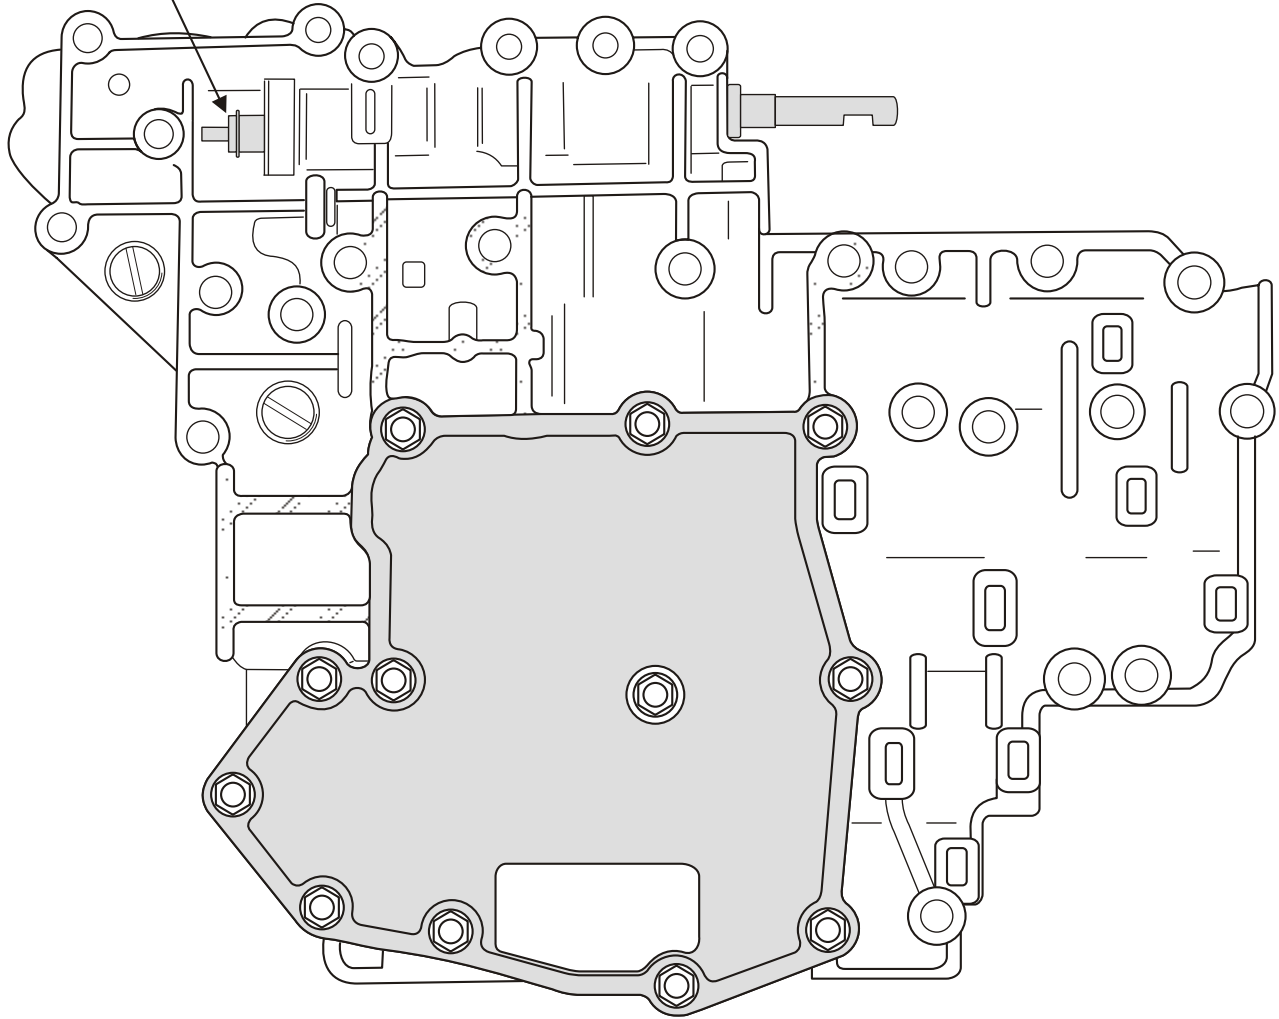
Note throttle valve stuck
in the full throttle position.

To correct this problem
push a 350/700 governor
spring onto the stem at the
back of the TV valve.
