# Technical Service Information

## THM 4T60-E NO CONVERTER CLUTCH APPLY

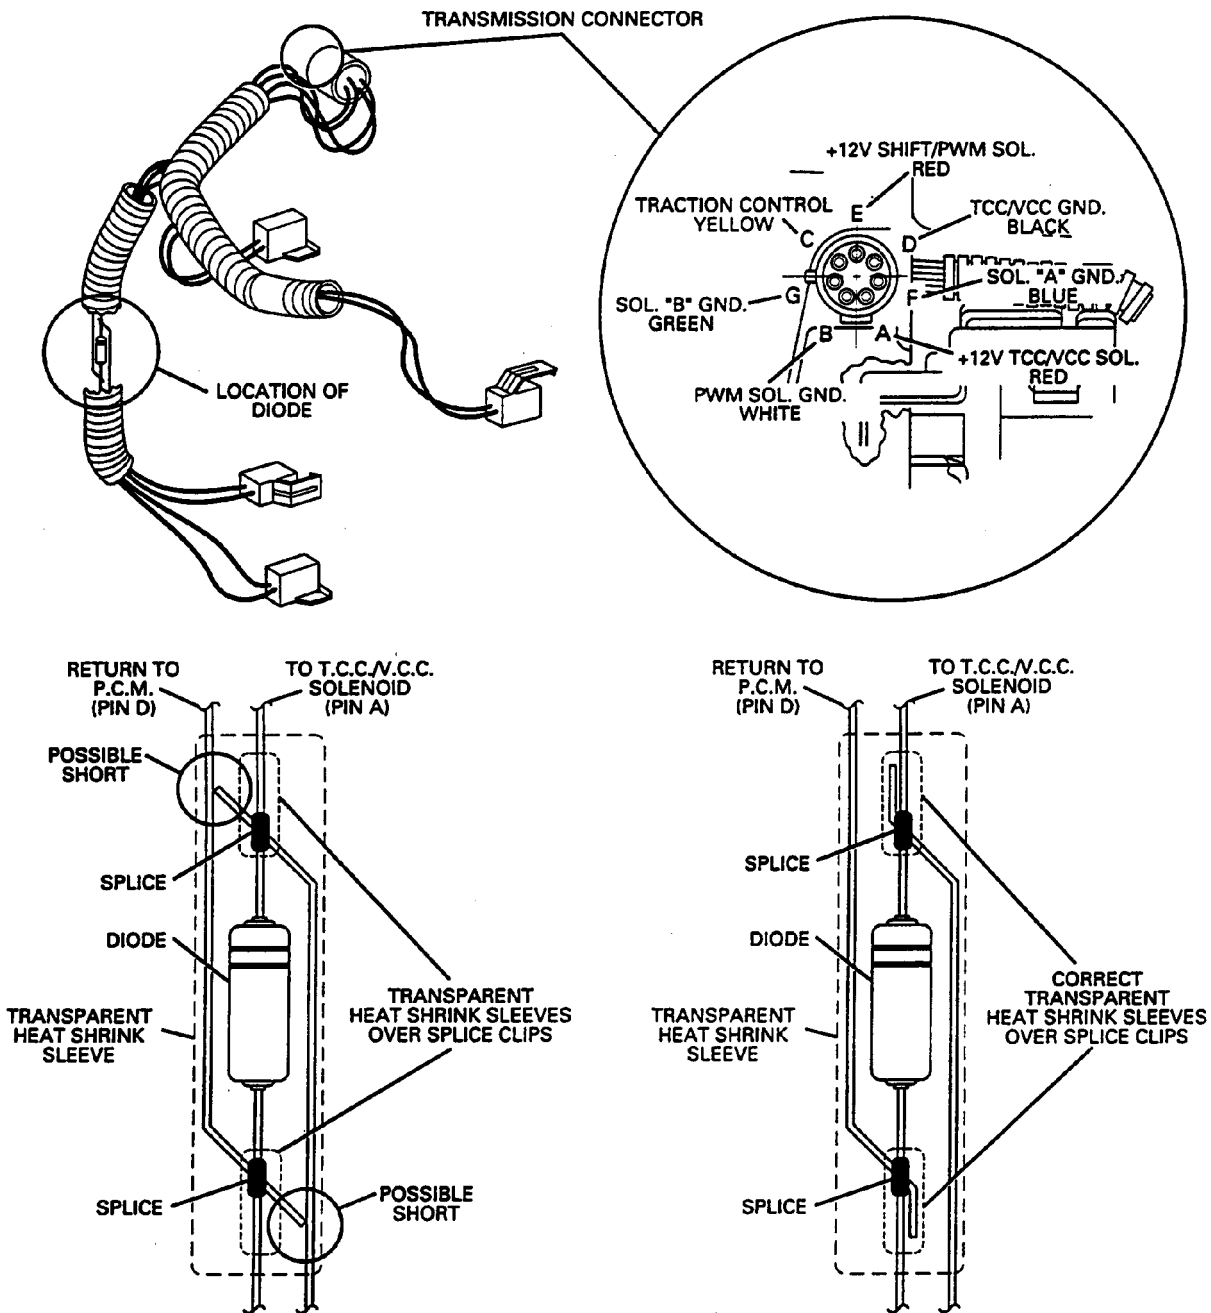
**CAUSE:** The cause may be a short at the diode in the internal wiring harness of the transaxle. The diode wire splice (Inside the Wire Harness) may have the ability to poke into the insulation of the adjacent wire causing a short (See Figure 1).

**CORRECTION:** To test for the above condition, the side cover must be removed, and disconnect the wiring harness from the converter clutch solenoid. At the transaxle case connector, place one probe of the DVOM on pin "A", and the other probe on pin "D". Refer to Figure 1 for pin location in the case connector. While monitoring the DVOM, manipulate the wire harness at the diode location. If continuity is present AT ANY TIME, the transaxle internal wiring harness MUST be replaced. 1991 MODELS
