# Technical Service Information

## FORD E4OD MANUAL LEVER DETENT SPRING BENT

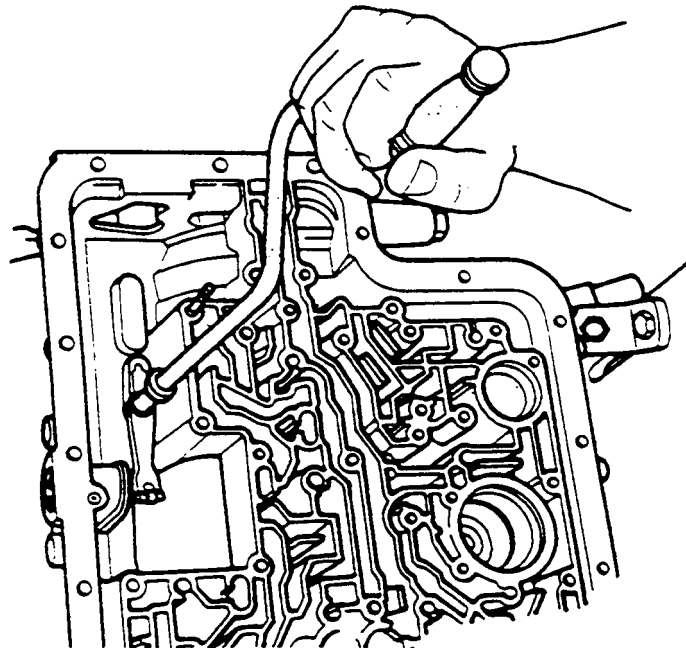
Figure 1

**COMPLAINT:** Manual lever detent spring bent or manual valve is misaligned.

**CAUSE:** While removing the 22mm. nut from the manual lever in order to replace the linkage seal, the rooster cone gets caught under the spring and bends it rearward.

1. Remove manual lever detent bolt and spring (See Figure
2. Using side cutters or suitable tool remove manual lever rollpin from the case (See Figure 2).
3. Remove lever nut while holding lever with suitable tool. (See Figure 3).
4. Remove detent rooster cone and park actuating rod (See Figure 4).
5. Remove manual lever Position sensor bolts and lever.
6. Replace seal.
7. Reverse steps 1-4.
